ILLINOIS STATE GEOLOGICAL SURVEY
Urbana, Illinois

I. Examination of Geological Conditions at Site of Proposed Underpass at Intersection of State Bond Issue Highway Routes Nos. 5 and 47 with Chicago, Milwaukee, St. Paul, and Pacific Railroad near Starks.

II. Examination of Geological Conditions Possibly Contributing to Cracking of Pavement in State Bond Issue Highway No. 53 South of Lisle.

January 16, 1933

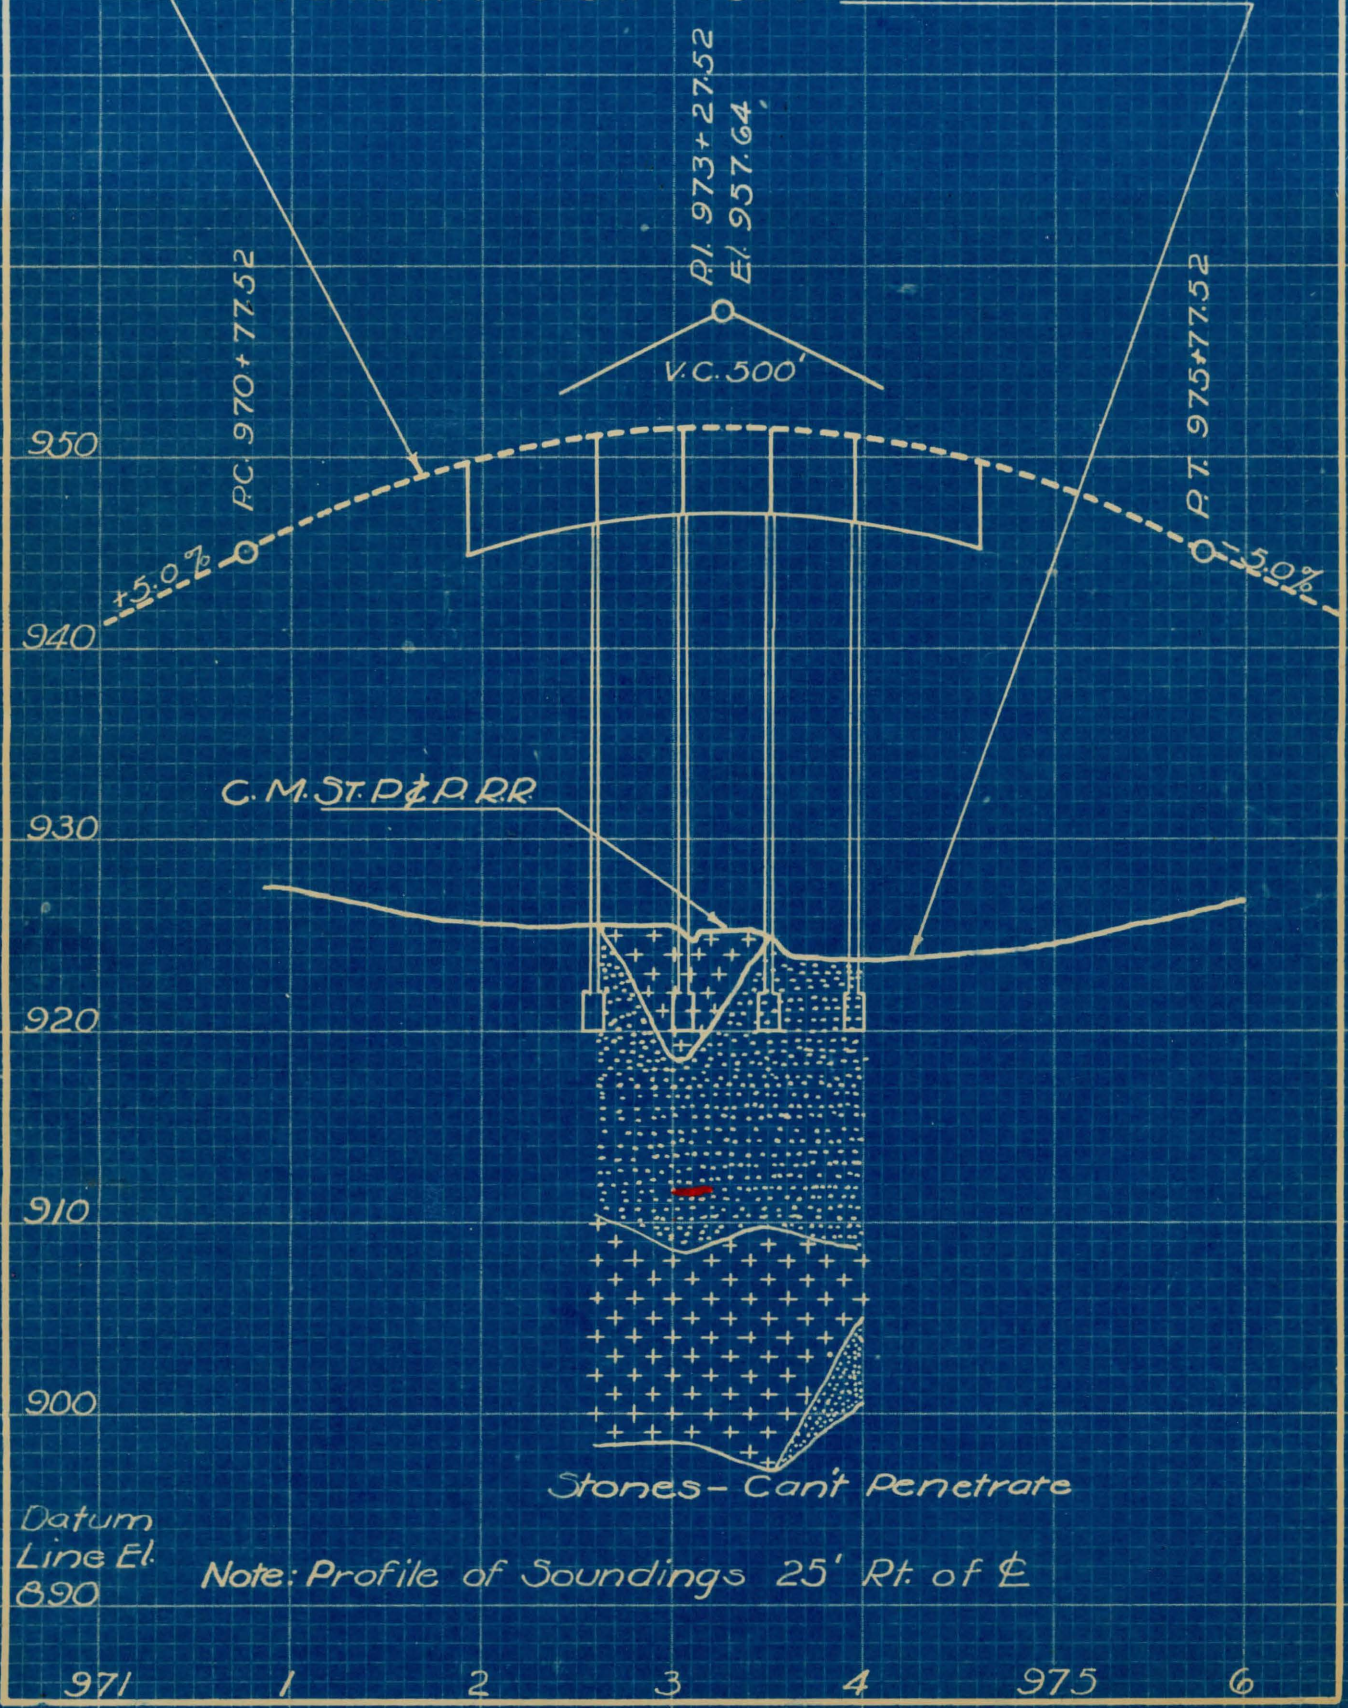
PEAT PROFILE

Stones - Can't Penetrate

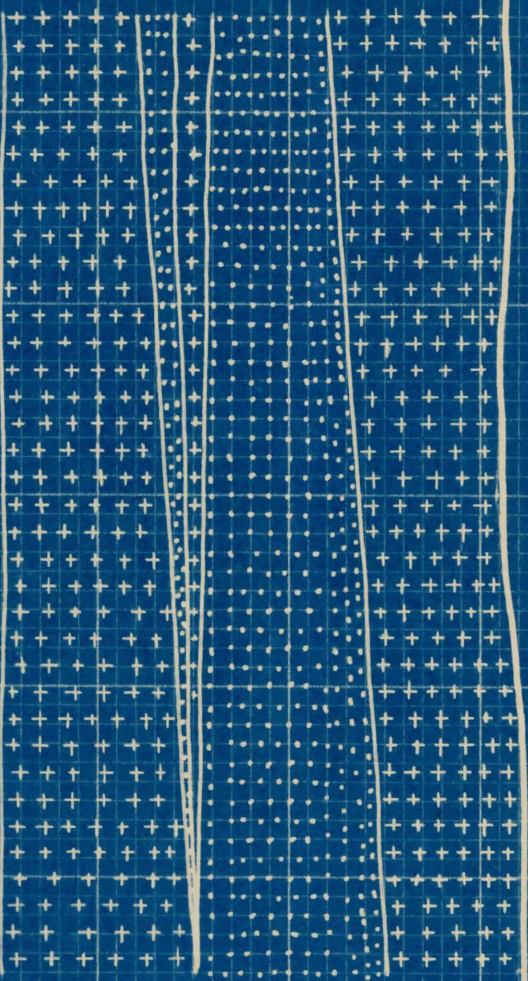
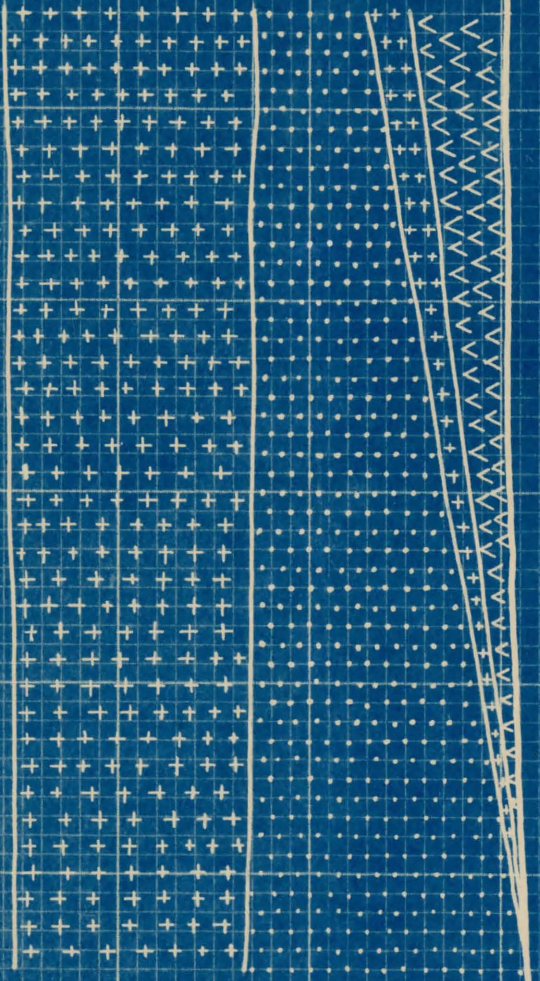
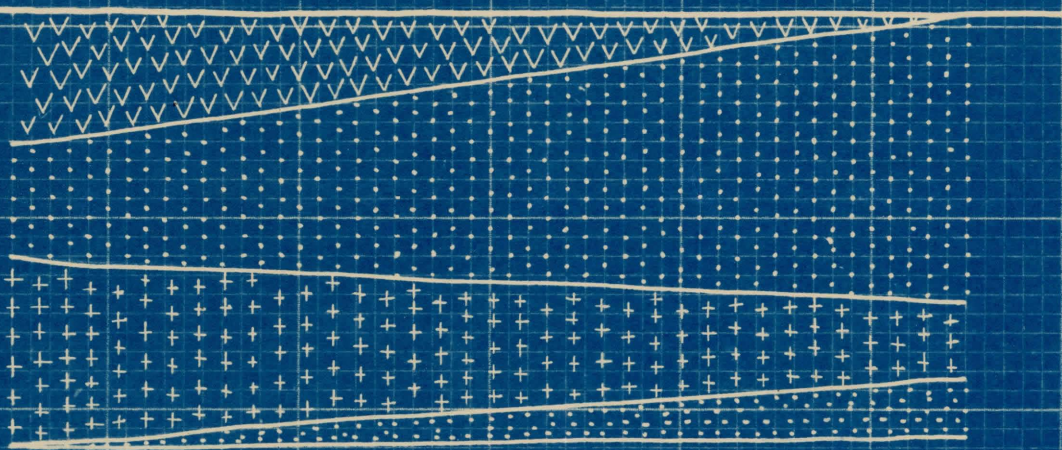
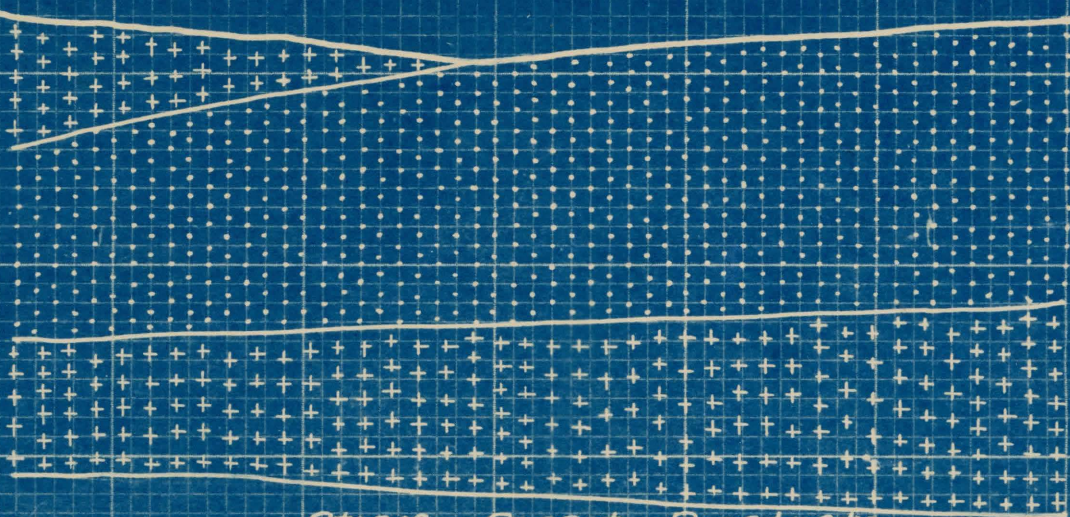
CROSS SECTIONS
PTE. 47 SEC. 106-V
STA. 972+60-973+96

Stones - Cannot Penetrate

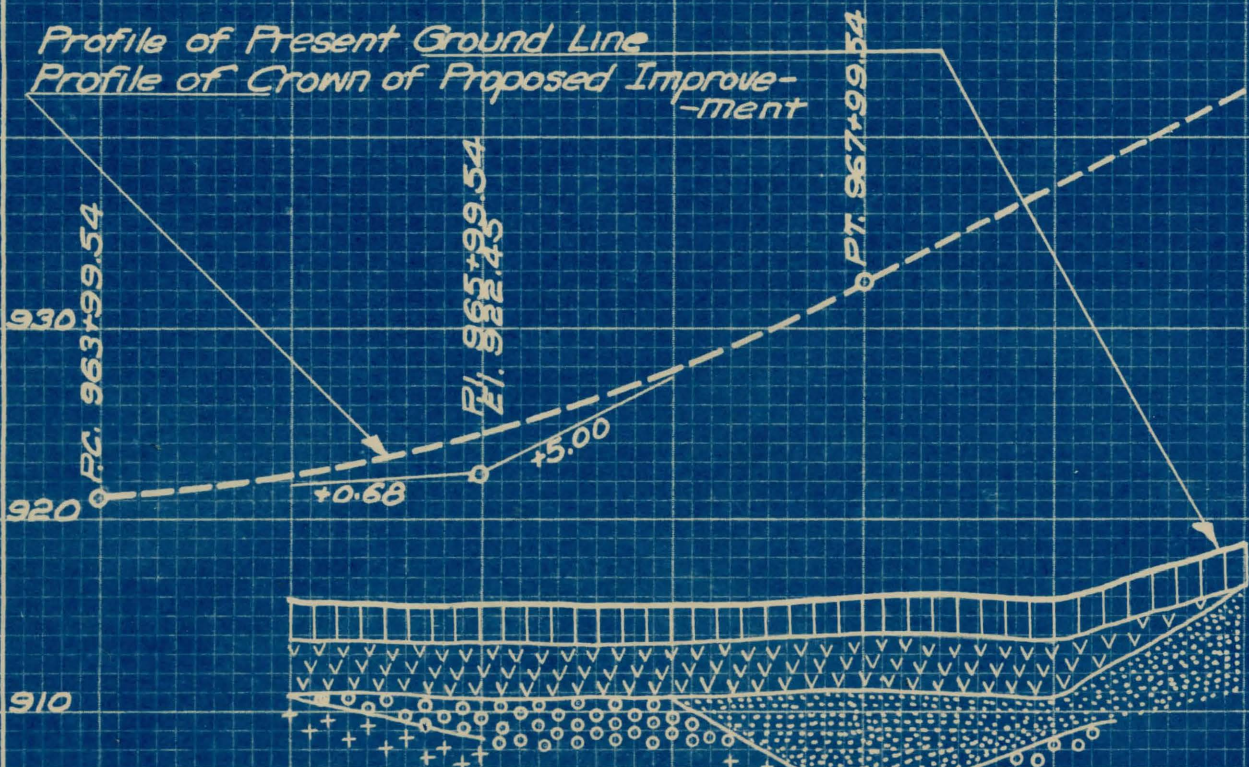
PROFILE OF MATERIALS
 RTE. 47 SEC. 106-X
 STARK'S STATION
 STA. 965+00-970+00

At Sta. 970, with very little stripping, a good grade of sand suitable for construction purposes could be secured. The fine grained silty sand at Sta. 968 and 969 is almost fine enough to be a quicksand. It is silty however, and dries as a hard mass rather than a powder. While not a particularly stable material its overburden and surroundings should hold it in place.
