Final Report: Hydrogeologic Characterization and Stream Assessment at Franklin Creek State Park, Lee County, Illinois

December 31, 2019

Open File Series 2019-2

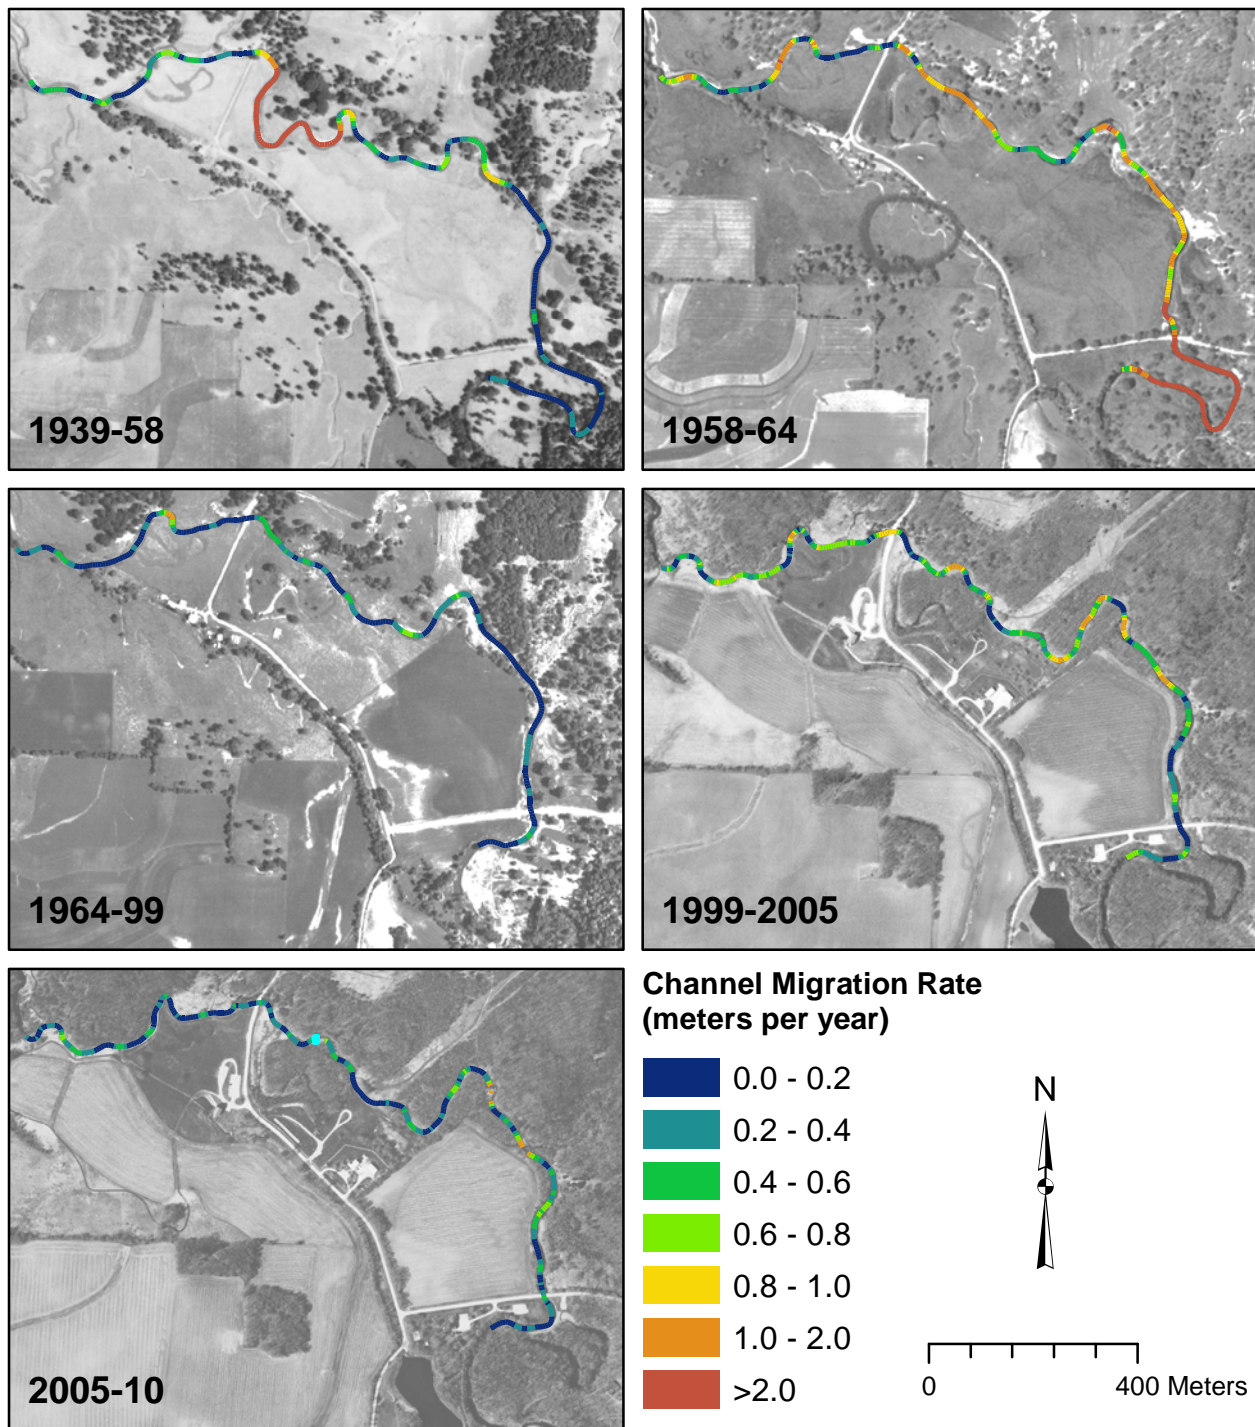
Channel migration rates under 1 m/yr (3 ft/yr) were much more common than higher rates. Rates greater than 1 m/yr (3 ft/yr) were most often found in more pronounced (i.e. higher amplitude) meander bends (Figure 19). Therefore, we evaluated six selected bends along the creek segment, including the subject bend of this study located at Site 5, to compare higher historical migration rates among meander bends (Figure 19, Table 1). During each interval, including the most recent, Bend 2 showed neither the highest nor the lowest migration rate. This indicates that, as least until 2010, Bend 2 was migrating at a rate that was within the range of variability for the selected bends within the Franklin Creek State Park and that the rate and mode (i.e., lateral and downstream) of migration is consistent with the natural stream processes at the park.

Figure 19. Channel migration rates along Franklin Creek at Franklin Creek State Park between 1939 and 2010. Background photos are the earlier year in the sequence.

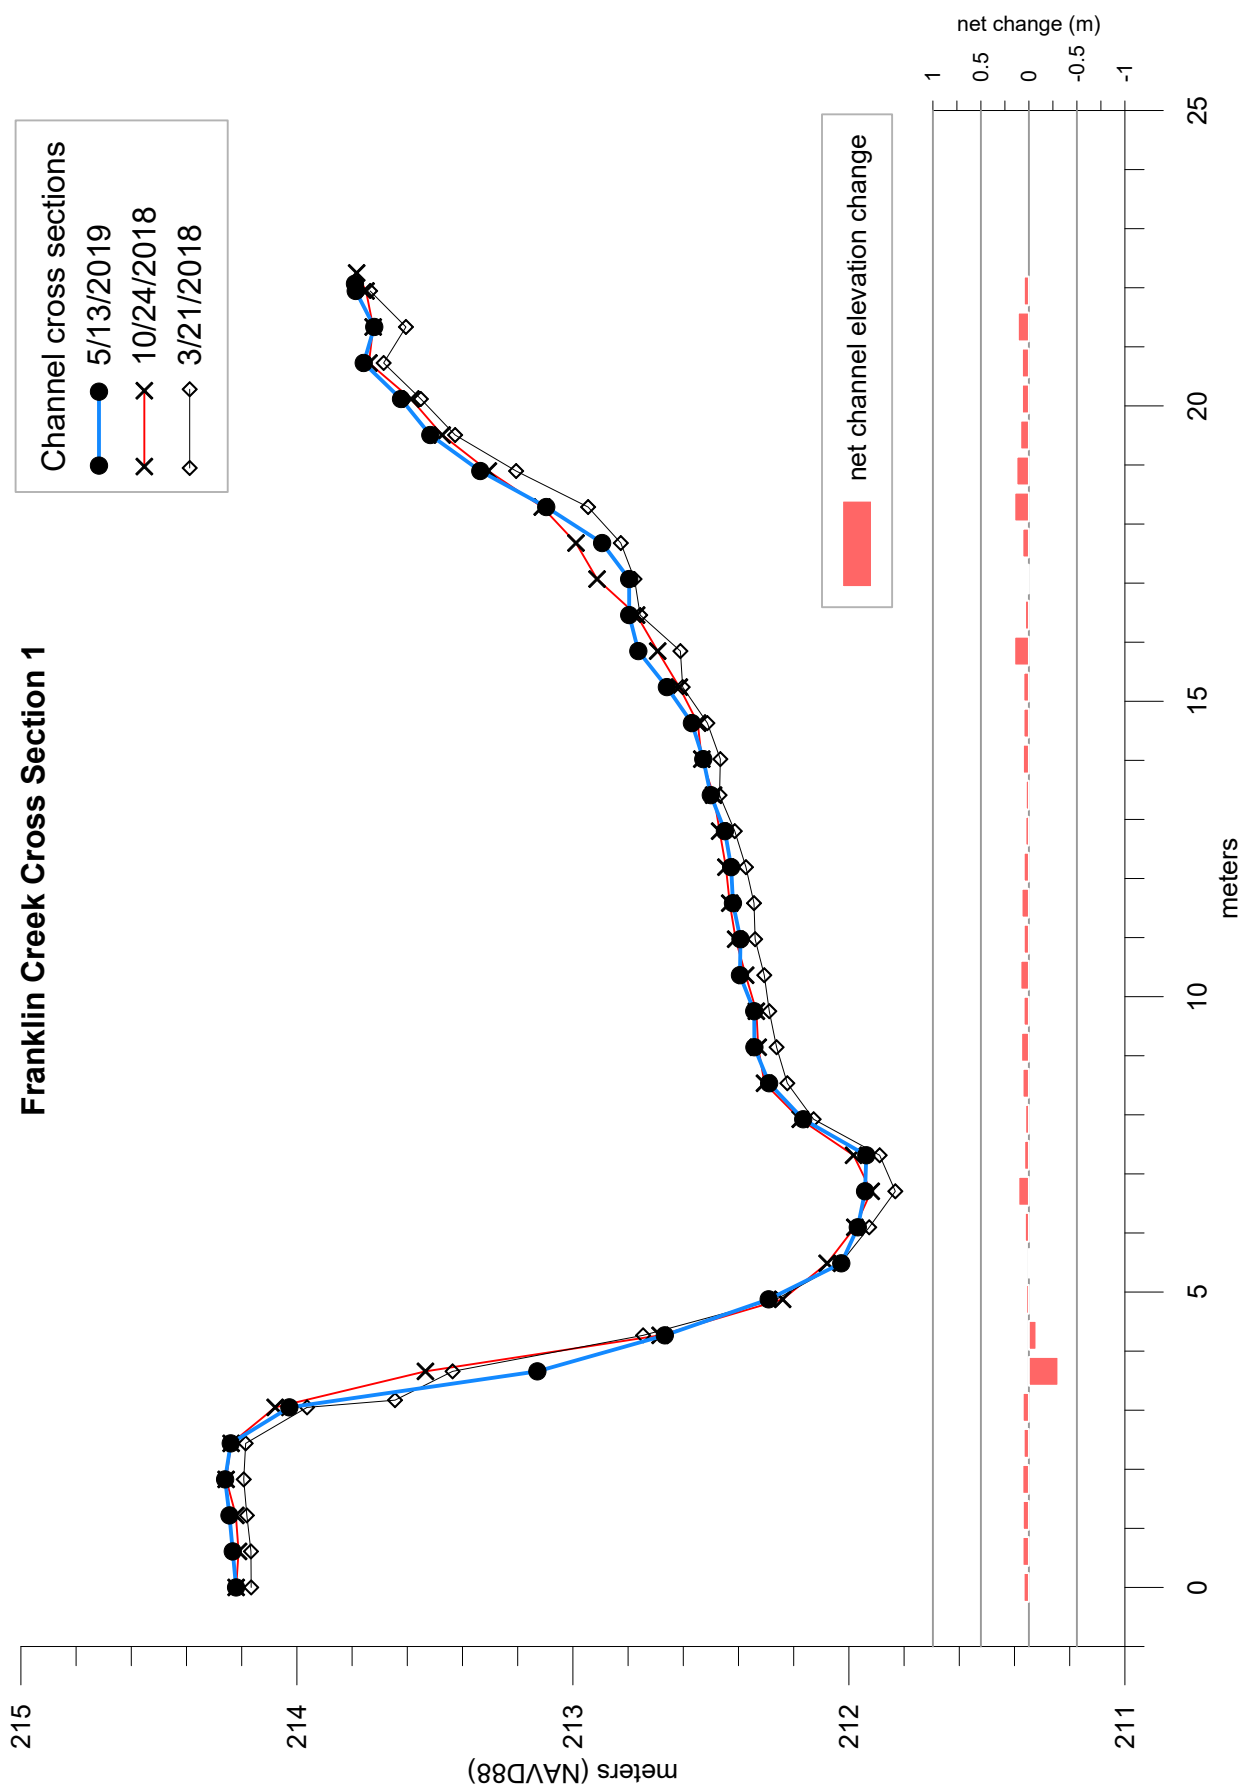
Figure 22a. Repeat channel cross section measurements of Franklin Creek channel at Site 5, cross section 1. The bar graph at the bottom of the figure shows the net change in channel elevation between March 21, 2018 and May 13, 2019.

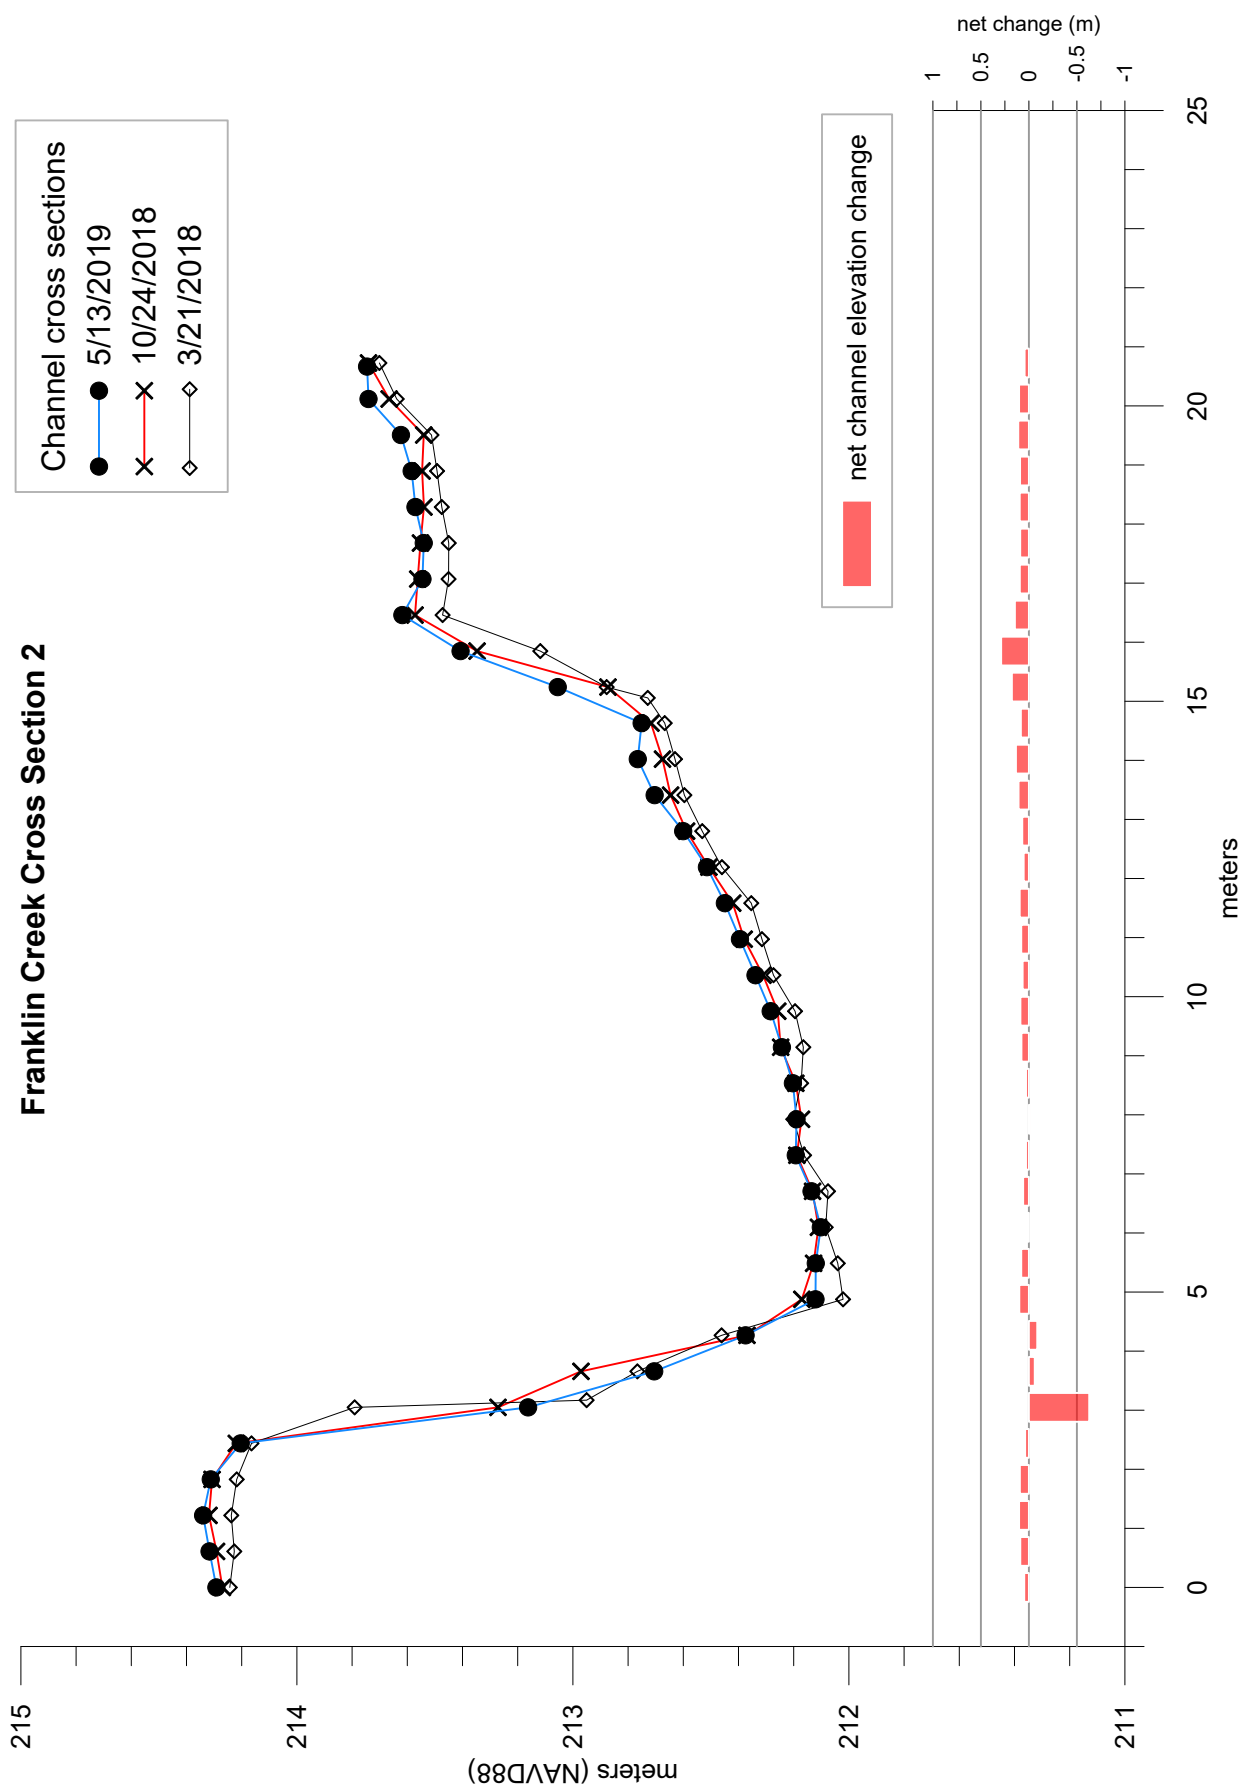
Figure 22b. Repeat channel cross section measurements of Franklin Creek channel at Site 5, cross section 2. The bar graph at the bottom of the figure shows the net change in channel elevation between March 21, 2018 and May 13, 2019.

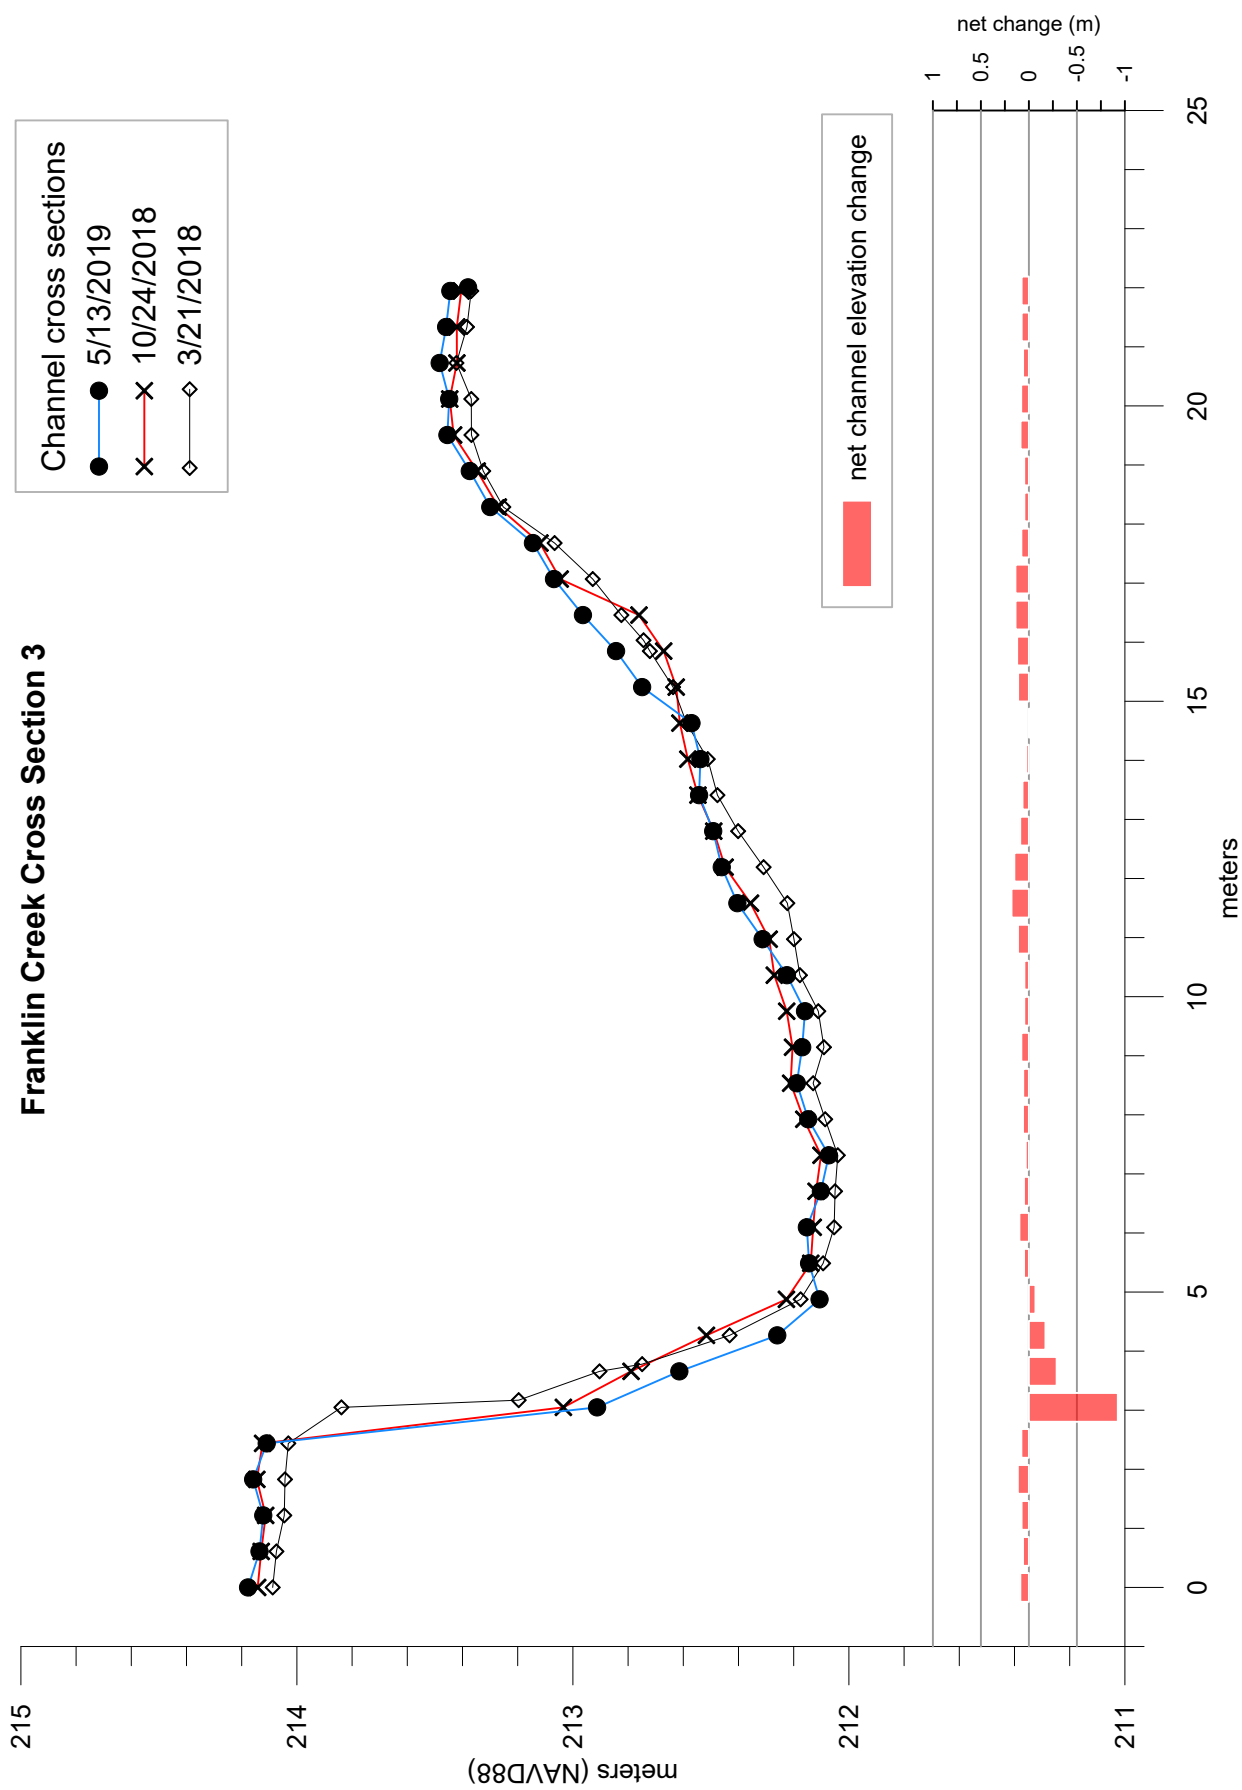
Figure 22c. Repeat channel cross section measurements of Franklin Creek channel at Site 5, cross section 3. The bar graph at the bottom of the figure shows the net change in channel elevation between March 21, 2018 and May 13, 2019.

Among the cross sections, the maximum (vertical) erosion per measurement point location was 0.93 m (3.05 ft) in cross section 3 and the maximum deposition measured was 0.29 m (0.95 ft) in cross section 2. All portions of the point bar (right bank) and most of the channel bed showed either no erosion or net deposition. Only those areas of the channel bed closest to the left bank showed net erosion in cross sections 1, 2, and 3. Cross section 4 showed some slight erosion in the center part of the channel.

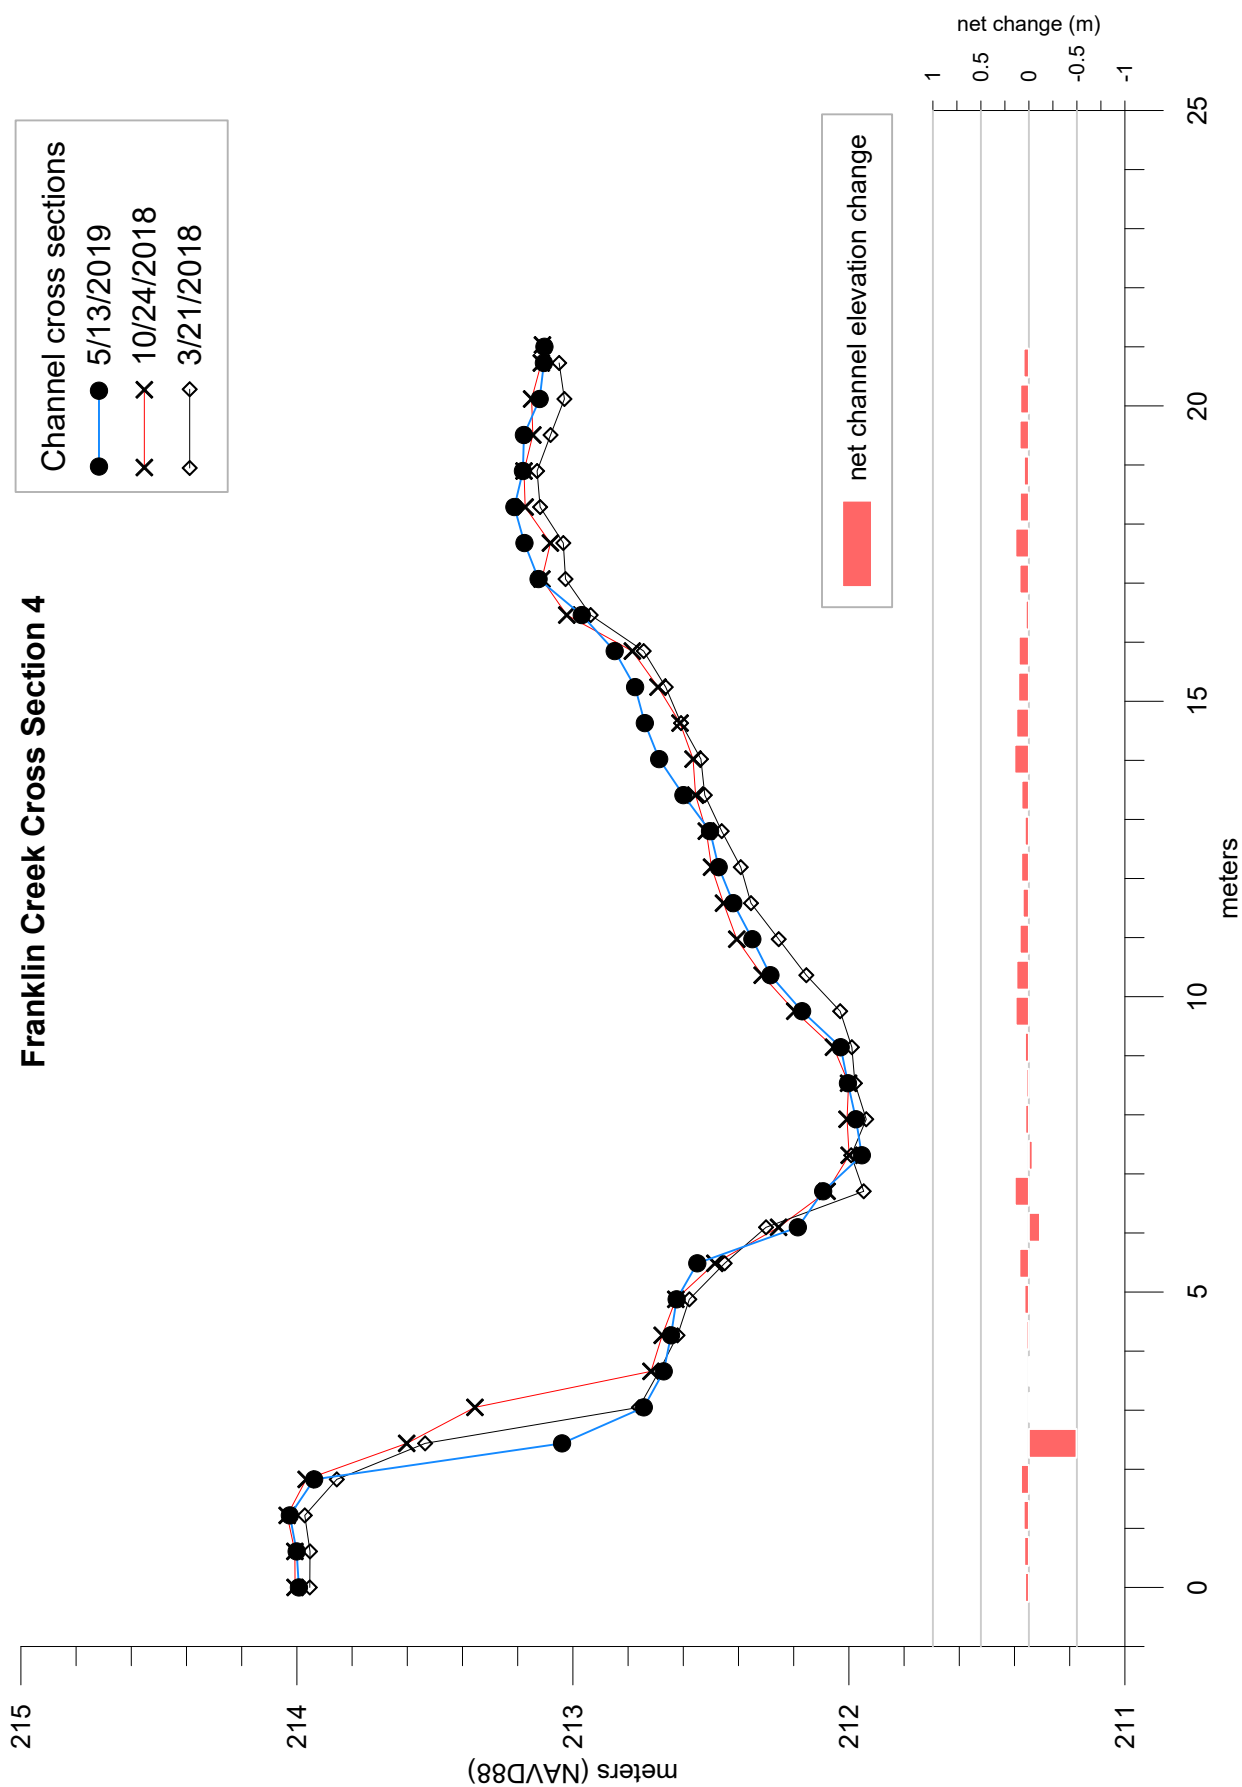
Figure 22d. Repeat channel cross section measurements of Franklin Creek channel at Site 5, cross section 4. The bar graph at the bottom of the figure shows the net change in channel elevation between March 21, 2018 and May 13, 2019.

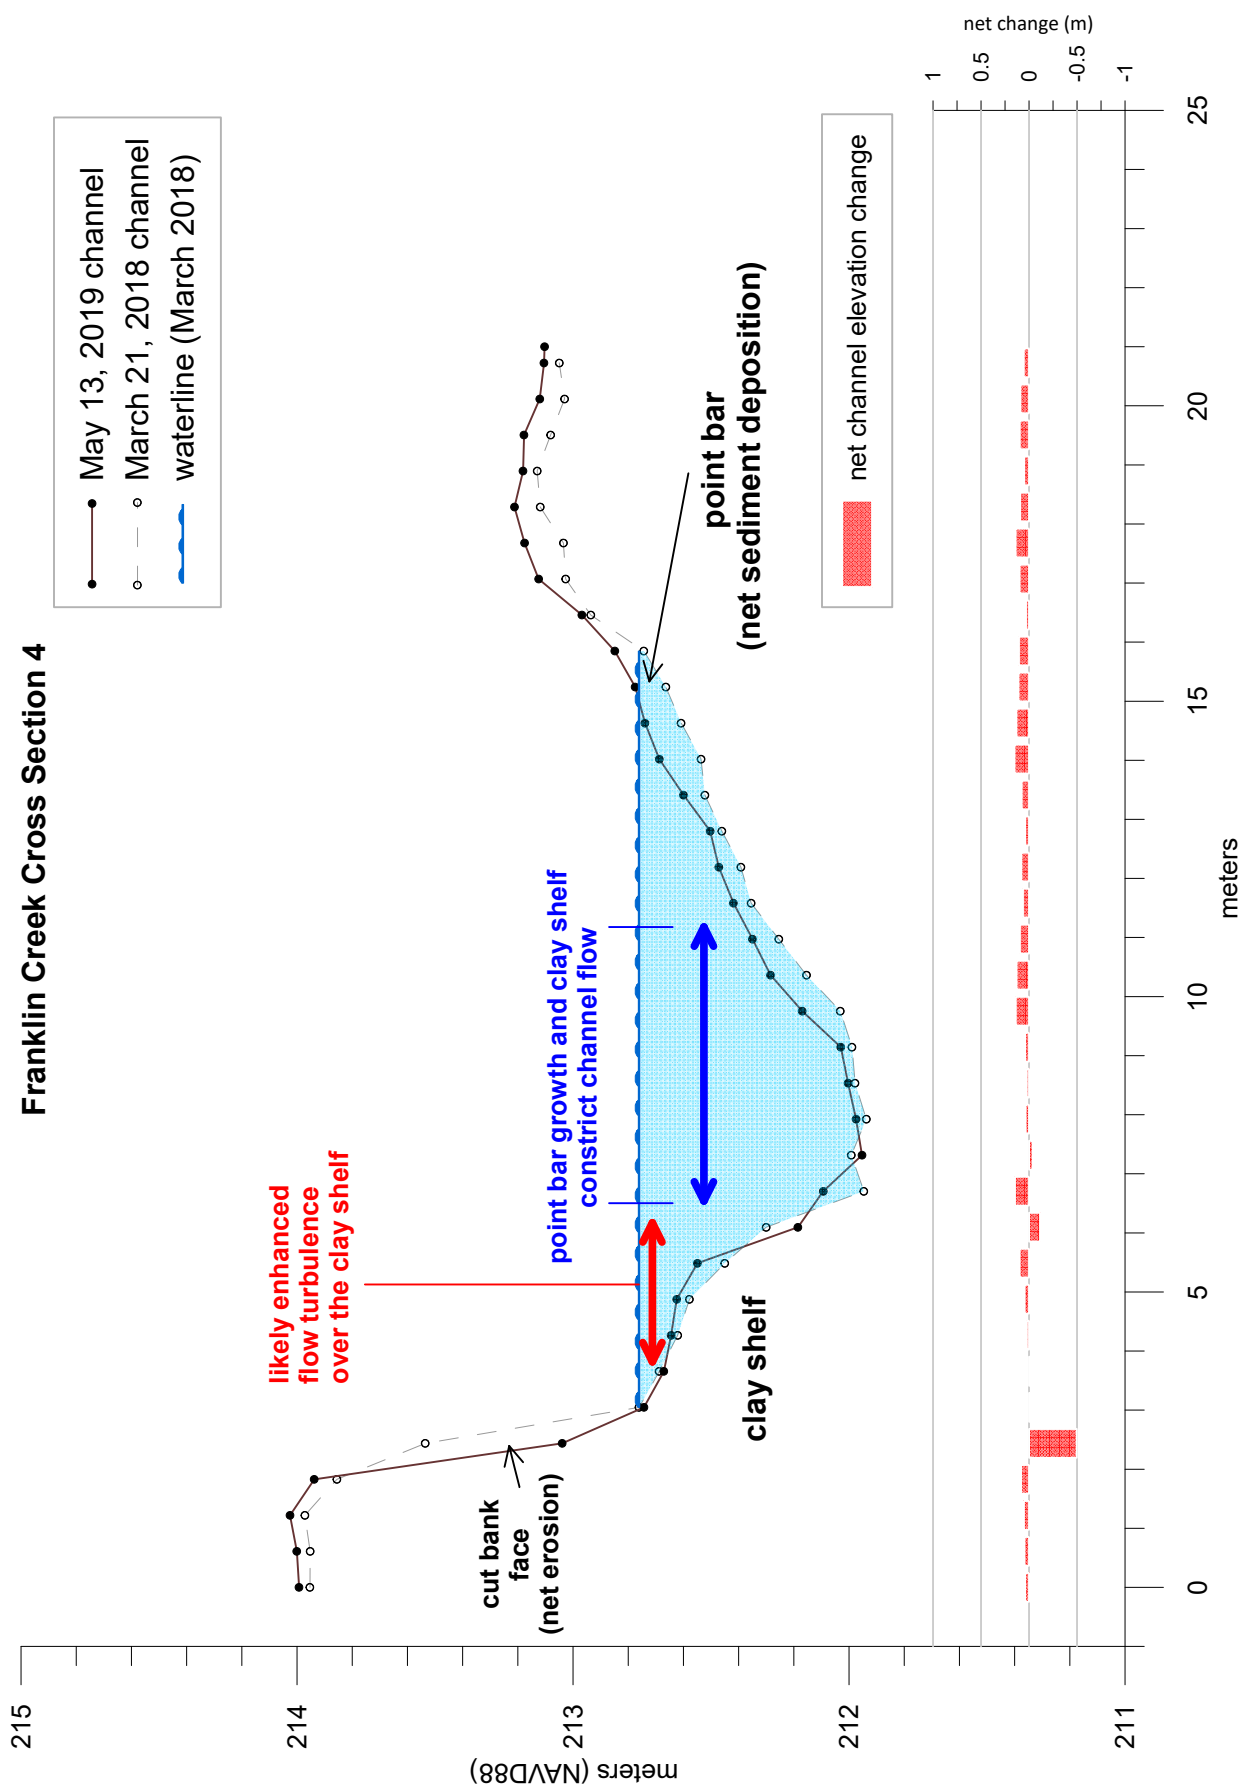
The cross sections 1, 2 and 3 reflect typical pronounced bar-pool topography and channel asymmetry associated with alluvial meander bends (Knighton 1998); a point bar along the right bank composed of finer grained sediments with the deeper part of the channel (i.e., pool) along center of the channel and toward the left bank with coarser grained materials. Cross section 4, however, is atypically symmetrical for the position in the bend. The more symmetrical channel shape in cross section 4 reflects the presence of a clay-rich deposit forming a shelf that protrudes into the channel slightly below base flow water level. The resistance of the clay shelf coupled with point bar deposition and growth along the opposite bank constricts stream flow and likely increases local stream velocity and turbulence near the bed and left bank (Figure 24).

Figure 24. Likely effects of the point bar aggradation and the resistant clay layer on flow at cross section 4, Site 5, Franklin Creek State Park. Flow constriction likely enhances bank erosion downstream of cross section 4.

but remains intact until it becomes unstable and falls into the channel. This bank failure process tends to occur at higher rates where the banks have shallow rooted or little to no vegetation. Cross-section 4 shows atypical channel symmetry for its position within the meander bend. The shape of the channel at this cross-section indicates the presence of a resistant clay rich deposit in the bed and banks. The clay-rich deposit along with active deposition on the point bar constricts flow in the downstream portion of Bend 2. The flow constriction likely causes local increases in stream flow velocity and turbulence near the bed and banks. This effect is likely enhanced at higher stream stages leading to increased erosion of less resistant material around the clay deposit and just downstream. This effect is particularly evident from the deep scour hole observed in the downstream portion of the bend and the bank failure immediately downstream.

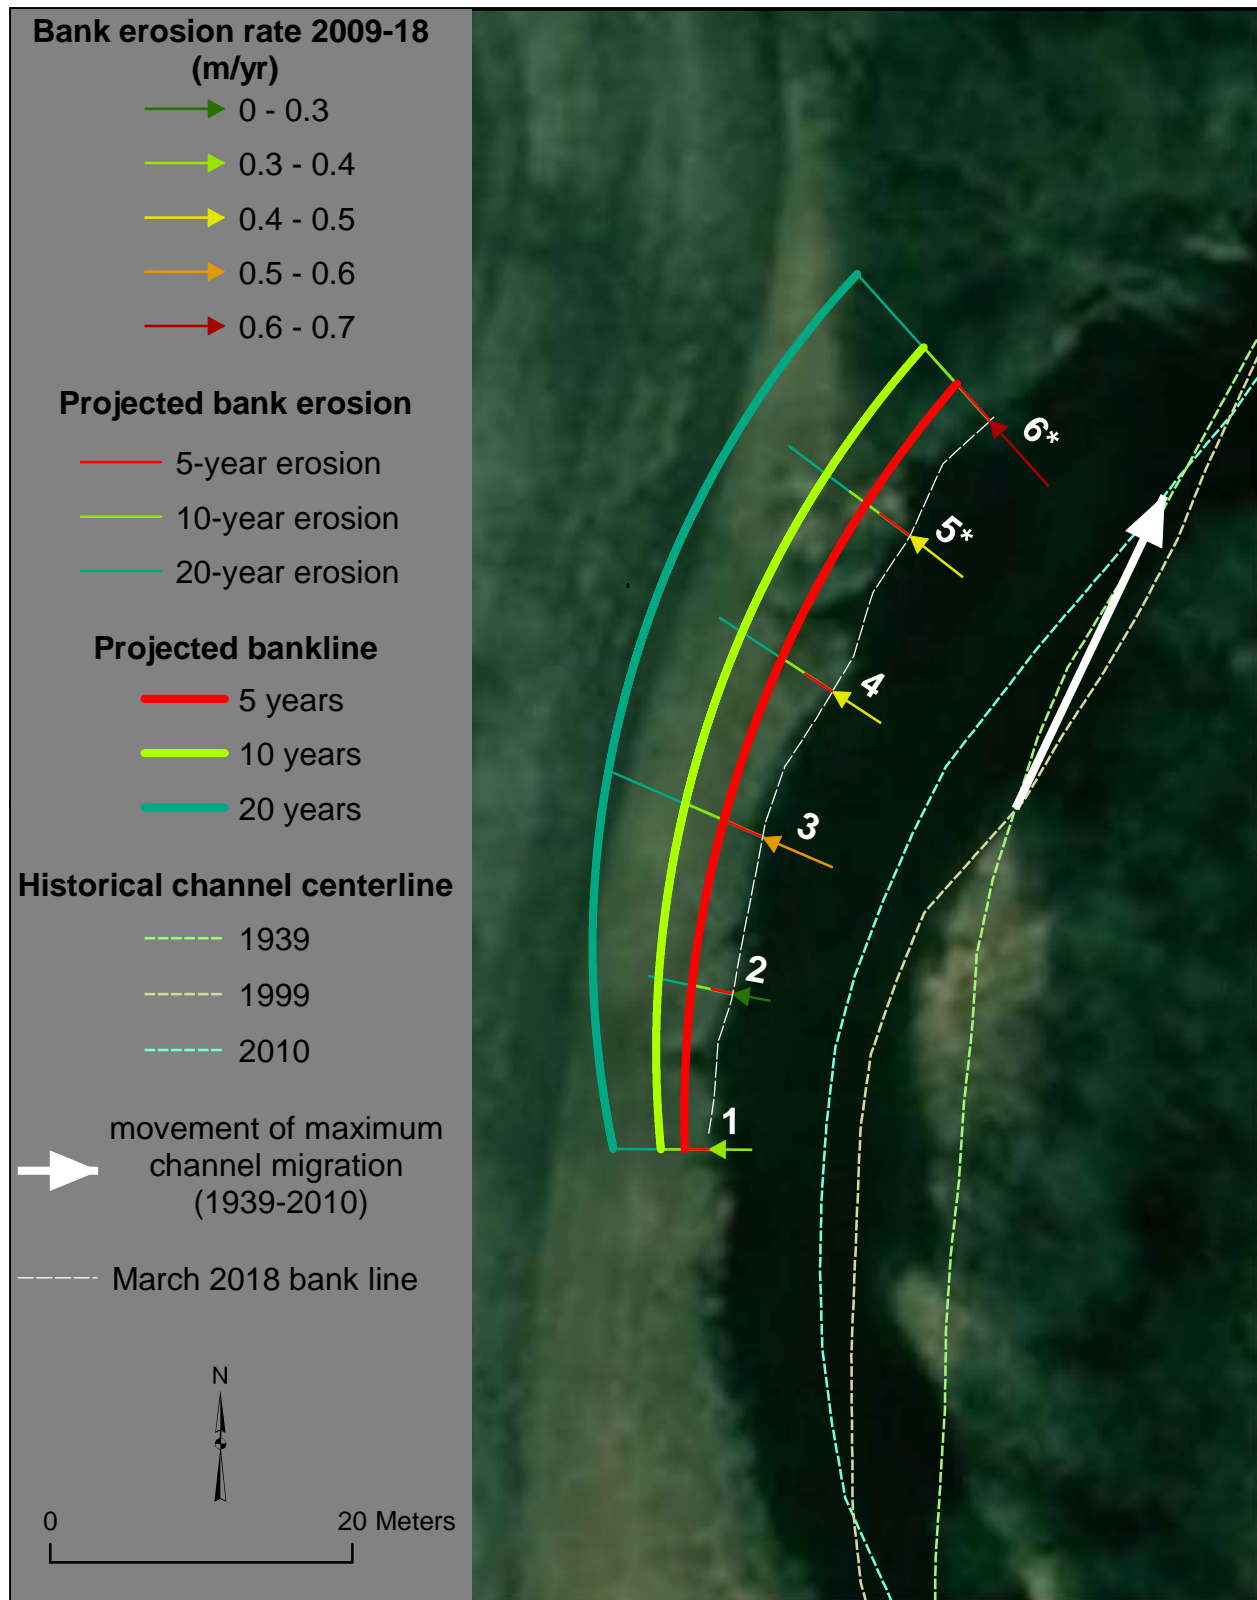
Comparison of the 2009 LiDAR elevations and the March 2018 bank line measured on-site with GPS shows bank retreat over this period throughout Bend 2 at Site 5. Total bank retreat ranged from 2.54 m at cross section 2 in the upstream portion of the bend to 5.85 m at location 6 in the downstream portion of the bend (Table 3). The corresponding erosion rates ranged from 0.28 m/y to 0.65 m/yr. The future position of the bank line was estimated based on these recent bank erosion rates and is shown in Figure 25. The approach we used to estimate future channel erosion does not account for the likely downstream movement of the location of maximum channel migration (see the white arrow in Figure 25) and cannot account for future changes in watershed conditions or climate patterns.

Figure 25. Projected bankline erosion at 5- 10- and 20-year intervals at Site 5. Projections were estimated using 2009-2018 erosion rates. Representation of the projected banklines are based on the maximum rates from this time period. Labels 1 through 4 correspond with measured channel cross sections locations 5 and 6 are assigned measurement locations with no corresponding cross section.

Also, the projection was based on current maximum erosion rates and therefore may overestimate the future erosion that could take place. Nonetheless, based on the assumption of erosion rates of similar magnitude to current and historical rate this provides a guideline for the range expected erosion to inform restoration activities. Based on the projection, the streambank margin at the 5 years threshold is expected to range from approximately 1.6 m at the upstream end to 3.25 meters at the downstream end. The margin at the 10 and 20 years would range from 3.2 m to 6.5 m, and 6.3 m to 13 m, respectively.

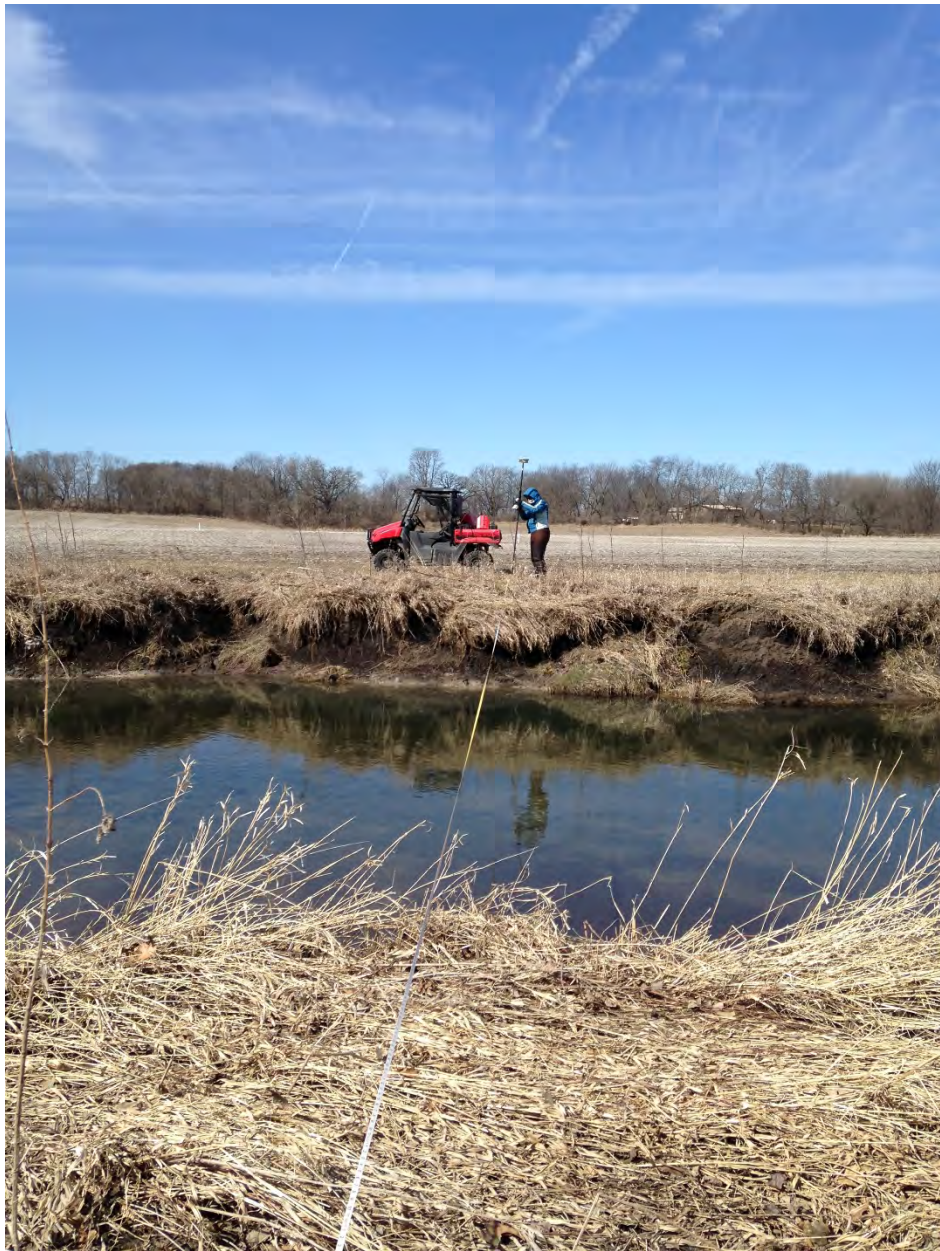
A4. Stream bank near Gauge A during the March 21, 2018.

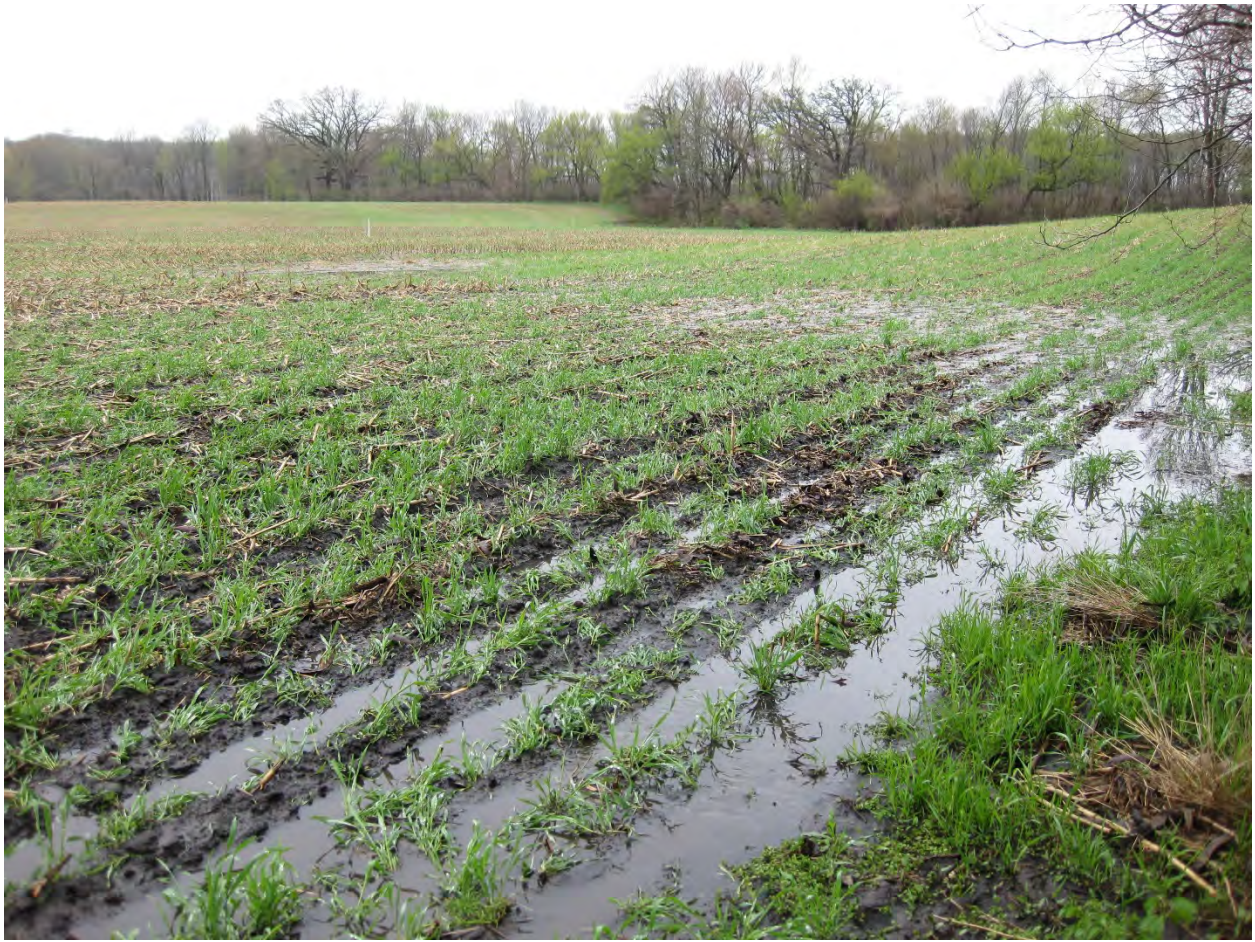
A7. Ponding on the farmed field during the April 29, 2019 site visit. Photo is looking southwest towards well 8.

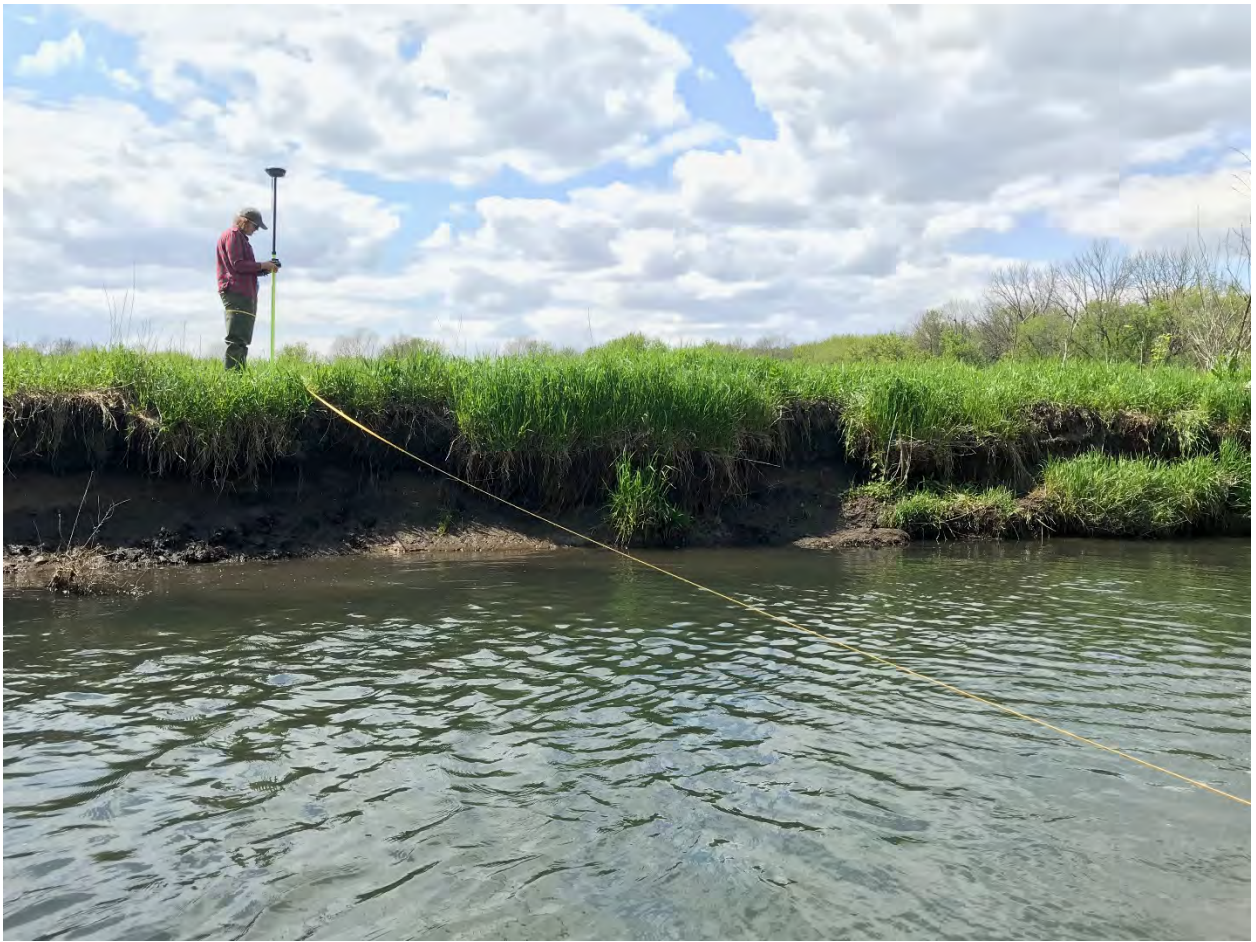
A9. Undercutting of bank near Gauge A taken during the May 13, 2019 site visit.
