STATE OF ILLINOIS
DEPARTMENT OF PUBLIC WORKS AND BUILDINGS
DIVISION OF HIGHWAYS

MEMORANDUM

TO J. D. Lindsay	SUBJECT Columbia Quarry Co. Ullin, Illinois
FROM S. M. Peters

The pictures in this group were taken at Columbia Quarry Company's Quarry at Ullin, Illinois on Wednesday, April 27, 1960. They show the quarry as it was when Frank Brock, District Engineer of Materials of District 9 and I, in company with Richard Kiel of this laboratory, and Jack Gore of the Columbia Quarry Company, were there on that date.

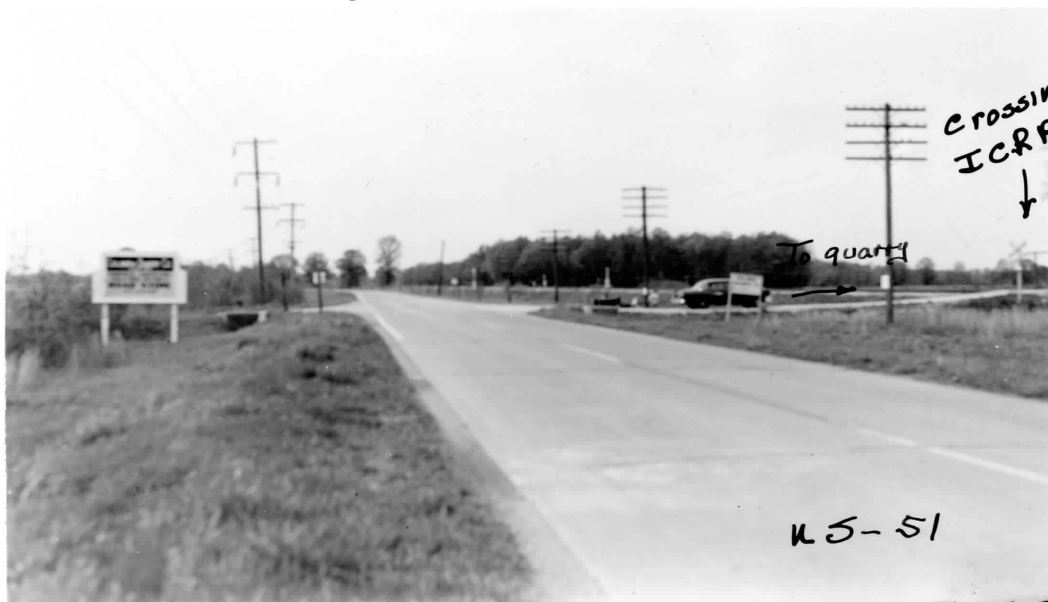
1

The pictures in this group show the quarry of the Columbia Quarry Company at Ullin in Pulaski County -- as it was on Wednesday, April 27, 1960. This picture shows the intersection on U.S. 51 where you turn northwest for about 1/2 mile to the quarry. Note the I.C.R.R. crossing at the right.

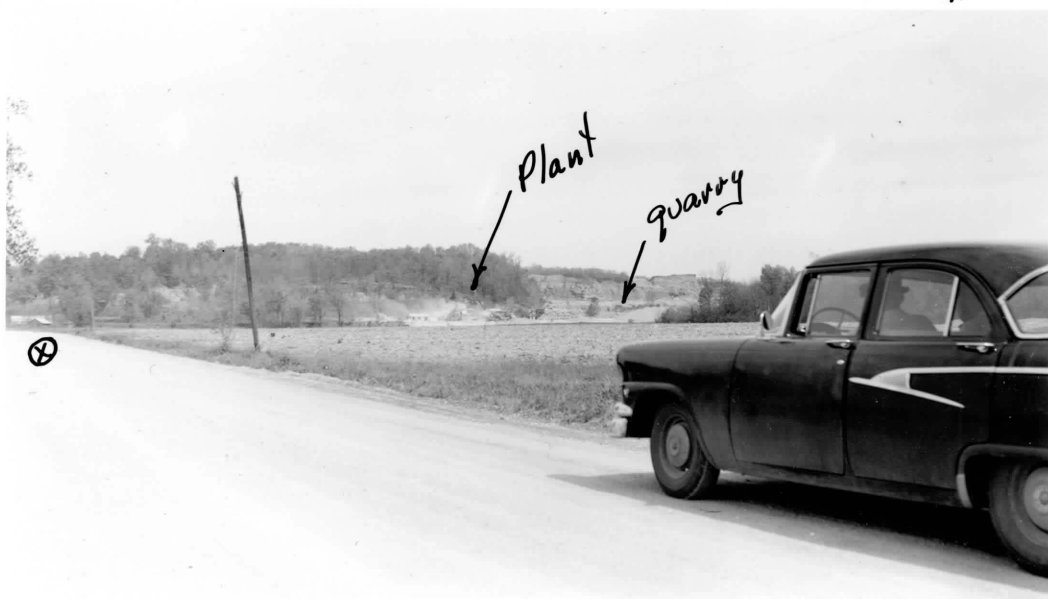
2

This shows the location of the plant and the quarry in the bluff-looking northwest from the township road from about 1/4 mile west of U.S. 51.

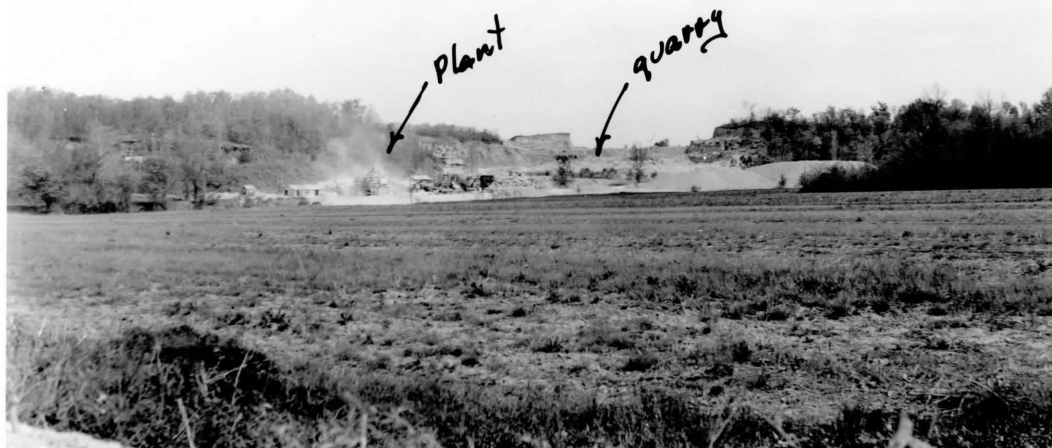
3

A closer view of the bluff, and the plant and quarry area--taken from the spot marked by the circled X on the road in picture No. 2. This bluff extends on a general northeast--southwest line for a distance of almost two miles. About 1/4 mile south of the quarry it bends to the west for about 1/2 mile before it turns back to the north.

According to Mr. J. E. Lear of the Illinois Geological Survey in his bulletin--"Limestone Resources of Extreme Southern Illinois"--dated 1959, the rock in this bluff is the Warsaw-Salem Formation of Mississippian age. This formation underlies the St. Louis Limestone and is just above the chert and silicious limestone of the Keokuk--Burlington Formation. About 100 feet of the Warsaw-Salem ledges are exposed here.

The point 1/4 mile to the south of the quarry where the bluff bends to the west marks the southernmost extent of the Warsaw-Salem exposure in this area.

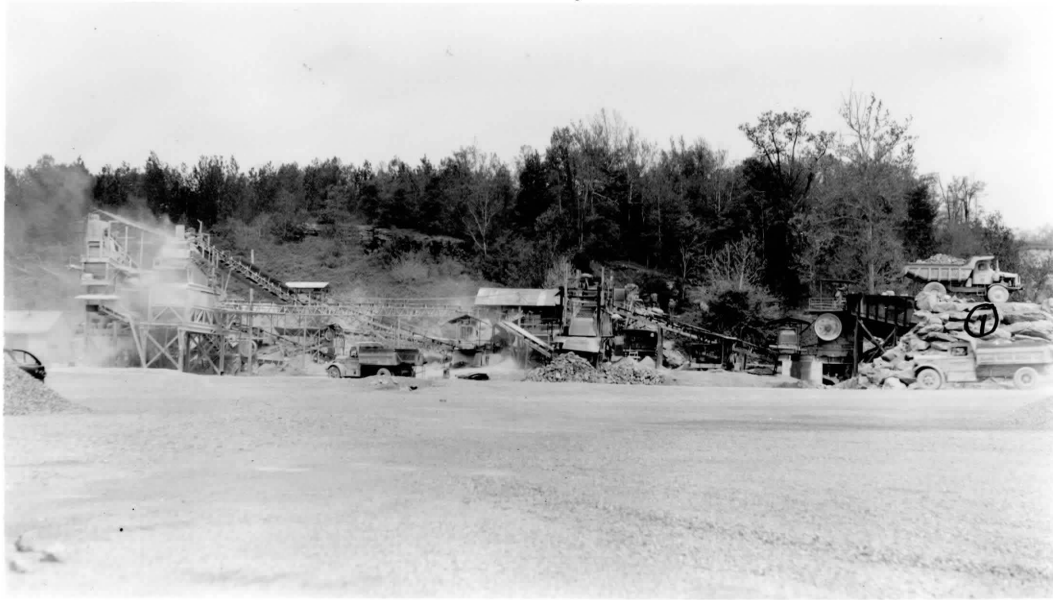
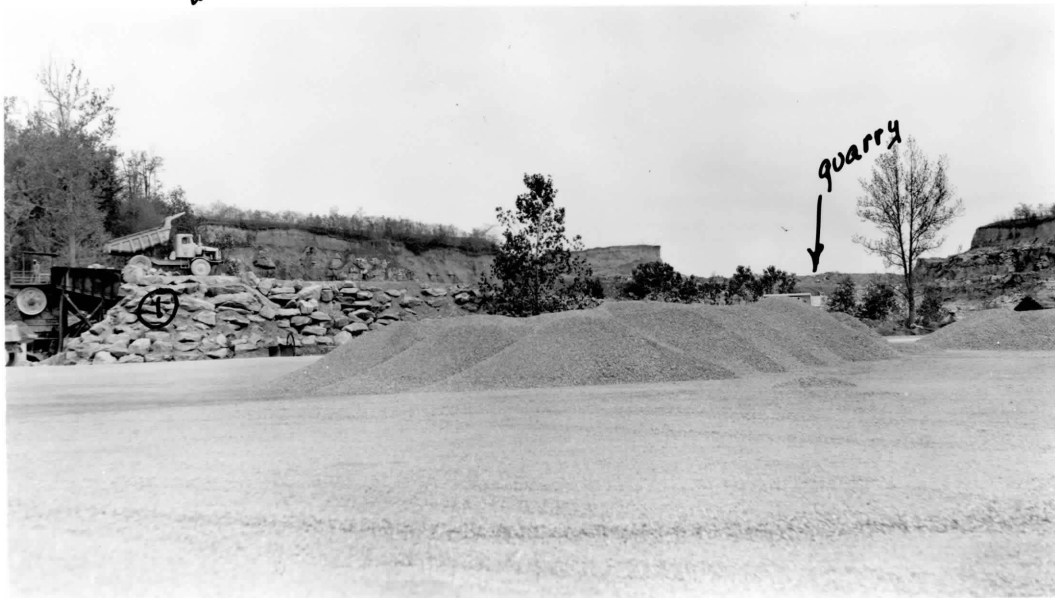
These pictures No. 4 and No. 5 show the crusher and the screening plant. The circled 1 marks the same spot in both pictures.

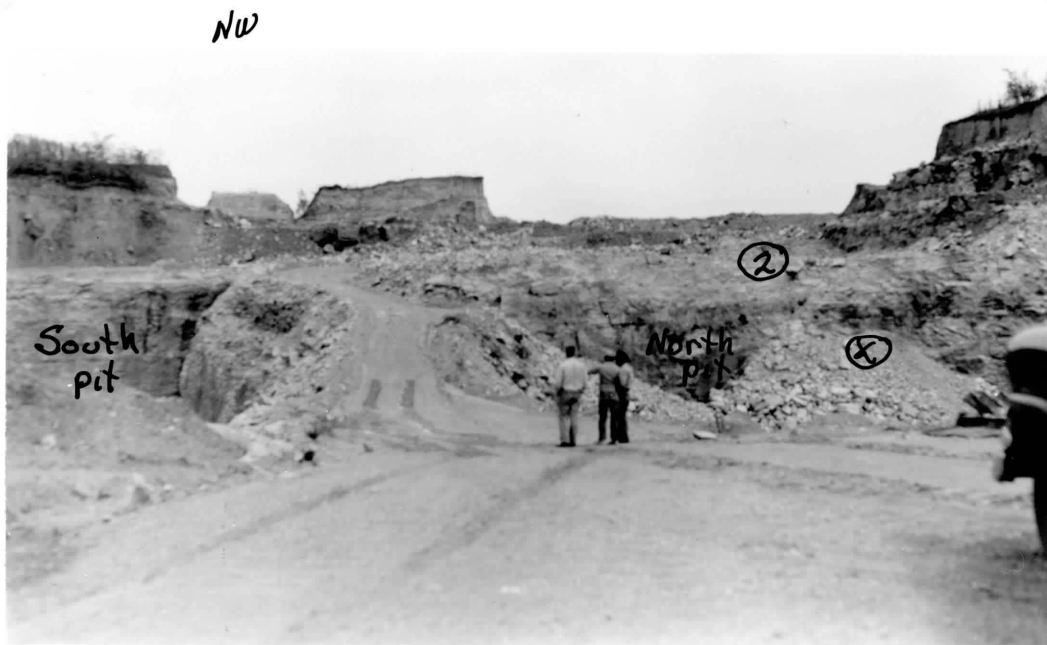
At the entrance to the quarry area -- looking northwest. This shows the old north pit on the right, the south pit that is presently being worked on the left, and the cleared area in the right background marked by the circled 2, where operations were to be started in the next month or so-- as soon as the lower level in the south pit was worked out.

When Columbia purchased this quarry from Hally, Ballard and Cato in 1950 the north pit was full of water. See pictures 7 and 8. The south pit, which had been worked to a depth of 35 or 40 feet, was dry. Columbia started in the south pit at that time, and have now worked it to a depth of about 100 feet. See pictures 9, 10, 11, 12.

On April 27, 1960, the main operation was in the bottom level at 76- to 94-foot depth. Mr. Bernard Bruce, of the Columbia Quarry Co., told us that this level would be worked out in about 2 or 3 months, and that they would then open an 18-foot level in the top ledges in the west face of the north pit. See the circled 2 in picture No. 6 in the attached file.

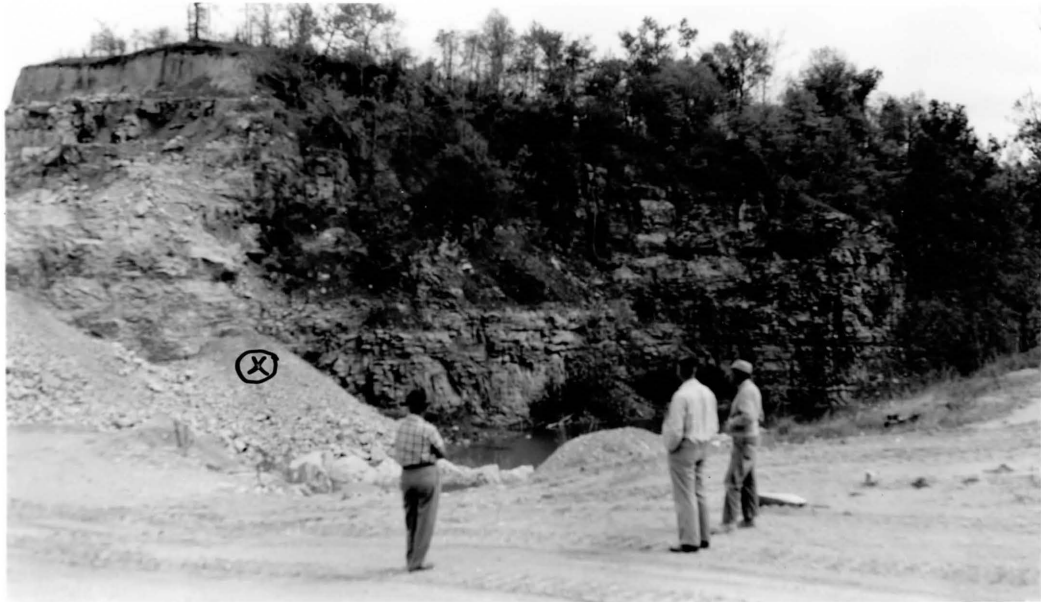
Two views of the north pit. This pit has not been worked since before 1947 or 1948. The face is about 60 feet in height. The circled X shows the same spot in pictures 6, 7 and 8. This picture shows a little of the roadway shown in No. 6.

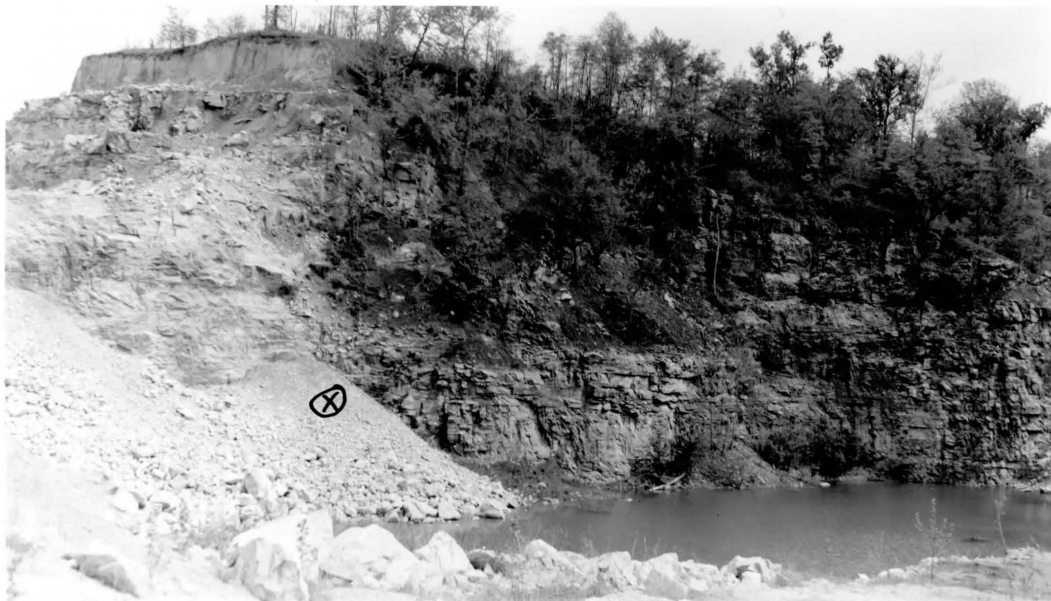
8

Another view taken a little farther north. This shows more of the water filled hole.

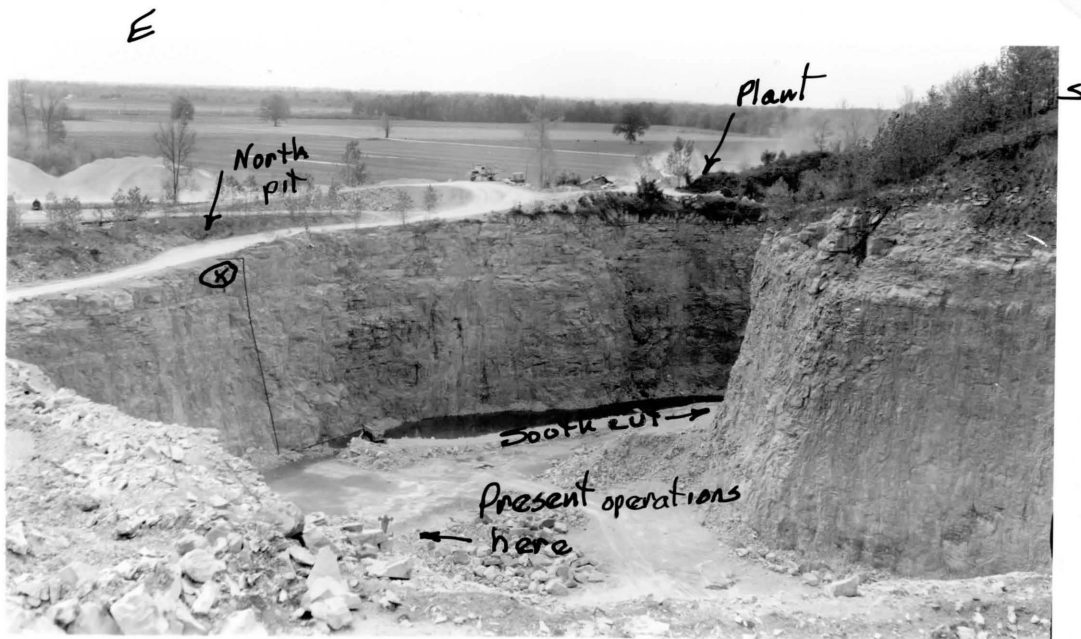
9

Two views of the south pit. This picture was taken looking east from the stripped area above the west face. It shows the east side and part of the floor but does not show the area in the lower level that was being worked at that time or the ramp that leads down along the north face. See pictures 11 and 12, which were taken from the southeast side.

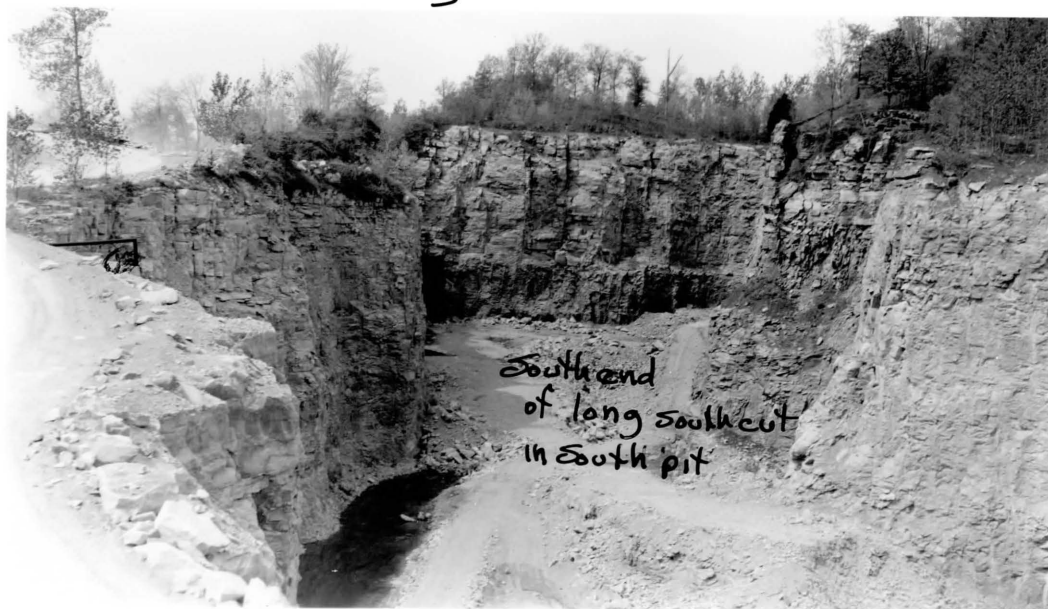
10

This shows the long south cut. It was taken from the road--looking south from the spot where picture No. 6 was taken. The circled X in this picture and in pictures 9 and 11 mark the same pipe.

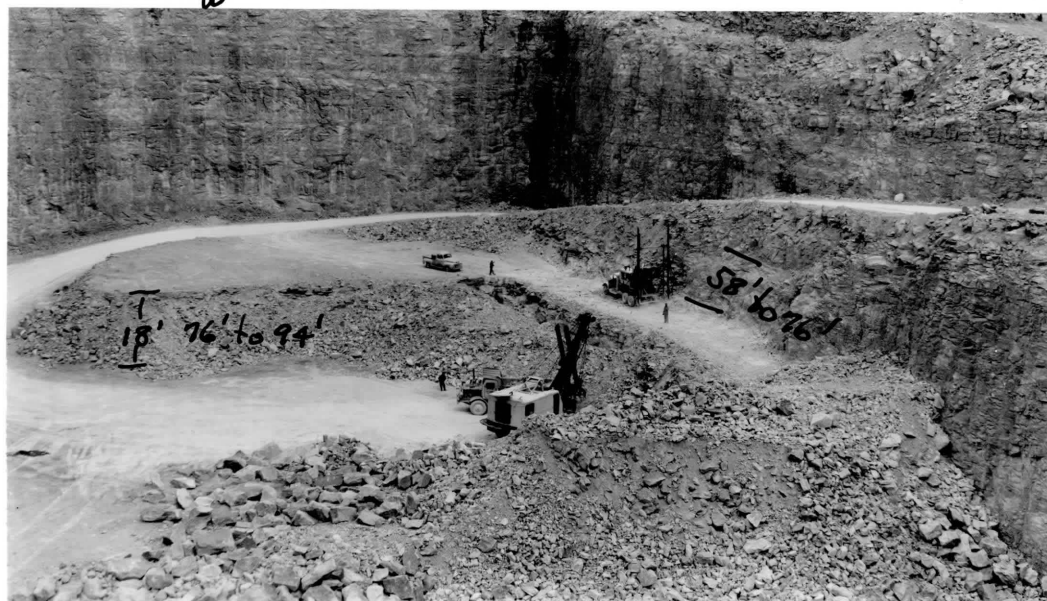
12

On Wednesday, April 27, 1960, operations were in the 18' lower level at 76' to 94' depth. The sample 60-1908 which was taken on that date was taken from crushed material that was produced from this level. When this level is worked out, operations will start in the area above and west of the north pit, which is shown in 6 and 11.

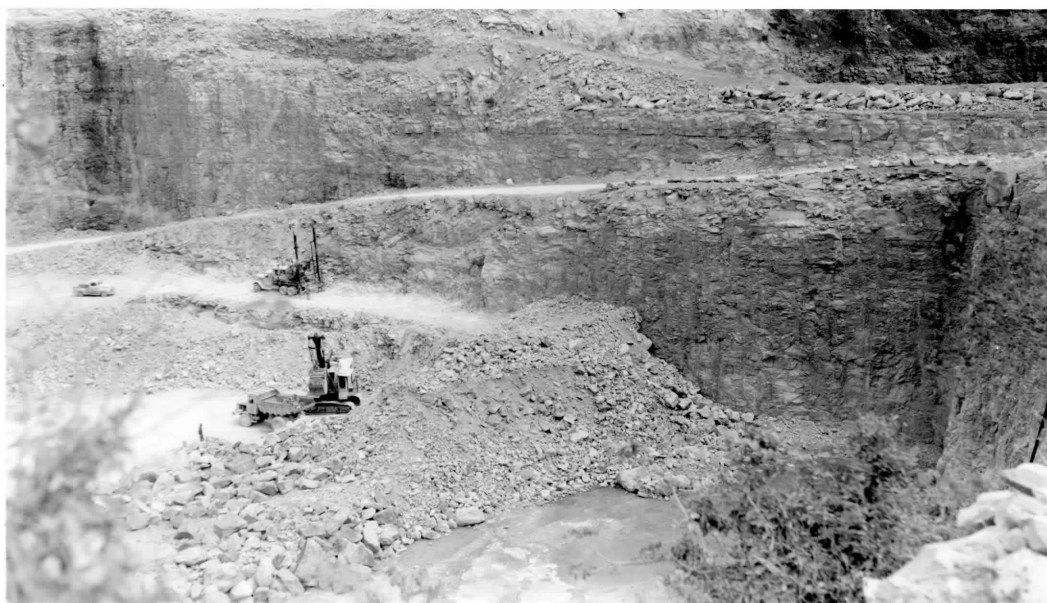
13

This shows more of the east side of the south pit. The area in the right foreground is the north end of the "long south cut" shown in picture No. 10.

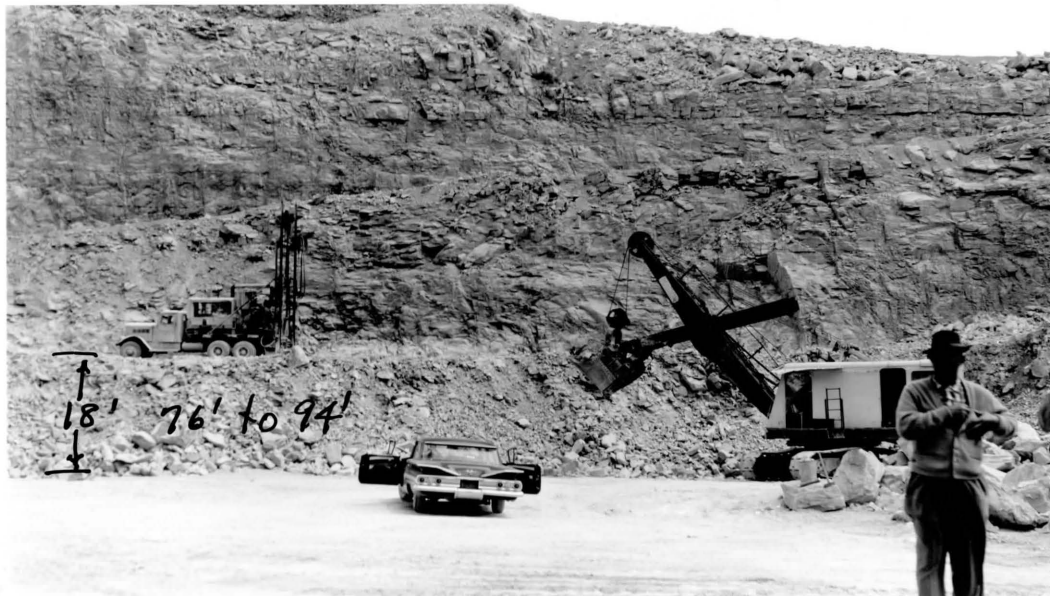
14

This is the 18' lower level - from 76' to 94' depth. Frank Brock at the right.

(The sample of the stone for filter media-59-12641, that was submitted to the laboratory on December 3, 1960, was produced from the next level above - from 58' to 76' depth.

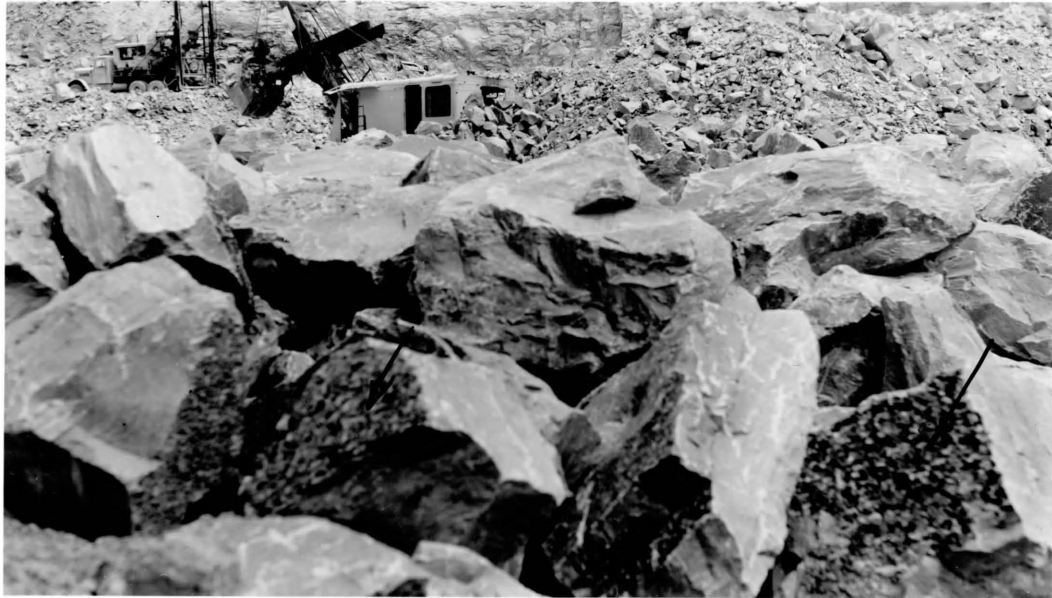
15

This shows some of the "dobies" that had been pushed aside in the lower level - to be "shot" later. Note the thin layer of carbonaceous and shaly material on several of these pieces.

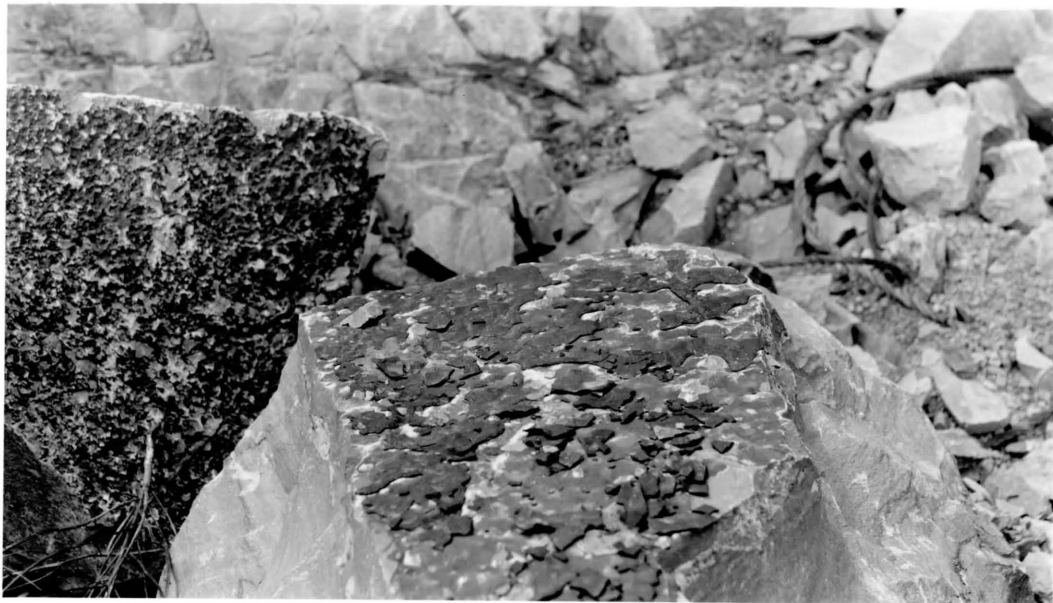
16

Close view of one of the thin layers of carbonaceous or shaly material. Most of this crushes out and only occasional small pieces of it are found in the stock piles.

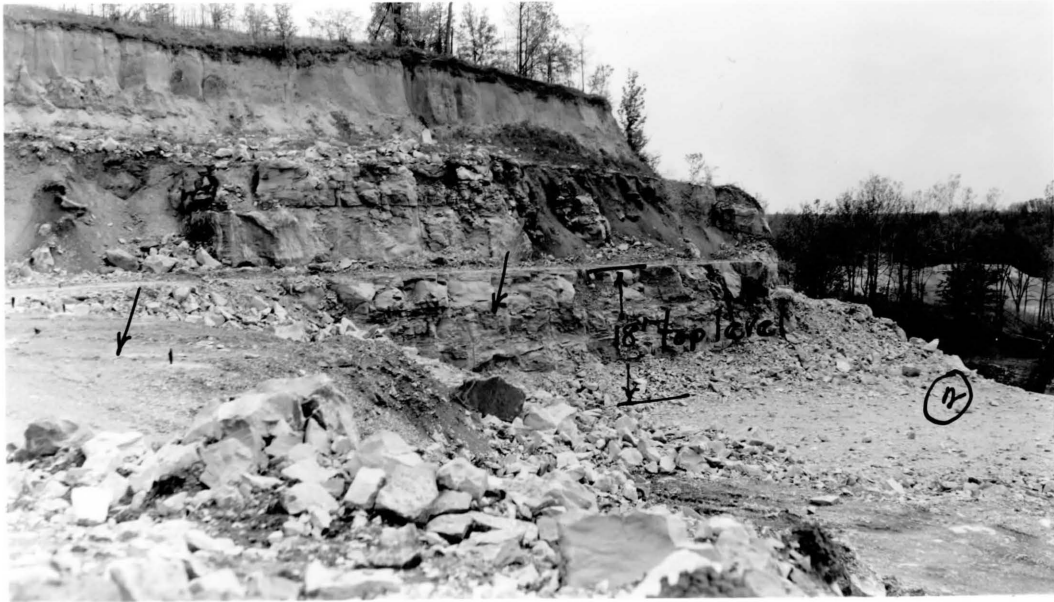
17

This is the 18' top level above the west face of the north pit, which is being worked off to clear the area marked by the circled 2, that will be worked next. The stone in this 18' level is being used for "dirty" ballast and rip rap.

Note at the left that several holes have been drilled in preparation for another "shot" in this level.

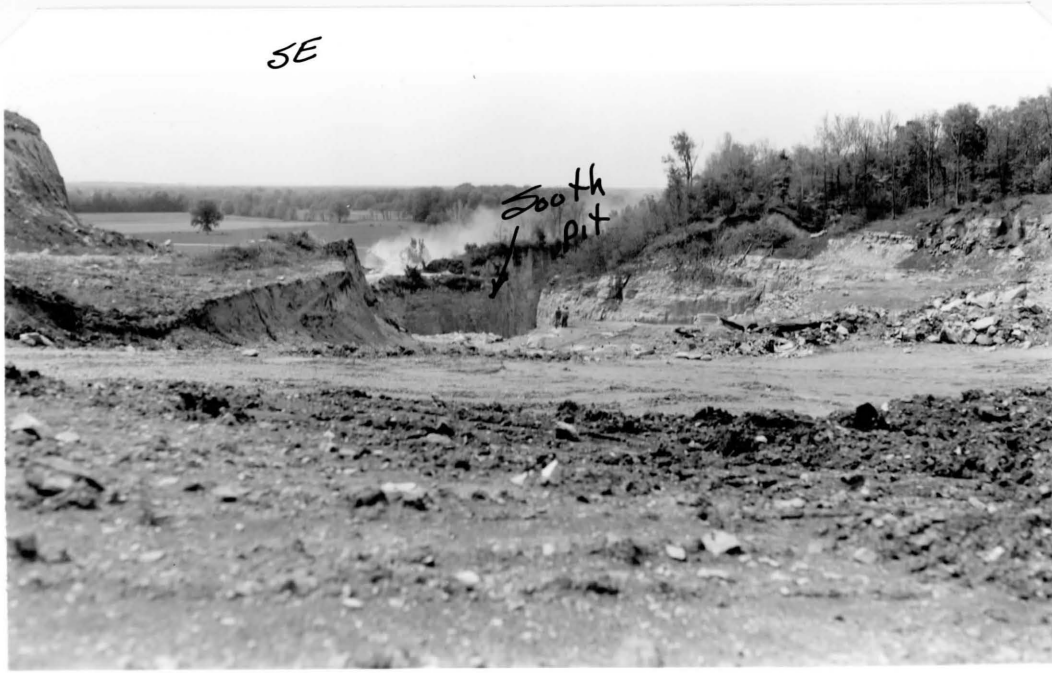
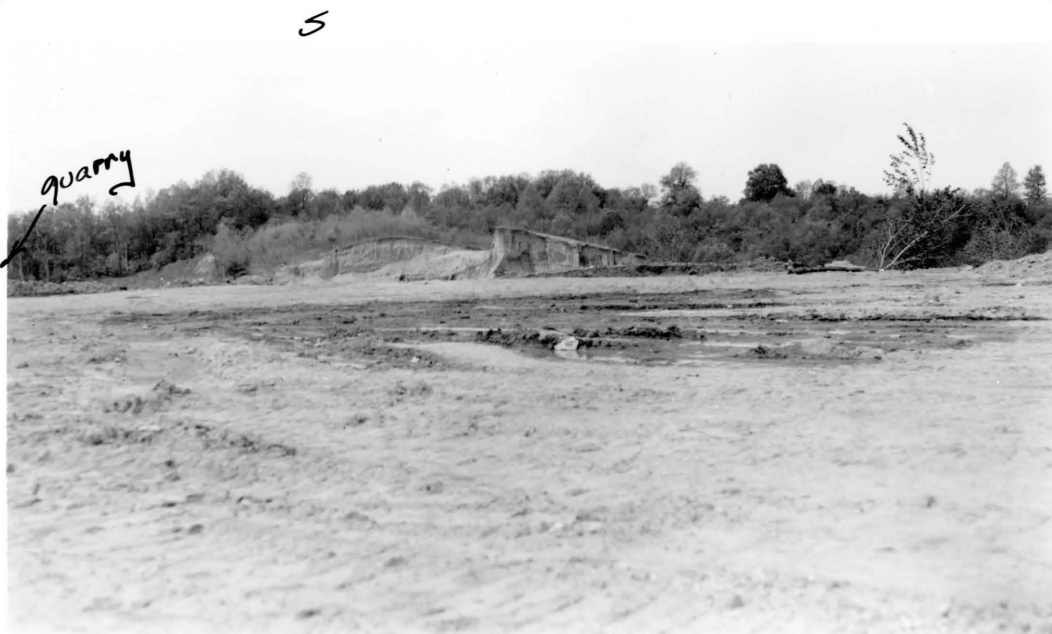
These pictures 18 and 19 were taken to show a little of the area that has been stripped above the quarry.

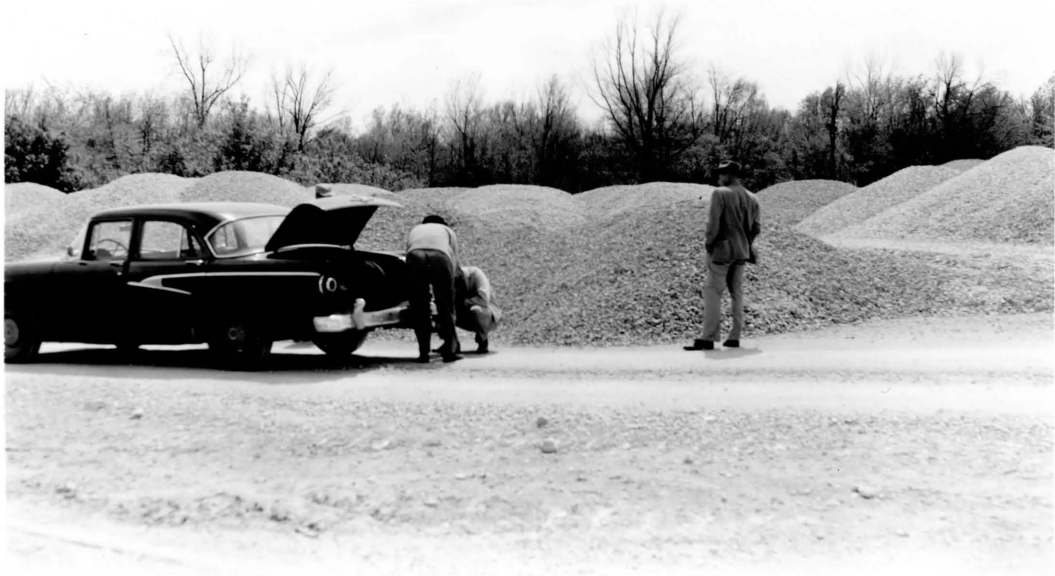
20

The sample 60-1908 was taken from this stock pile. It was taken by Frank Brock and Richard Kiel.

We took a sample of the crushed material from one of the stockpiles, representative of the current production which at that time was from the lower level at the 76- to 94-foot depth. The results of the tests that were made on that sample are given below.

Lab. No.	Produced From	Sp.Gr.	% Abs.	Los. Ang. Abr. loss, %	Sod. Sulf. Sound. loss, %	Chert
60-1908	76' to 94'	2.65	1.3	29.4	5.98	0.2

These tests indicate the stone from this level to be of very good quality and that it is satisfactory for use in both p.c. concrete and I-11 bituminous work.
