Identification of mine subsidence on aerial photographs in central Illinois

Philip J. DeMaris
Robert A. Bauer

November 1983

Illinois Department of Energy and Natural Resources
STATE GEOLOGICAL SURVEY DIVISION
Champaign, Illinois

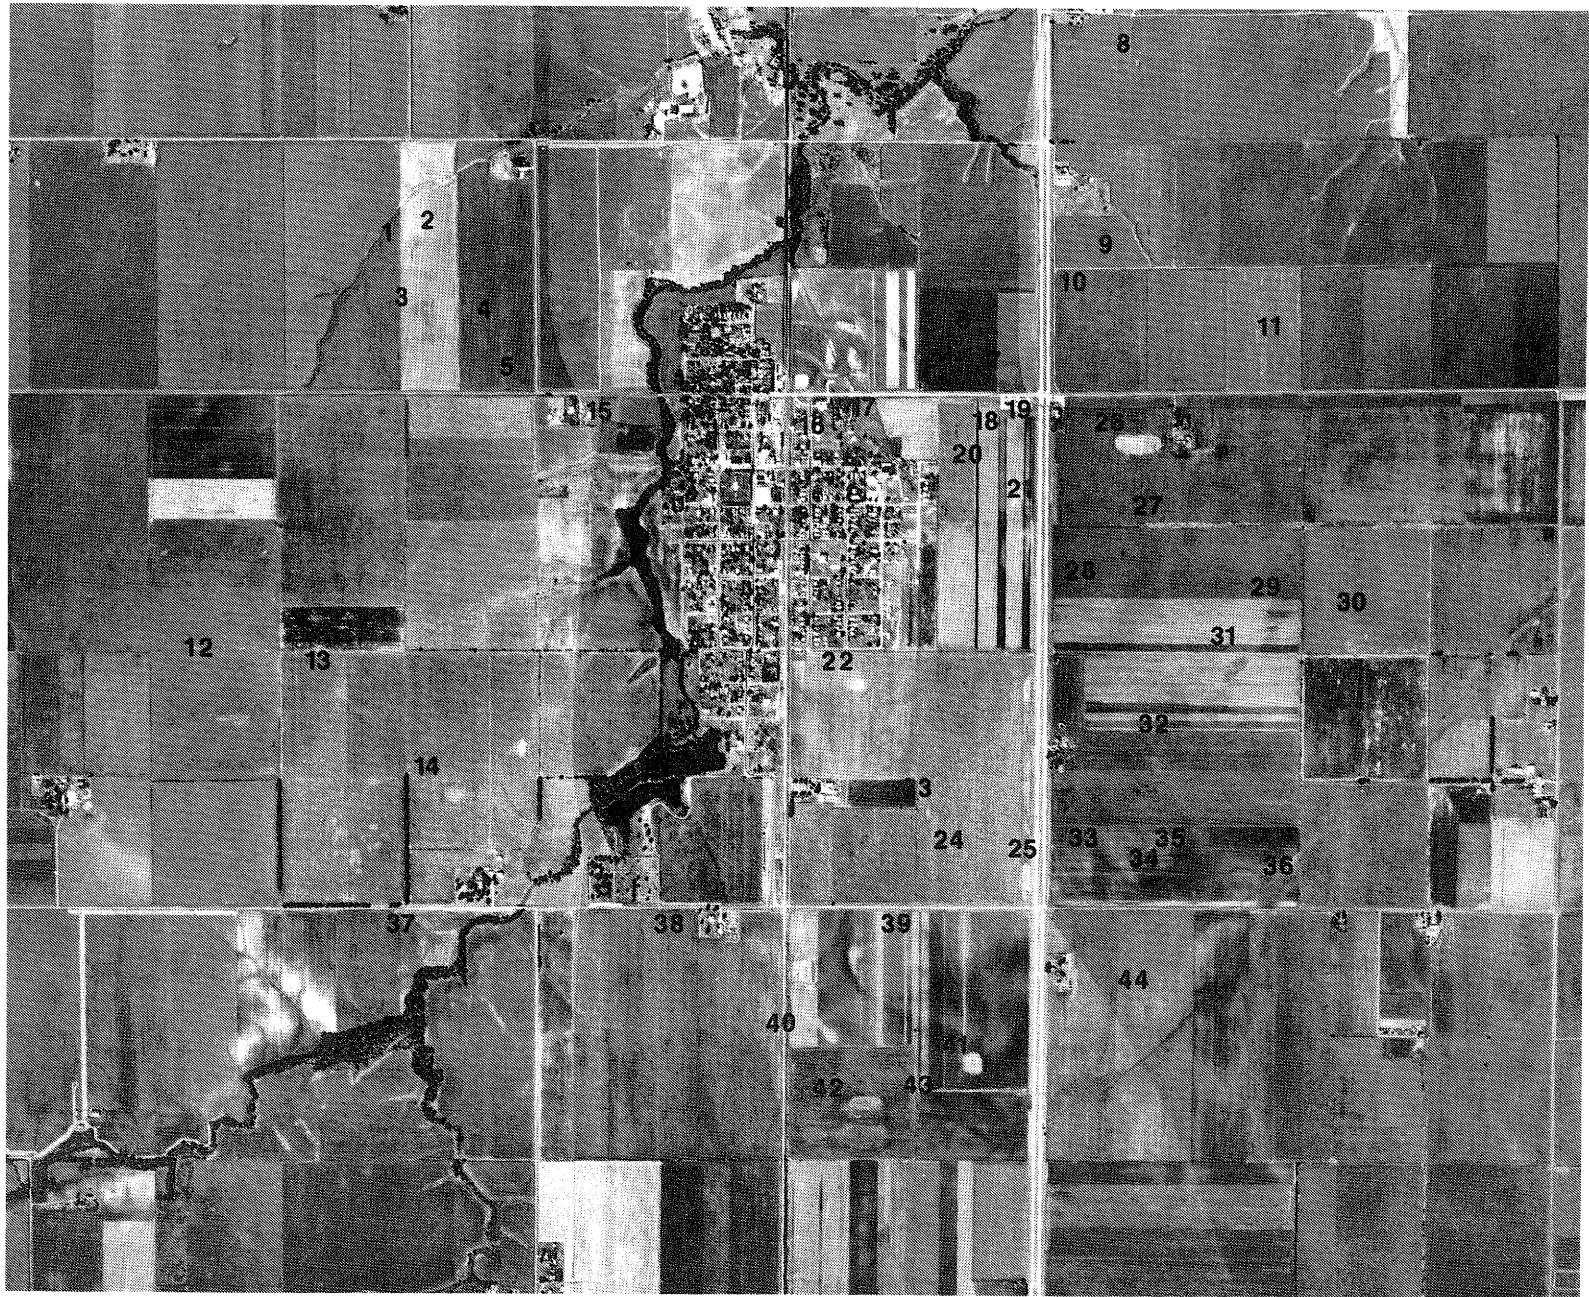
Figure 6. Mosaic of aerial photos showing location of anomalies.

Site-Specific Evaluation. Forty-four sites in the Divernon area were studied on the sets of aerial photographs (fig. 5 and 6). All air photo anomalies and reported sites in or within about one-quarter mile of the general mapped boundary of the mine were considered for this study. Table 1 shows the disposition of the indicators for each site on the various sets of aerial photographs. Each site is categorized for each set of photographs as 1) "Positive" - the site showed some topographic, tonal or textural indication on a set of photos; 2) "Neutral" - the site was altered or obscured on a set of photos; or 3) "Negative" - the site was not found on a set of photos. The positive indicators were subdivided into "weak" and "strong" categories on the basis of how strong the visual contrast was between the site and the normal tonal, textural and topographic variations. Positive and negative indicators for each site were then compiled for use in the analysis (table 2). Also on table 2 are notes on each site concerning their persistence amongst sets of air photos, overall strength of indicator, and other observations.

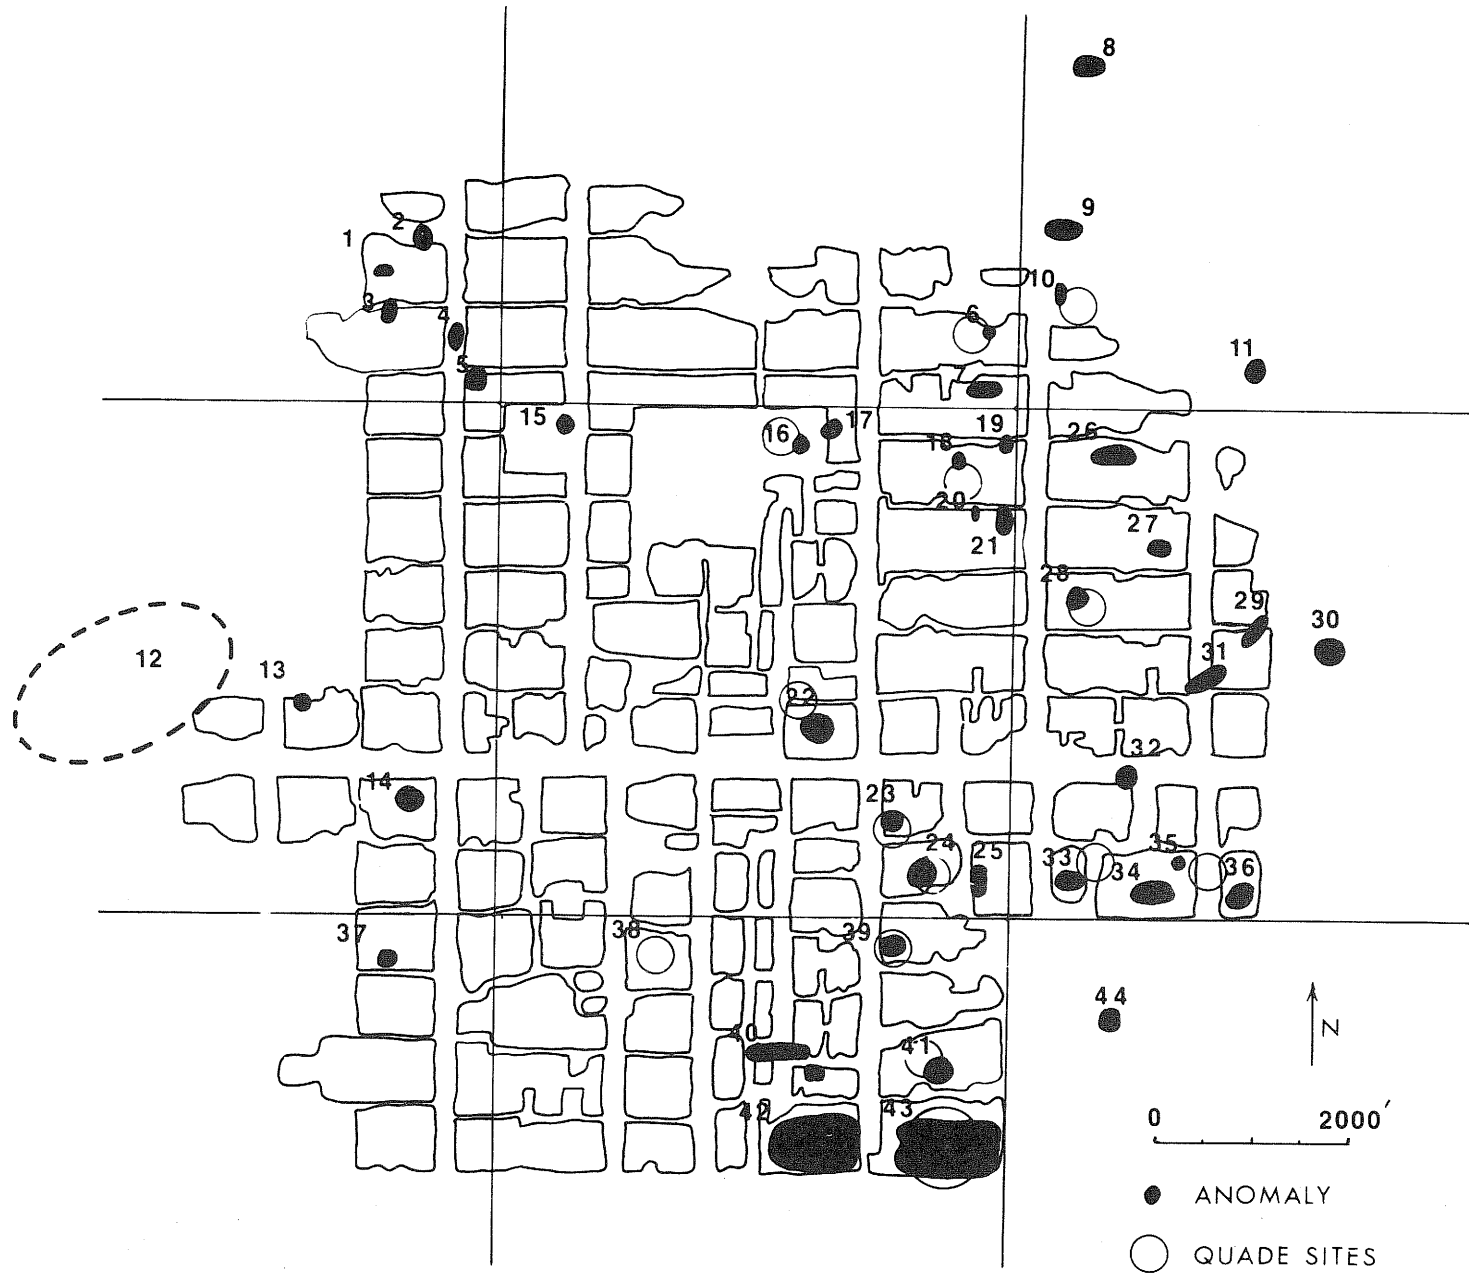
Figure 7. Anomalies and Quade subsidence sites superimposed over outlines of mine production panels.

Projection of Sites on Mine Map. The major downward movements of coal mine subsidence events are over and well within the boundaries of the production panels. The production panels are the highest extraction areas of the mine and are wide enough so that if overburden support is lost the event will reach the surface and cause subsidence. This is in contrast to the low extraction, narrow main entryways bound by barrier pillars. Even if all the pillars lost support in the main entryways in this mine, the collapsed width would be too small to reach and affect the ground surface. Only 28 of the 44 sites (63%) are positioned

properly over production panels of the mine (table 3, fig. 7). Of these 28 sites, 13 are subsidence sites designated by J. C. Quade's report or areas marked on the mine map where squeezes had taken place in the mine (table 3).

The southeast portion of site 40 is located over very large chain pillars along the haulageways in the production panel. The production part of this panel is only the southern 2/3 of the outline shown in figure 7. The haulageways are the northern part of the panel.
