**Erosion and Accretion Trends Along the Lake Michigan Shore
at North Point Marina and Illinois Beach State Park**

**Year-1 (1995) Report of a Four-Year Study of Coastal Geology and
Coastal Geologic Processes**

**Michael J. Chrzastowski
Anthony M. Foyle
and
C. Brian Trask**

**Illinois State Geological Survey
Coastal and Wetlands Geology Section
615 E. Peabody Drive
Champaign, Illinois 61820-6964**

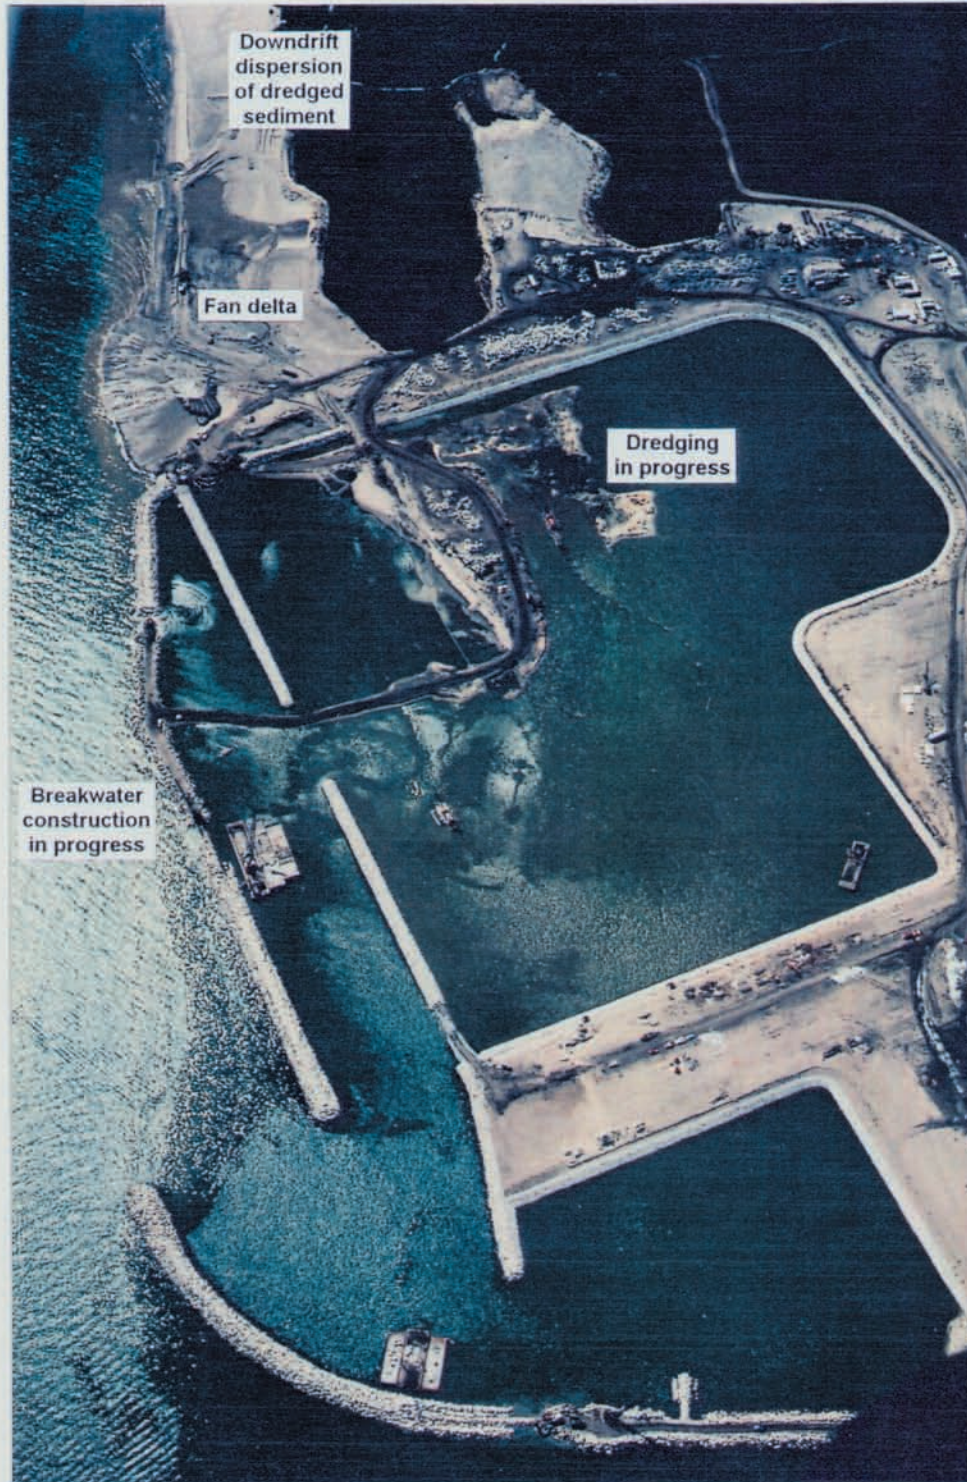
Figure 1-4 Oblique aerial view of the North Point Marina construction site on September 14, 1988 looking toward the south. Sediment dredged from the marina basin is being discharged by slurry pipe to create the fan delta. The fan delta reached its maximum lakeward extent within three months after this photograph.

In terms of coastal processes at NPM and the IBSP North Unit, the formation of this fan delta was the single most significant event associated with marina construction. The fan delta added a major volume of sediment to the littoral system; it was then the site of the most rapid coastal changes in the first few years following marina construction. Figure 1-4 shows the fan delta when it was nearing its maximum lakeward extent in summer 1988.

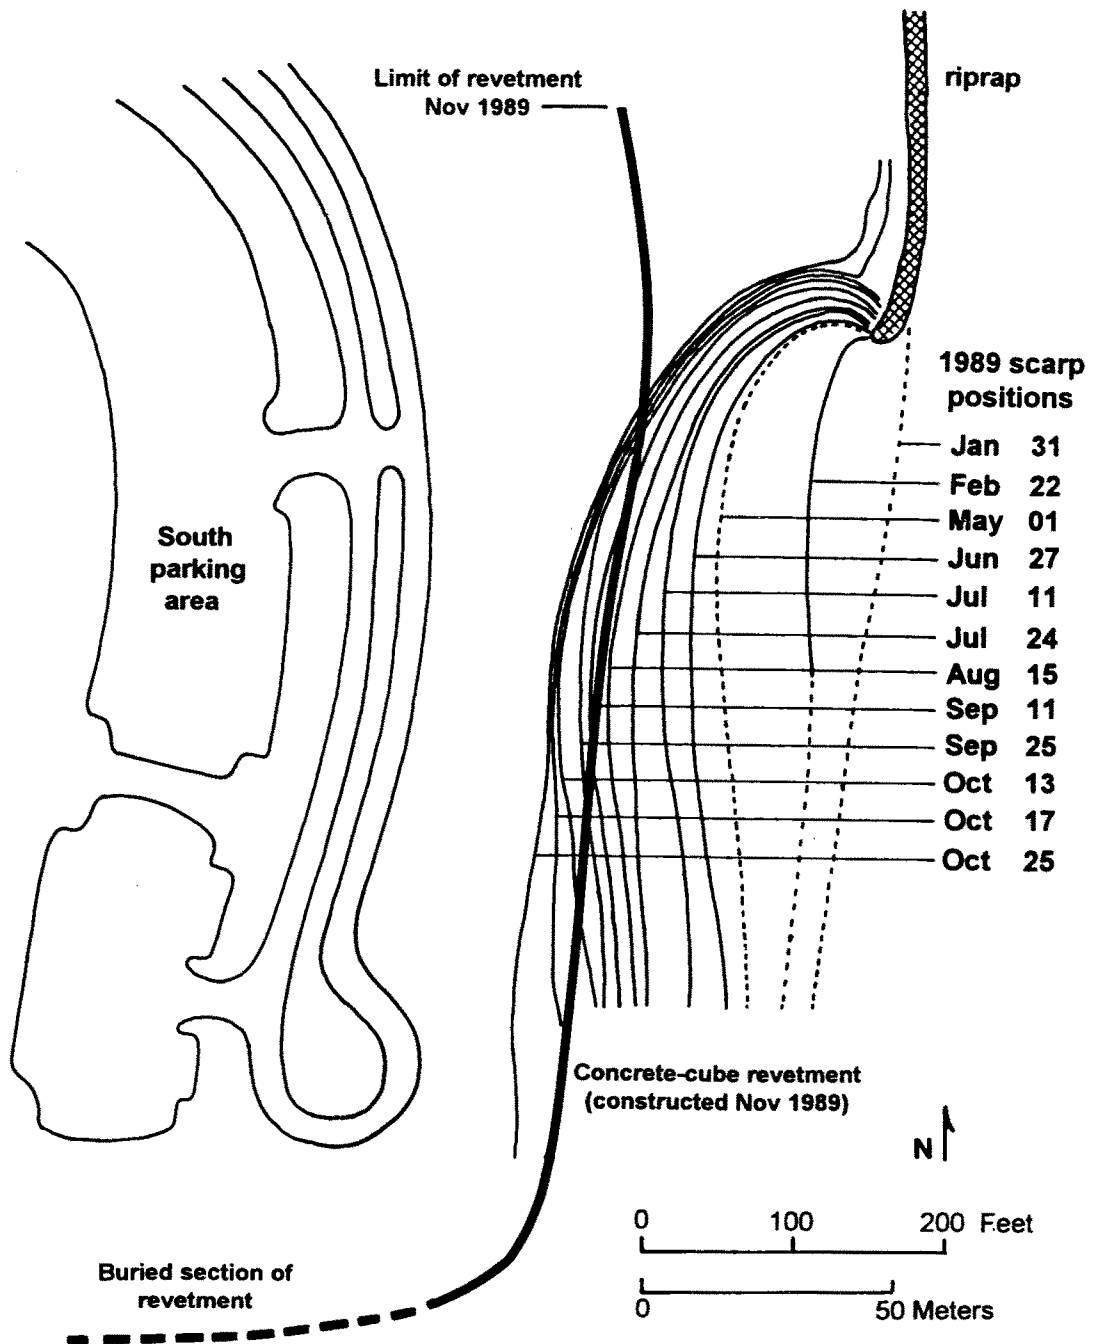
Figure 1-5 Record of 1989 erosion at the fan delta that occurred south (downdrift) of the riprap. These recession lines are along the crest of a 6- to 12-ft high scarp that was parallel to the shoreline. The southern tip of the riprap acted as a headland around which northerly waves refracted and eroded the hook-shaped embayment. Construction of the cube revetment in November 1989 halted the landward recession.

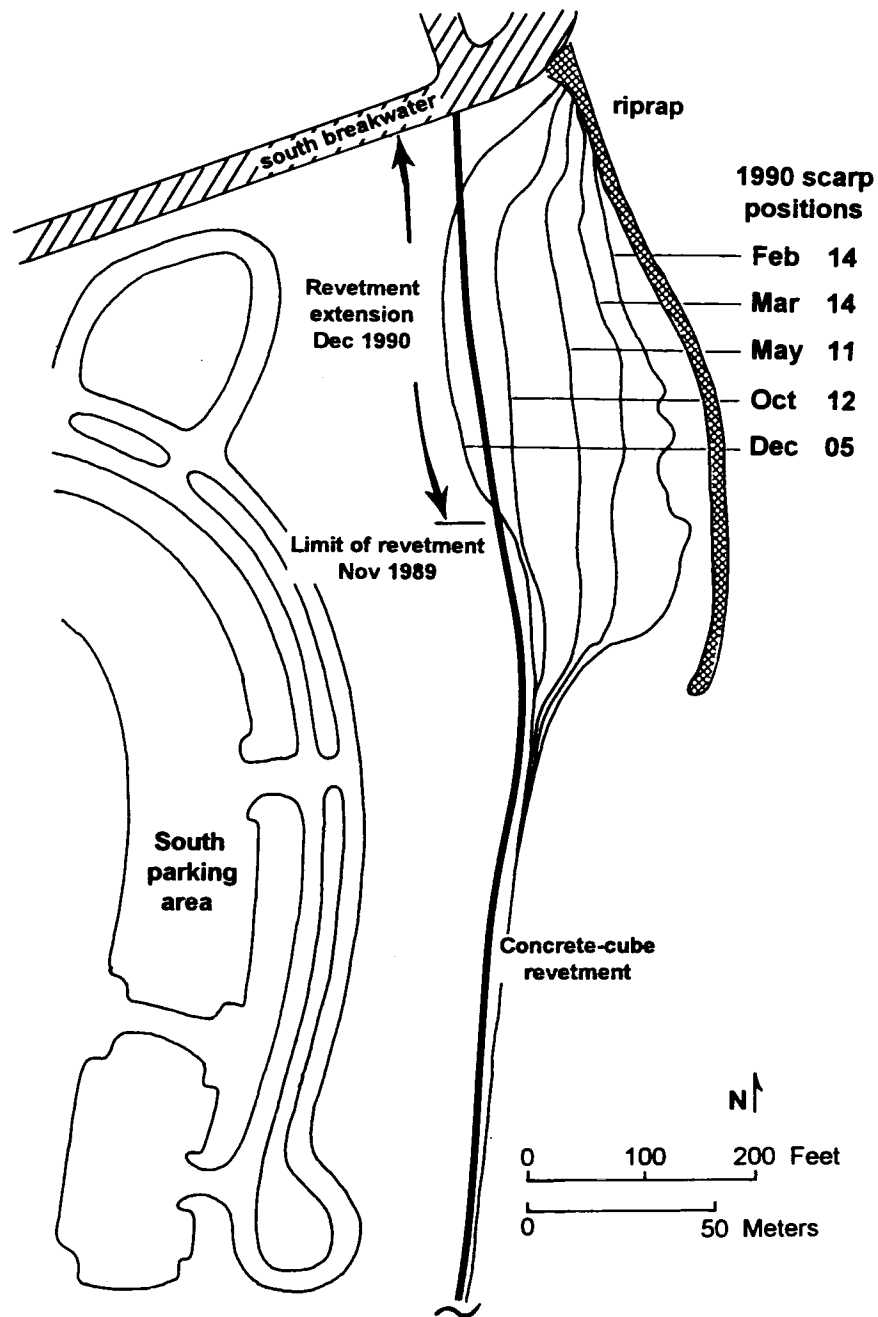
Figure 1-6 Record of the 1990 erosion at the fan delta that occurred landward of the line of riprap. These recession lines are along the crest of a 6- to 10-ft scarp that was parallel to the shoreline. In December 1990, construction of a northward extension of the original cube revetment halted the landward recession. The riprap is now a submerged feature.

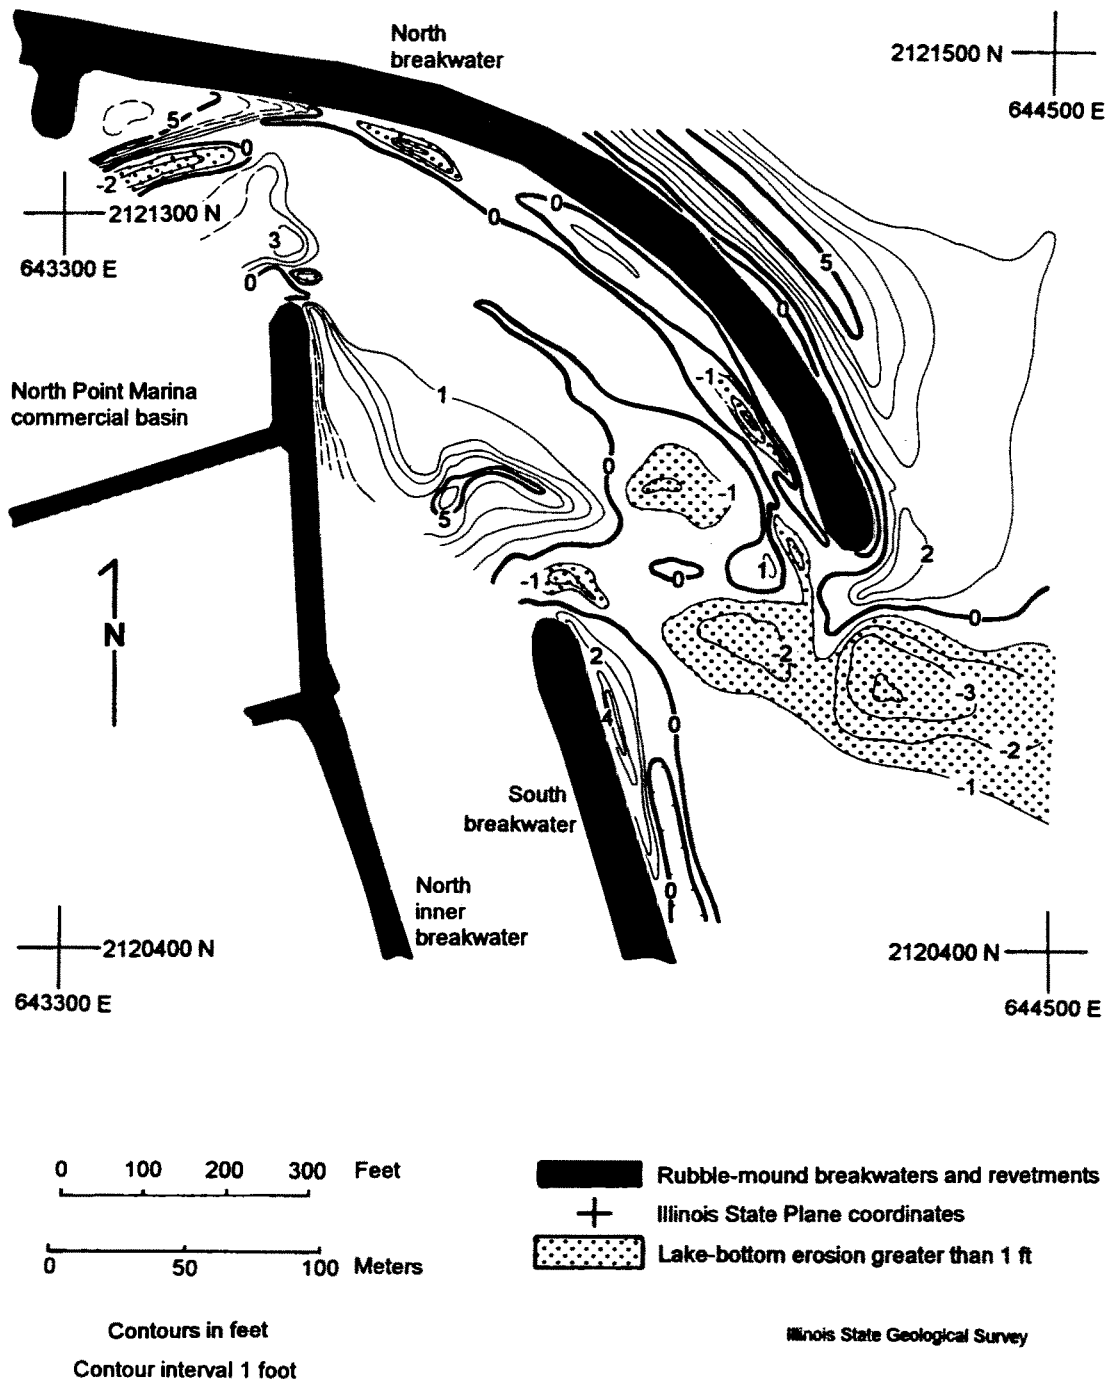
Figure 2-10 Isopach map of 1992-1995 lake-bottom changes in the North Point Marina entrance area. The accretional lobe along the south and east side of the north breakwater is the southern part of a 1992-1995 accretional lobe that is continuous from the WI-IL state line (see Figure 2-6).

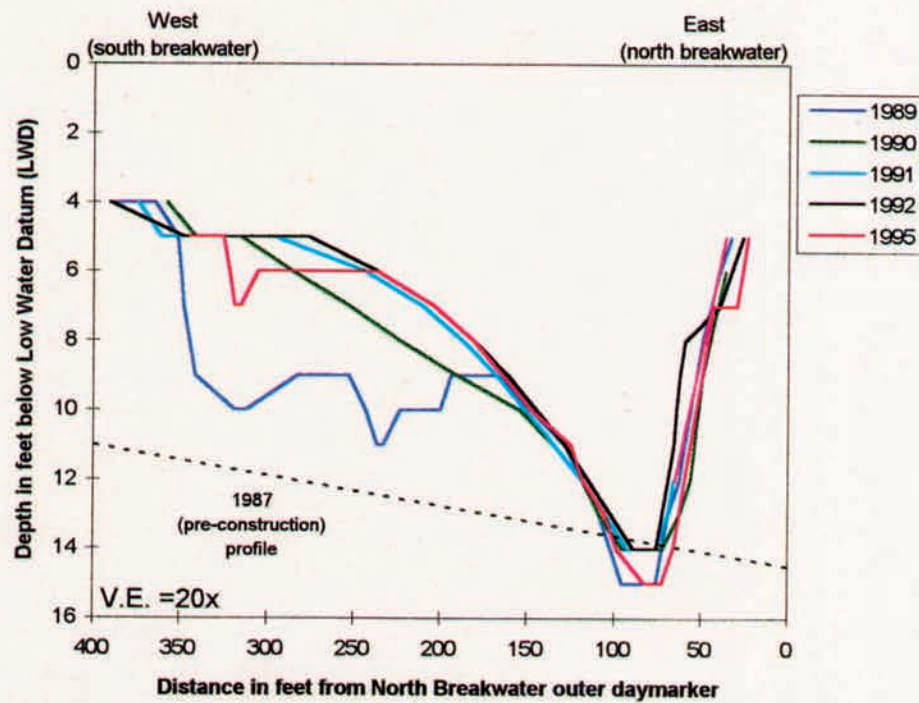
Figure 2-11A Profile comparisons across the NPM marina entrance from 1989 through 1995. Profile line runs approximately west to east between the ends of the south and north breakwaters. Index map shows profile locations and limits of 1992-1995 volume calculation.

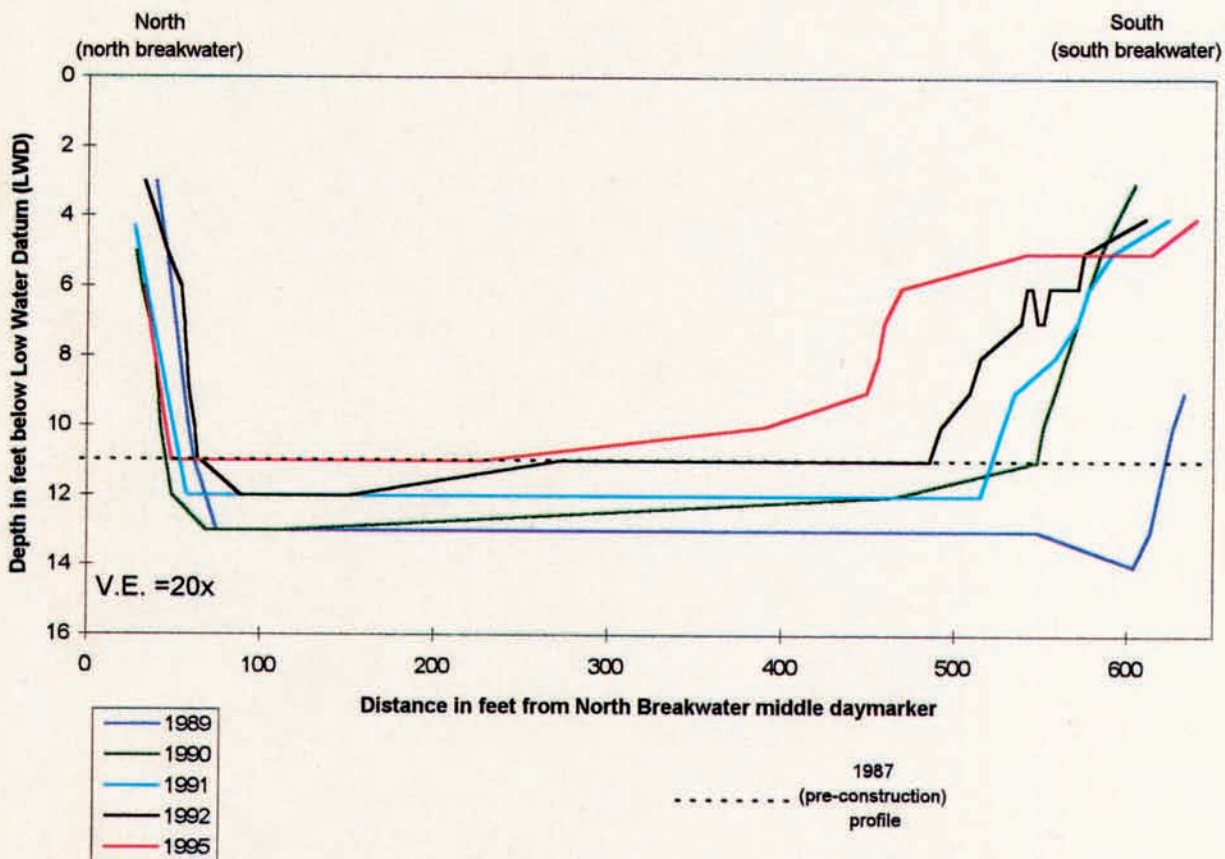
Figure 2-11B Profile comparisons across the inner part of the marina entrance from 1989 through 1995. Profile line runs approximately north to south, from the middle daymarker of the north breakwater to the north end of the south breakwater. See inset map on Figure 2-11A for location.

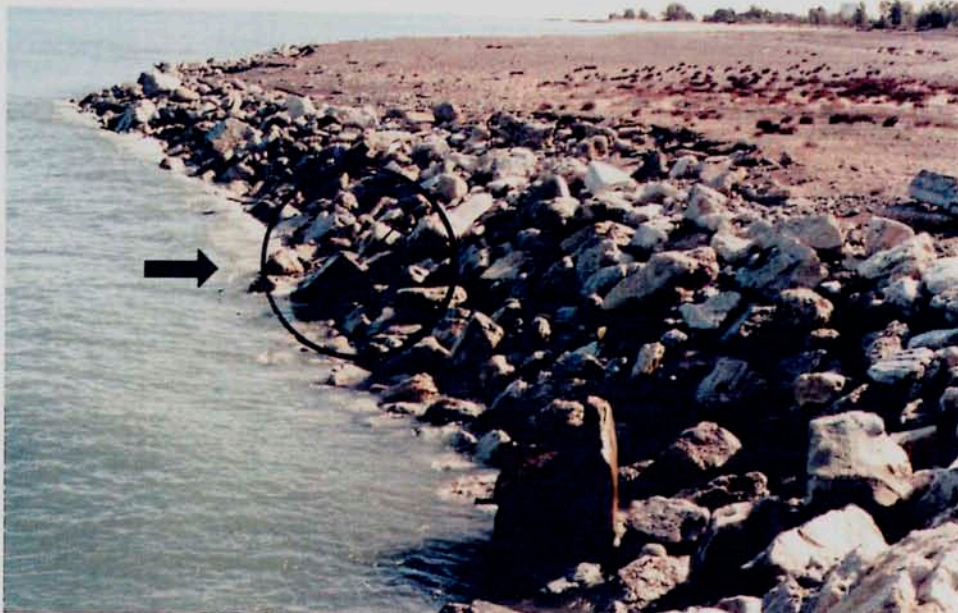
The name "submerged riprap" refers to approximately 600 ft of submerged rock that was originally placed as above-water shore protection along the lakeward edge of the fan delta between late autumn 1988 and early winter 1989. This riprap subsequently was undermined and eventually became submerged. The undermining was caused by wave-induced erosion of sand lakeward of and beneath the riprap. The location of the submerged riprap relative to the NPM facility is shown in Figure 2-1. The 1995 bathymetry at the submerged riprap is shown in Figure 2-14. In general, the submerged riprap forms a broad arc extending southward from the elbow in the south breakwater. The submerged riprap is important because it has significantly influenced the lake-bottom morphology lakeward of the northern half of the south parking area. In addition, the submerged riprap will lie beneath a segment of a proposed submerged reef which is part of planned shore protection for the south parking area (Appendix D; Patrick Engineering, 1993, Exhibit V-5; 1995, Sheet C-1).

Figure 2-16 View of the riprap looking south from the south breakwater in October 1989. Note the variety of stone sizes and shapes. For comparison with the photograph in Figure 2-17, note the position and height above water of the concrete block supporting an upright steel pole, at left center with black arrow (Photo date October 4, 1989).

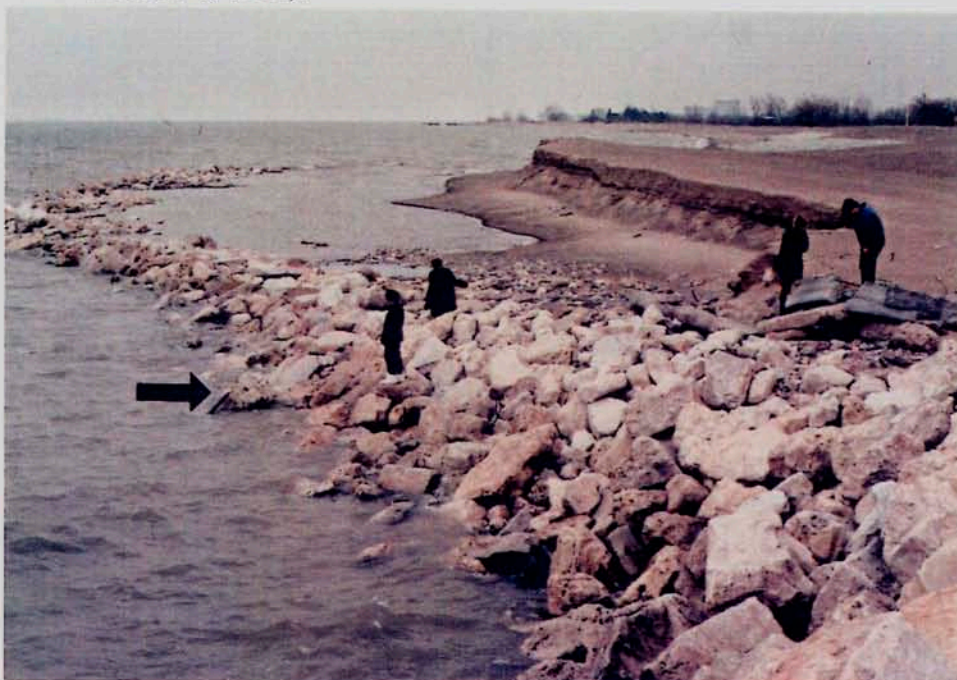
Figure 2-17 Same view of the riprap six months later in April 1990 showing the degree of riprap subsidence and landward erosion (Photo date April 13, 1990).

The important observation is that most of the riprap continues to subside. As of 1995, this riprap had yet to reach an equilibrium lake-bottom elevation. The settling of the submerged riprap does not involve the stone sinking into the lake-bottom sediment. The settling is a response to a widespread lowering of the lake bottom caused by the net erosion of lake-bottom sand (see South Parking Area Nearshore; Fig. 2-15). As of 1995, the base of the submerged riprap is at about 8 to 9 ft LWD. Considering past changes across the nearshore at the fan delta, erosion has been active to at least 15 ft LWD. Thus, if the erosion process continues, the submerged riprap has the potential to subside several more feet.

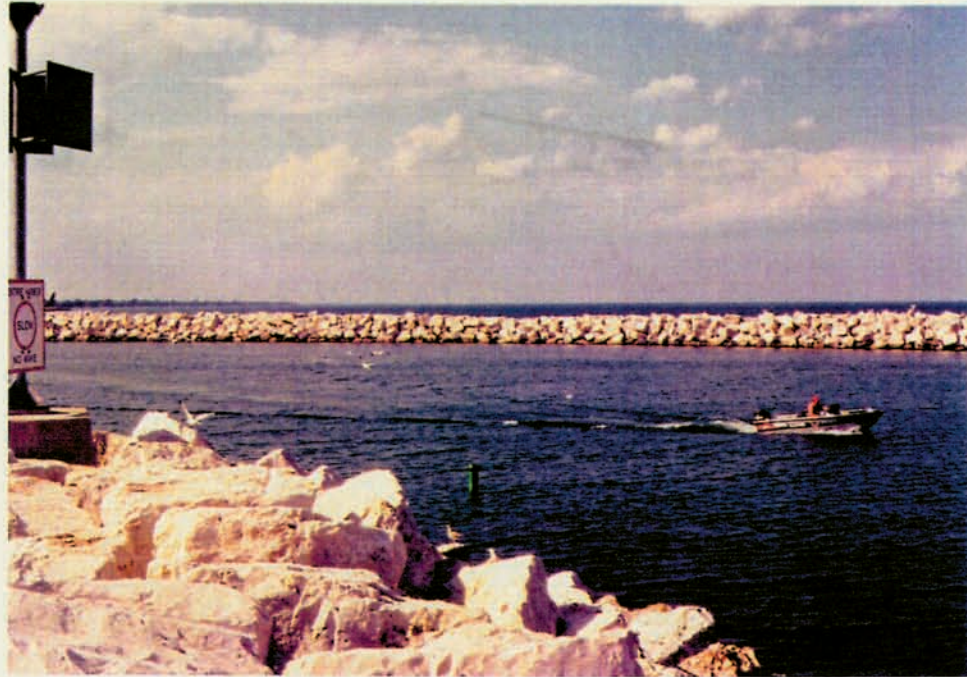
1995 observations No above-water evidence of stone shifting or settling along the north breakwater was apparent at any time during ISGS field studies at NPM through 1992. During field work in summer 1995, however, an apparent sag in the breakwater crest was observed along the northeast-facing section between the inner and outer daymarkers. The location of the sag corresponds with the segment of the breakwater that is adjacent to the lake-bottom depression previously discussed.

Figure 2-21A View looking north toward the north breakwater "sag" from the north end of the south breakwater. The extent of a sag in the crest can be seen by comparing the breakwater crest against the horizon. The sag is located between the inner and outer daymarkers (not visible in the photo) (Photo date July 18, 1995).

The amount of apparent vertical settling on the north breakwater is unknown at this time. Data were not collected as of this report to determine differences between existing crest elevations and those at the completion of breakwater construction. Also, no early post-construction photographs have been recovered to make photographic comparisons with present conditions. A visual estimate is that the maximum displacement in the central sag is 1.5 to 2 ft. To accurately determine the degree and extent of settling, a detailed survey is recommended to compare existing breakwater elevations with early post-construction data.

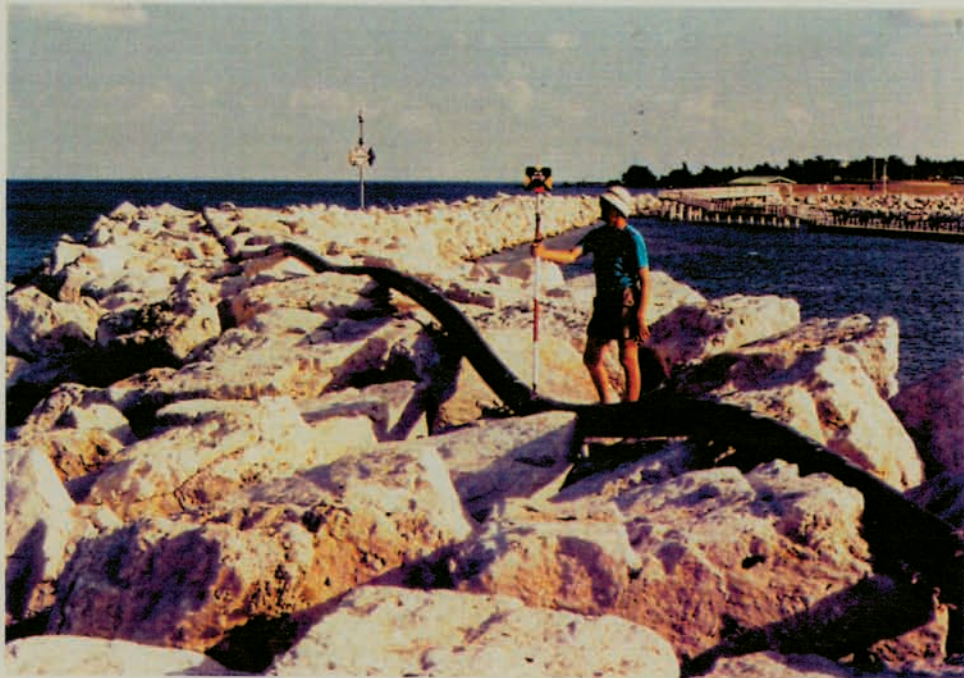
1995 observations Figure 2-22 shows an area of discontinuity in crest elevation at a location about 360 ft north of the inner daymarker. Pipe for the ongoing hydraulic dredging of the marina is visible in the photo and provides a useful indicator of irregularities in the breakwater crest elevation. This particular site of stone displacement is the most severe observed anywhere on the south breakwater. Estimated settlement is 1 to 1.5 ft.

Figure 2-22 View showing localized subsidence of capstones along the middle section of the south breakwater. Discharge pipe for hydraulic dredging lies along the breakwater crest. This sag is located about 360 ft north of the inner daymarker which is visible in the distance. Note colored 1-ft increment bands on the prism pole for scale (Photo date July 18, 1995).

Additional observations and survey data are needed before the magnitude and causes of any differential settling can be determined. Where apparent settling has occurred, the stone along both the lakeward and landward sides of both the north and south breakwaters shows no apparent outward displacement. Thus, the settling is uniform across the width of the breakwater. The possible factors contributing to the settlement are: 1) compaction of sediment beneath the breakwaters; 2) shifting, settling, and/or winnowing of quarry-run stone at the base of the breakwaters; or 3) winnowing of lakebed sand from beneath the breakwaters.

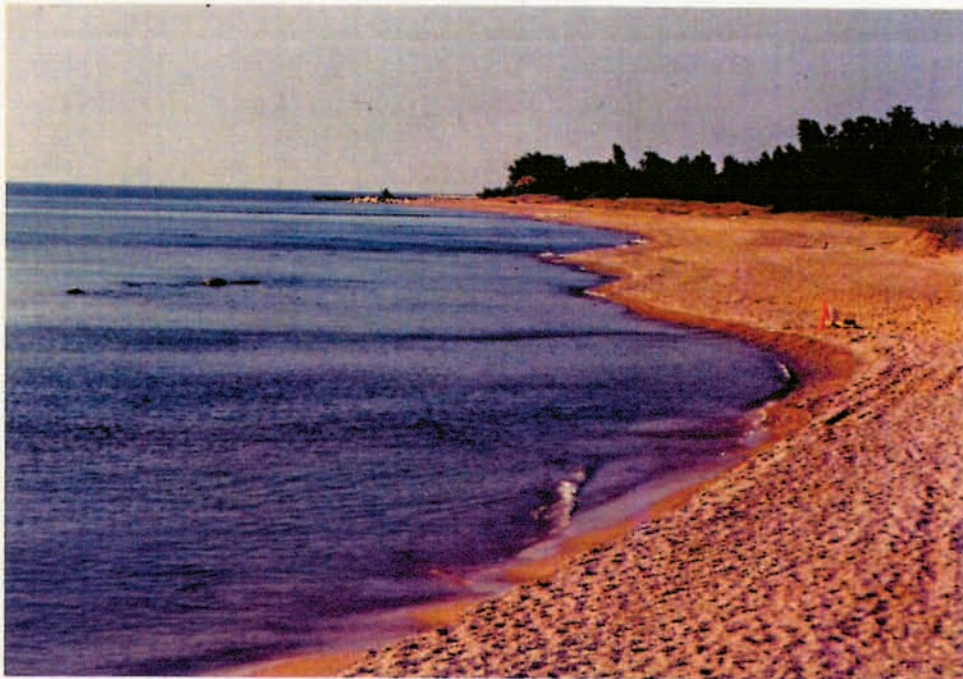
Figure 2-27 View showing the influence of submerged nearshore ruins on shoreline configuration just south of the marina/state park boundary. The view is southward toward the Camp Logan headland in the distance. Location of the nearshore ruins is indicated by one rock protruding above water level. Note the lakeward perturbation of the shoreline opposite the ruins which are acting like an offshore breakwater (Photo date July 17, 1995).

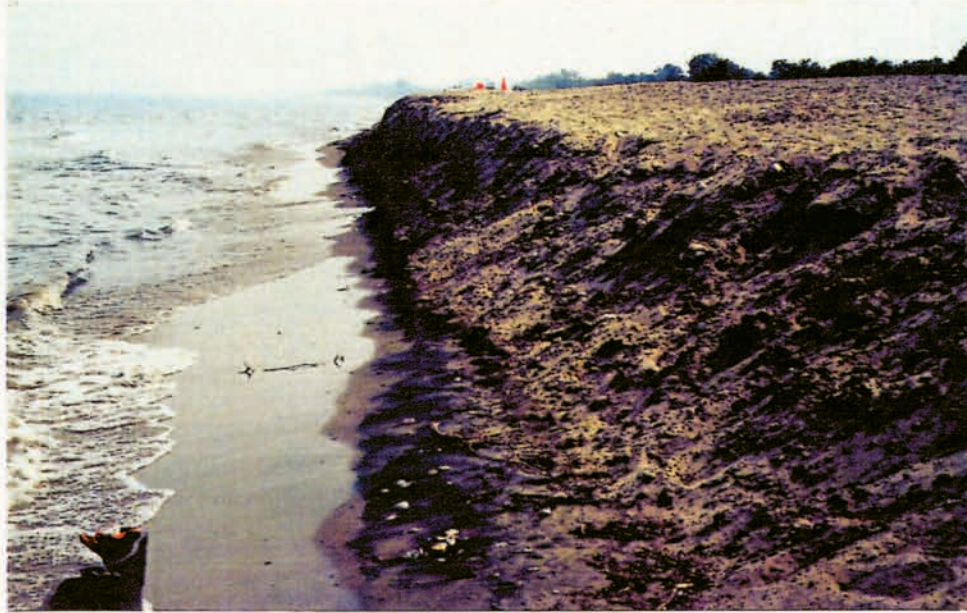
Figure 2-31 View looking southward along the South Unit nourishment site three days before completion of the June/July 1995 nourishment. Photograph is taken from the steel sheetpile (lower left) that defends the north end of the South Unit shoreline. Approximately 10 ft of recession has already occurred (Photo date July 11, 1995).

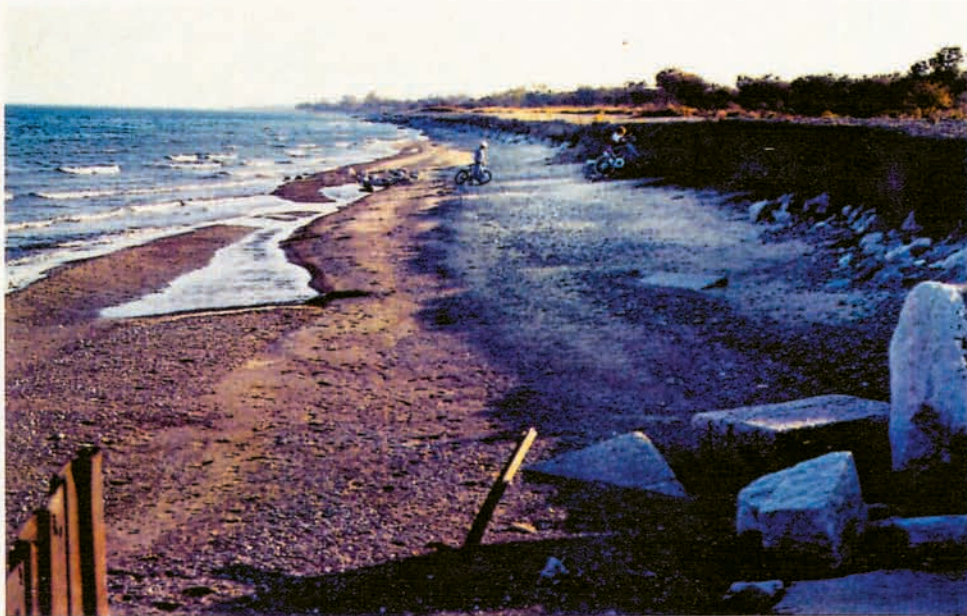
As was the case for the nourishment at the North Unit, the storm of September 7-8, 1995 resulted in the highest rates of beach and nearshore change observed during the 1995 monitoring. Between August 9 and September 8, the scarp crest at the North Bathhouse and Grass Knoll locations retreated approximately 25 ft and 15 ft, respectively. Most of this retreat is attributed to the storm of September 7-8. This single storm event caused erosion along the entire length of the nourishment stockpile with recession rates up to two orders of magnitude greater than those recorded between late June and early August.

Figure 2-32 Same view as Figure 2-31 showing what remained of the South Unit nourishment stockpile in November 1995. The scarp crest has receded approximately 35 ft compared to the photo in Figure 2-31 to re-expose the riprap that defends this reach of shore (Photo date November 8, 1995).
