**LEVEL II HYDROGEOLOGIC CHARACTERIZATION REPORT**  
**Potential Wetland Compensation Site 6W,**  
**West Freeport Bypass**

**Stephenson County, Illinois**  
**(Federal Aid Project 301, Sequence Number 10487)**

February 6, 2007

**Illinois State Geological Survey**  
**Open-File Series 2007-01**

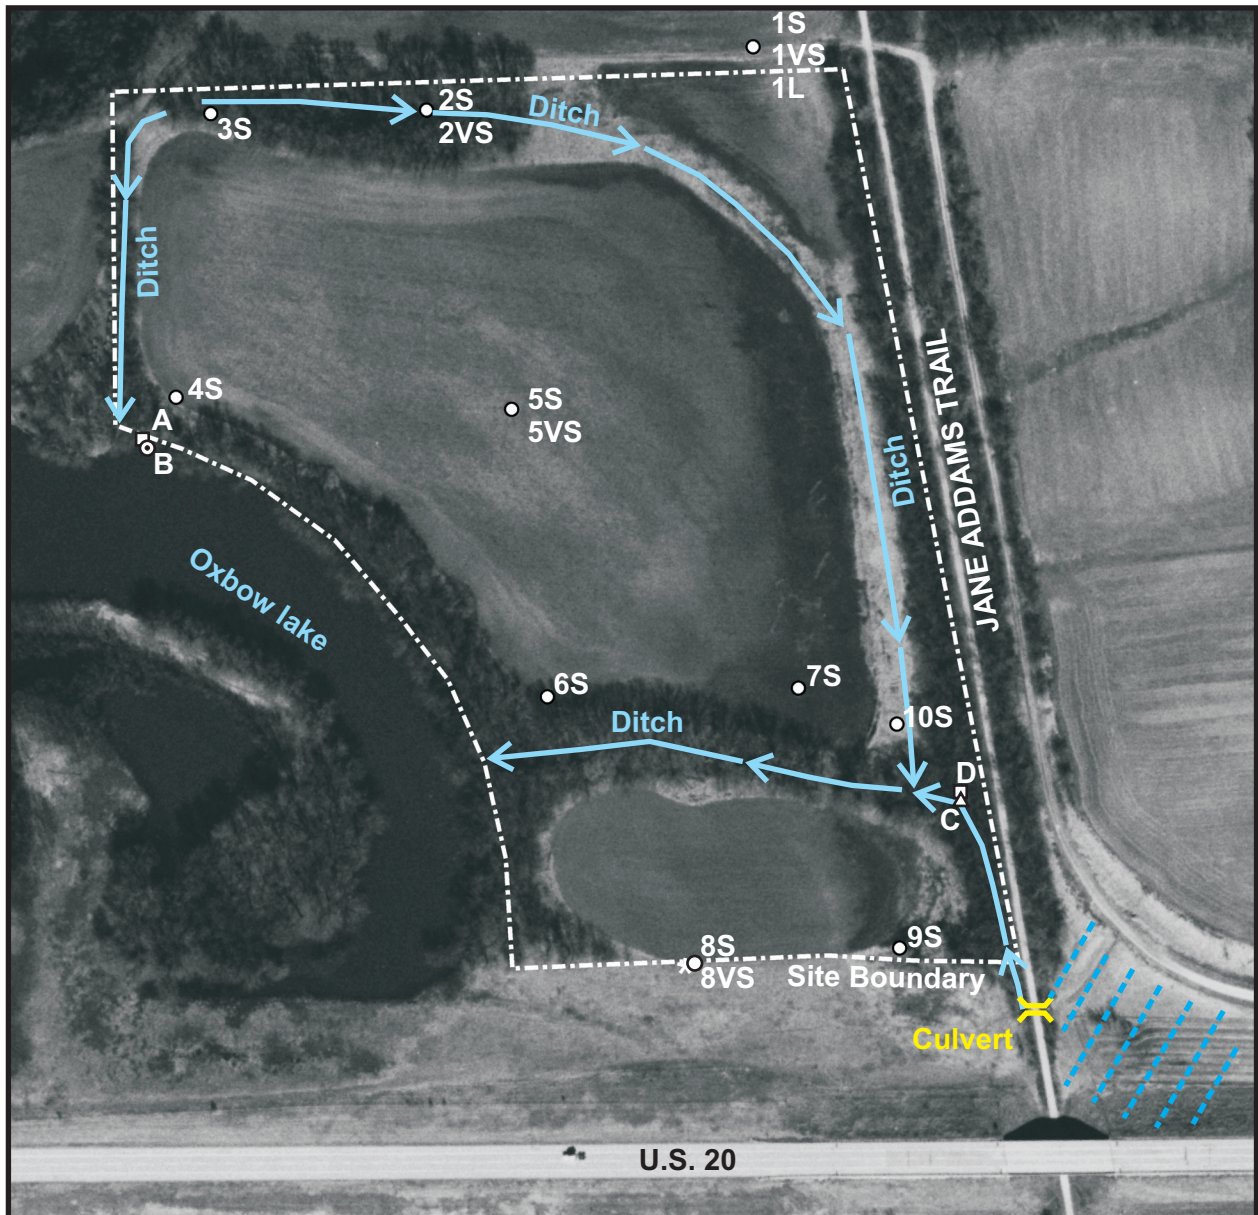
**Figure 4** Hydrologic alterations present at Site 6W (figure drawn on ISGS 2005b).

- Hydrologic alterations at the site include drainage ditches along the northwestern, northern, and eastern site boundaries, in addition to one bisecting the center of the site from east to west (Figure 4). The northern and eastern ditches direct surface-water off the site by channeling it into the central ditch where it then flows westward into the oxbow lake. However, during flood events, the central ditch is the primary pathway by which flood water enters the site as the oxbow lake floods. In addition to the drainage ditches, a culvert is located near the southeastern corner of the site (Figure 4). During heavy rainfall events, the culvert diverts runoff onto the site from the uplands to the east.

- Any compensation site design that interrupts the current drainage network must provide a continued means of drainage for adjacent agricultural areas immediately north, east, and west of the site. The constructed berm should not have any adverse offsite impacts, with the exception that water may back up at the culvert near the southeast corner of the site. This may cause water to temporarily stand in the strip of land between the access road to the site and U.S. 20, which may already be IDOT right-of-way (Figure 4).

Site 6W of the West Freeport Bypass lies within the floodplain of the Pecatonica River, approximately two miles (3.2 km) northwest of the intersection of U.S. 20 and IL 26 near the town of Freeport, Illinois (Figure 1). The 9.6-ha (23.6-ac) site is bounded by the raised roadbed of U.S. 20 to the south, the Jane Addams Trail (a former railroad grade) to the east, agricultural fields to the north and northwest, and an intermittent oxbow lake to the southwest (Figure 1). Broad, shallow drainage ditches are present along the northwestern, northern and eastern edges of the site, and an east-west trending drainage ditch bisects the center of the site (Figure 4).
