# Assessment of the Geology and Hydrogeology of Two Sites for a Proposed Large Dairy Facility in Jo Daviess County Near Nora, IL

Samuel V. Panno and Donald E. Luman

Illinois State Geological Survey

2008 Illinois State Geological Survey Open File Series 2008-2

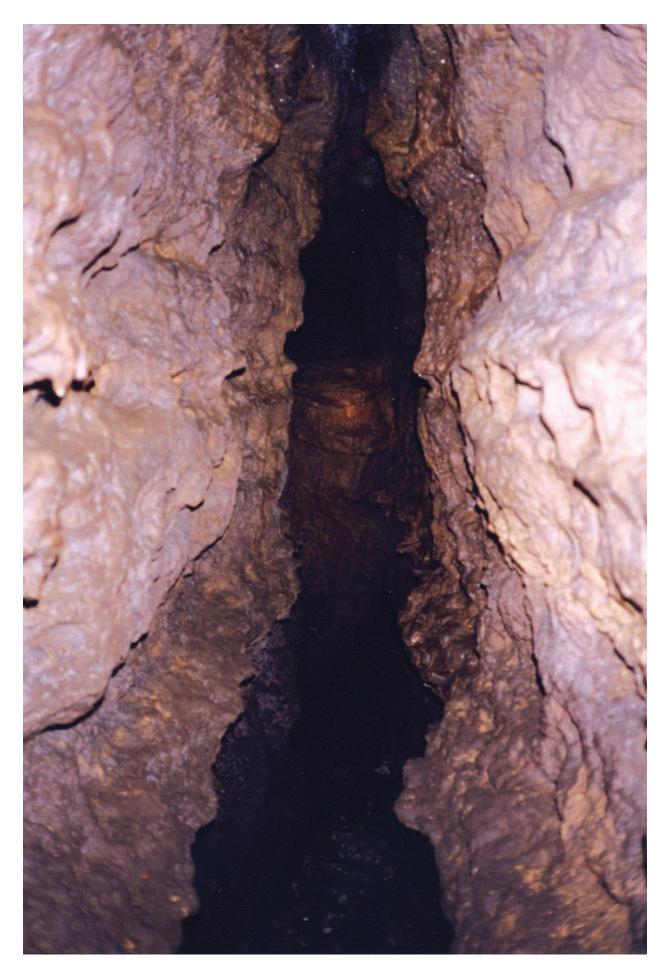
**Figure 3.** Passages about 3 feet wide in a cave located along Route 20 in western Jo Daviess County near Long Hollow Scenic Overlook. The cave was formed in carbonate rock of the Galena-Platteville Group.

passages, often at right angles to one another (Figures 2 and 3). One of the mapped caves is located less than 3 miles southwest of the proposed dairy facility, although, not all caves in the county have been mapped and many more may be present. Initial mapping of cover-collapse sinkholes in Jo Daviess County suggested that they were more localized and found near Chestnut Mountain Resort, just south of the town of Galena, and in Mississippi Palisades State Park just south of Jo Daviess County in Carroll County, in soil cover overlying Silurian-age dolomite (Figures 2 and 4). It is important to understand that an area does not have to contain sinkholes to be classified as karst; the term "karst" does not just refer to surface features such as sinkholes and large springs, and cave openings. Whereas, these surface expressions are indicators of karst areas, if an area is underlain by karstified carbonate bedrock, then the area is classified as karst even through no sinkholes are present (Figure 5). It is the karstification of bedrock that transforms it into a prolific aquifer that is key. Groundwater flowing through a karst aquifer can travel miles per hour, whereas, groundwater flowing through a sand and gravel aquifer may travel feet per year. In a karst aquifer, surface-borne pollutants (e.g., a spill or seepage of animal waste) can contaminate wells miles away from the source in a matter of hours. Consequently, based on the bedrock geology map of Jo Daviess County (McGarry 2000) that shows most of the county having carbonate bedrock (Figure 2) and a relatively thin sedimentary overburden, we would classify the entire county as karst. Exceptions to this generality would include the Mississippi River Valley and areas where there are thick sequences of Maquoketa shale that might afford protection to the underlying karst aquifer. However, shale thickness should probably be at least 10 feet or more to avoid movement of water through fractures and/or macropores (e.g., root pathways of vegetation, animal burrows).

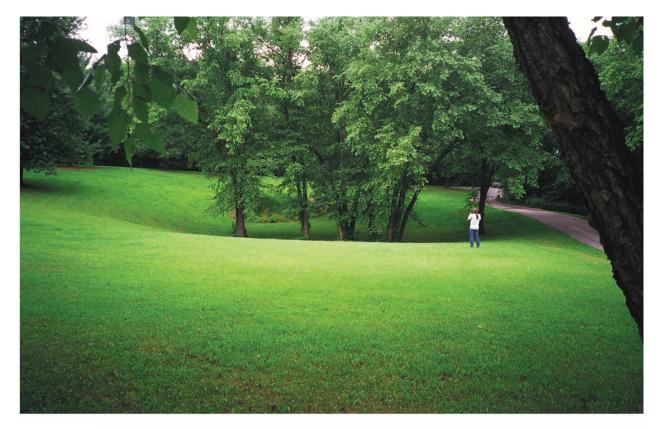
**Figure 4.** Sinkhole located in Mississippi Palisades State Park just south of the county line in Carroll County. The cover-collapse type sinkhole formed in unconsolidated sediments overlying Silurian-age dolomite.

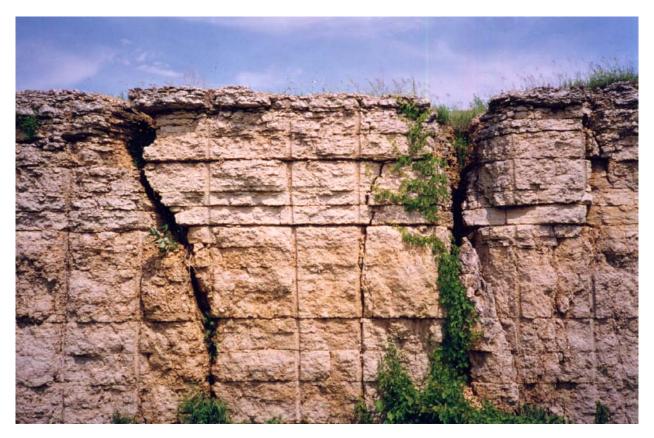
Figure 5. Creviced carbonate rock of the Galena-Plattville Group exposed along Route 39 just south of Rockford, Illinois.

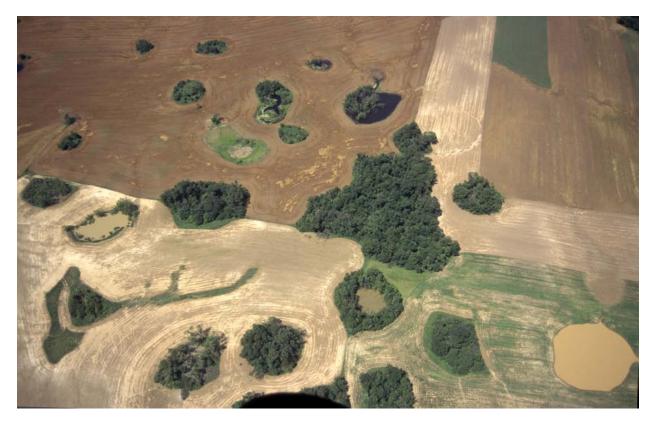
Figure 8. Aerial photograph of a farm field in St. Claire County, southwestern Illinois, showing cover-collapse sinkholes similar to those seen in Jo Daviess County (Figure 7). From Panno et al. (2008).

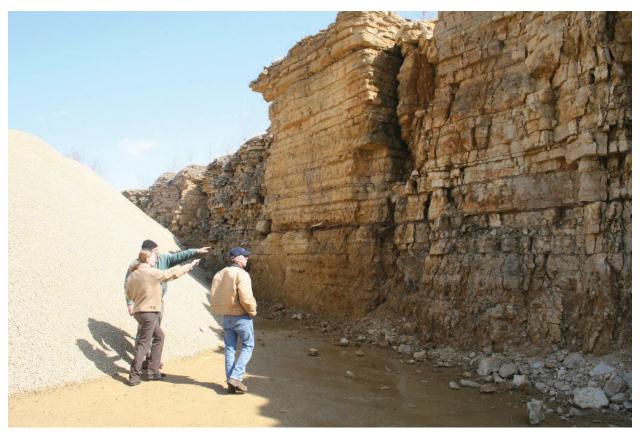
**Figure S2.** Exposure of Galena Group carbonate rock in a quarry located 1.5 miles south of the proposed dairy (Traditional South site). Two sets of solution-enlarged crevices are visible in this photograph, one set are fracture planes parallel to the quarry face and the other set are fracture planes nearly perpendicular to the quarry face. All are vertical or nearly so, have a width of several inches, and show evidence of dissolution on their surfaces.

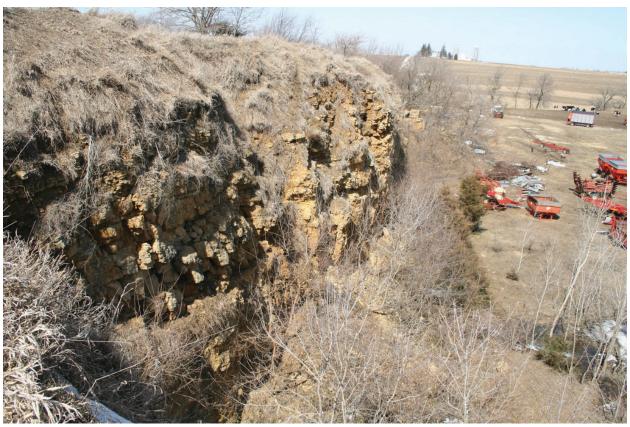
**Figure S4.** Exposure of Galena Group carbonate rock in a quarry located about 1.5 miles north of Nora, IL. The walls of the quarry are craggy and badly weathered. A racoon and birds were seen entering and exiting the openings.

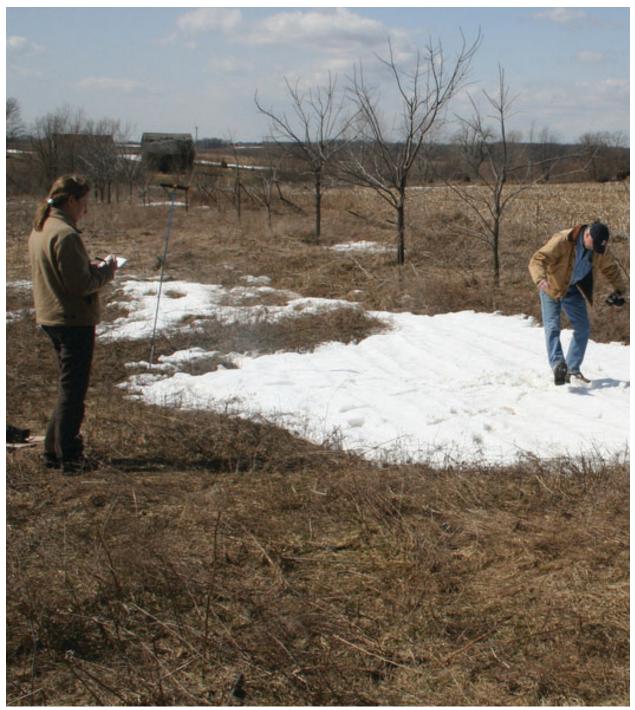
**Figure S5.** A nearly circular, snow-filled depression located on Todd Sargent's farm. The snow overlying this depression was about 3 feet deep with a diameter of about 10 feet. Bedrock in the area was Galena Group carbonate rock.

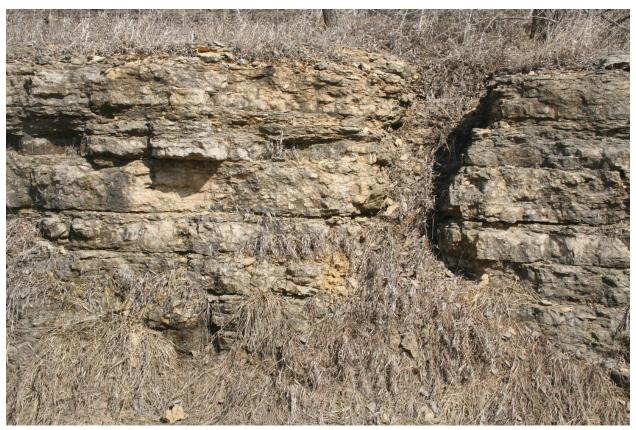
Figure S6. Road cut about 100 feet northwest of Todd Sargent's farm showing a solution-enlarged crevice about 6 inches wide.

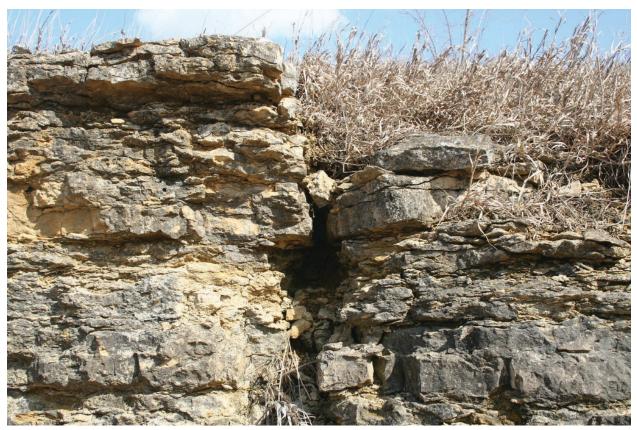
Figure S7. Road cut near Sargent's farm showing a solution-enlarged crevice about 2-3 inches wide.

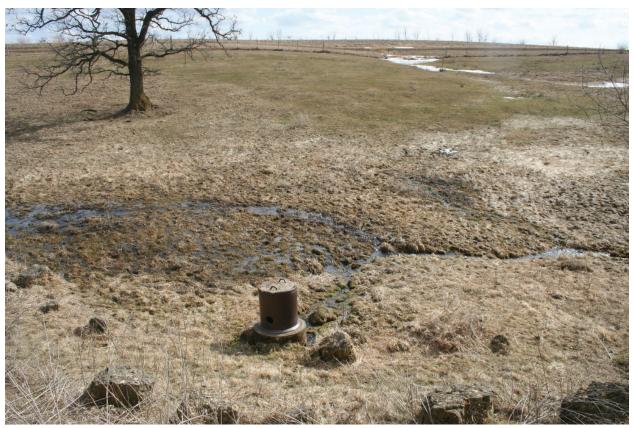
**Figure S9.** A large springs located about 1.5 miles north-northeast of the proposed sites. The spring was contained by the land owner who used a large conduit (cattle were digging at the spring and causing erosion). The spring flows year around and discharges about 50 gallons per minute. Specific conductance of the water suggests a chloride concentrations ranged from 30 to 40 mg/L (elevated above background levels of <1 to 15 mg/L).

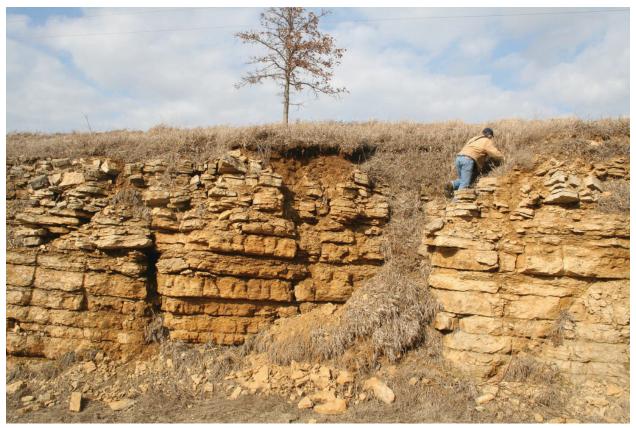
Figure S11. A closeup of the above road cut showing numerous crevices betwen 1 to 6 inches wide. Bedding planes were prominent throughout the exposure.

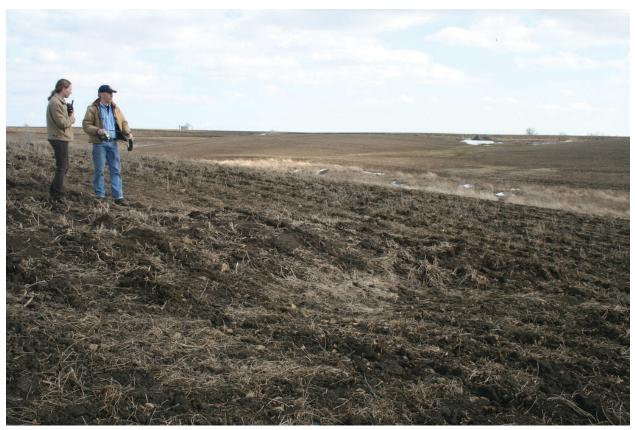
Figure S12. A small depression about 5 feet in diameter in a cultivated field, and located in a field just west (about1.5 miles) of Nora, IL, appears to be a sinkhole. Fragments of carbonate rock littered the field indicating that the soil overlying bedrock was relatively thin in this area.

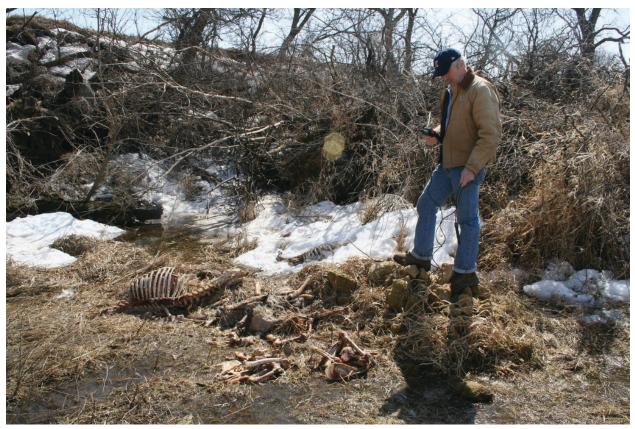
Figure S13. A small quarry containing the remnants of butchered deer. The quarry walls were small and so overgrown that a clear view of the rock was not possible.
