The Great Flood of 1993

Geologic Perspectives on the Flooding along the Mississippi River and Its Tributaries in Illinois

March 1994
Special Report 2

ILLINOIS STATE GEOLOGICAL SURVEY
Morris W. Leighton, Chief

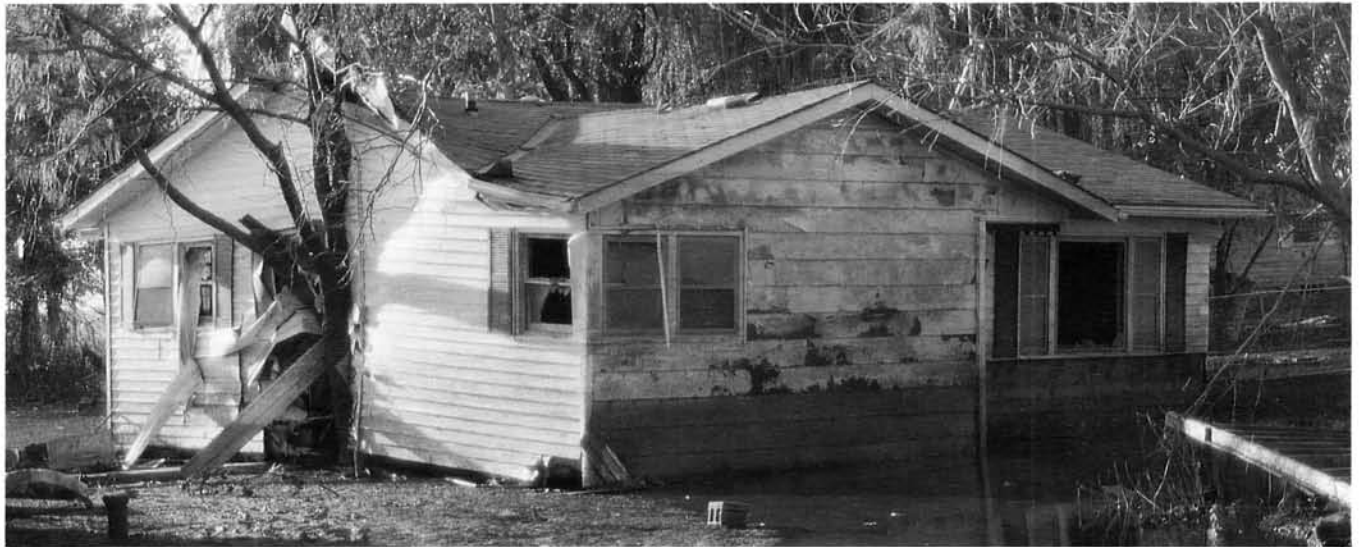
2 Monroe County: Flood water rushing through the town of Valmeyer lifted this house off its foundation and carried it until it collided with a tree (October 12, 1993).

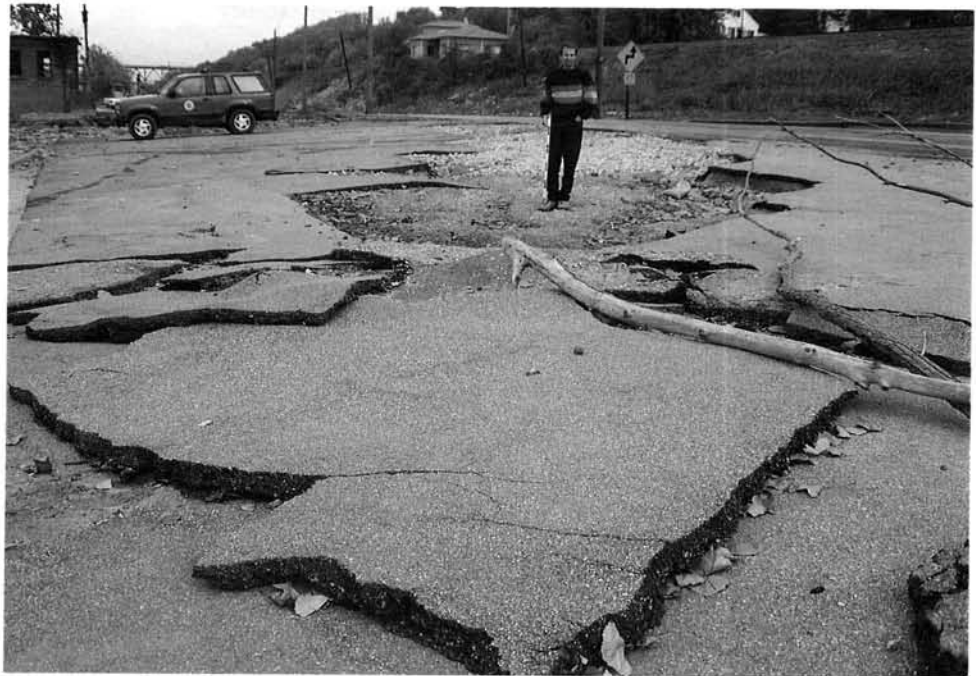
4 Randolph County: Asphalt pavement slabs next to the river-front road at Chester were lifted and transported by flood water. Robert Bauer, ISGS engineering geologist, stands where the blacktop slabs were eroded (October 13, 1993).

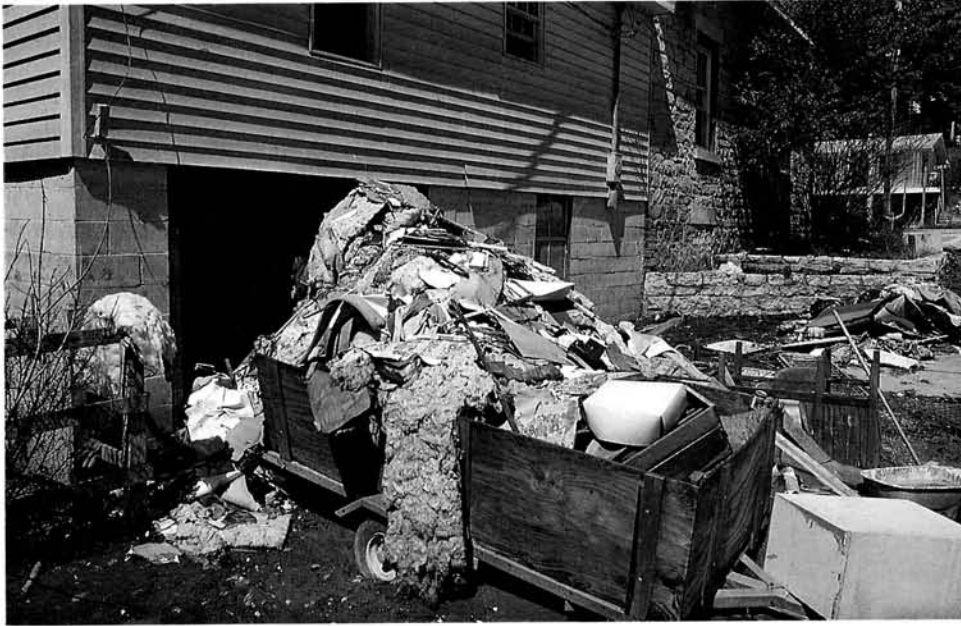
5 *Jersey County: Aerial view (below) shows how much of Grafton was flooded at about the time of the highest flood crest (August 6, 1993). Water-saturated plasterboard and insulation removed from flood-damaged houses such as this Grafton home (left) cannot be reused. The debris from buildings affected by flood water will be a new burden on landfills. (September 3, 1993)*

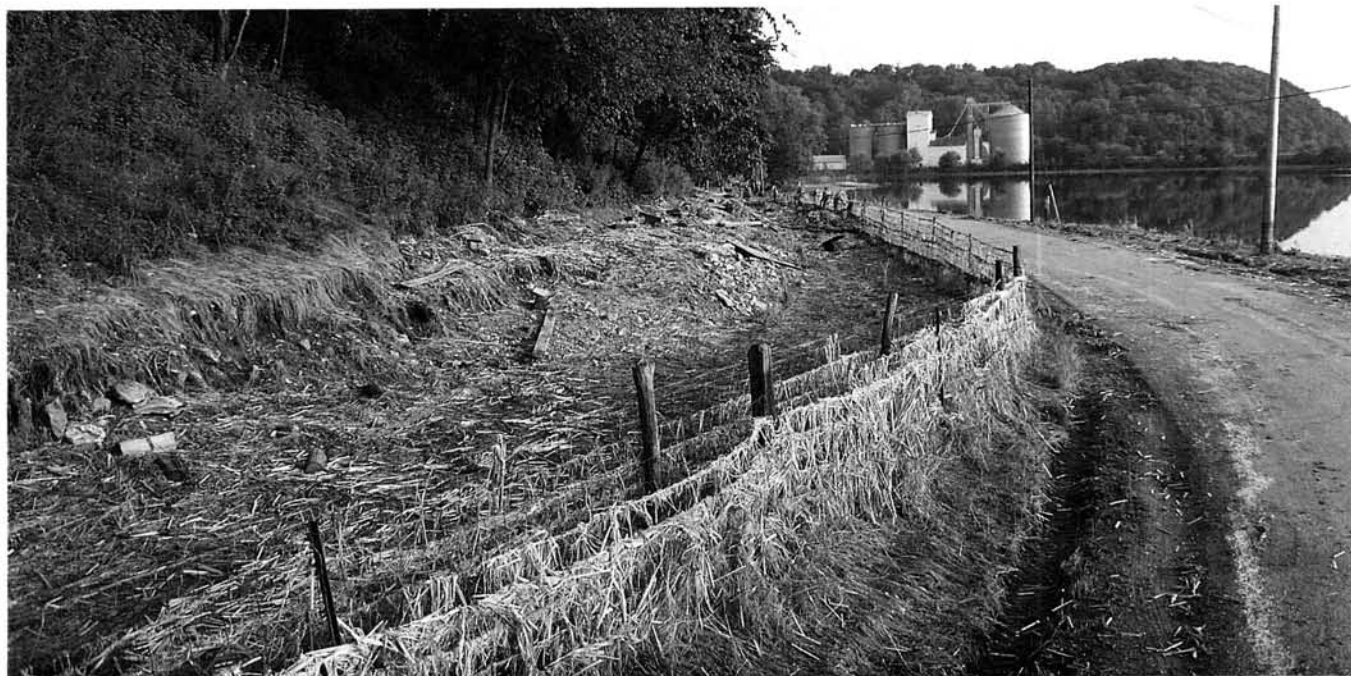
17 Greene County: Dead vegetation (above) commonly marks high water line, as in this view of the Illinois river valley within the Hillview Drainage and Levee District. The town of Hillview is in the distance. Note the abundance of corn plant debris caught in the barbed-wire fence (August 25, 1993). Topographic map of Hillview and vicinity (left) shows configuration of the high water line. Spacing between contours relates to land slope. The widely spaced contours represent the relatively flat land of the floodplain. Closely spaced contours are the steep slopes of uplands and bluffs. Base map, Pearl East Quadrangle, USGS 7.5-minute topographic map, 1980.

In any particular area along the flood margin, the surface elevation of flood water was uniform and defined a curving line of uniform elevation on the land surface (like the contours on a topographic map; fig. 17). As flood water receded, the high water line was well marked by the upper limit of dead vegetation, something like the ring left in a bathtub after the water drains out. Figure 17 shows the high water mark on a hillslope along the margin of the Illinois River valley. The extremely high water levels in this area caused flooding above the limits of the floodplain and up onto a bluff slope. The valleys and floodplains of tributary streams draining the uplands were low areas where flooding could extend even farther from the main river channel. The high water line in figure 17 goes around the hillslope and into the distant valley.

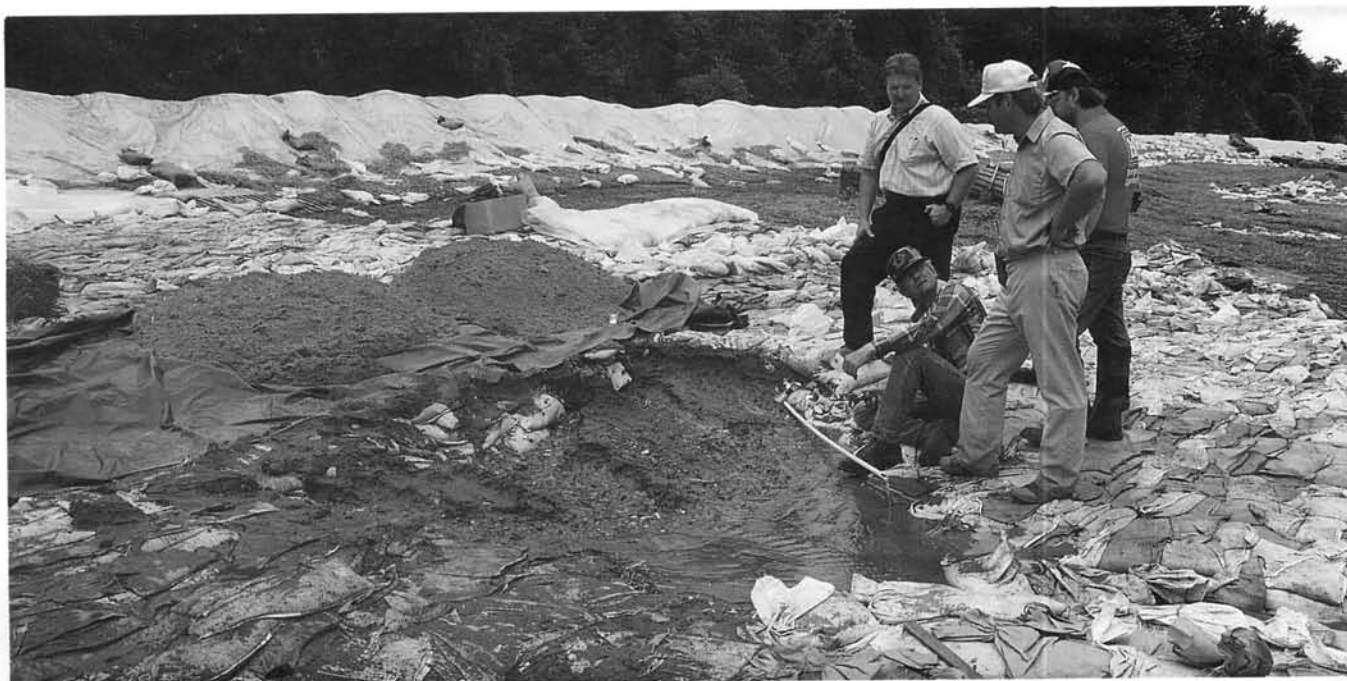
24 *Pike County: Water seepage caused piping of sandy material in the Sny Island levee, at about the place where it failed on July 25, near East Hannibal. The observers are engineers from the U.S. Army Corps and officials of the Sny Island Drainage and Levee District (July 21, 1993).*

Flood water on the river side of levees applies pressure to the levees, which are constructed to hold back water for a short time. Because of the unusually long duration of high water in the flood of 1993, water infiltrated permeable layers within and beneath the levees. The result was seeps piping sand out of the levee on exposed levee slopes. Along much of the Sny Island levee bordering the Mississippi River south of Quincy, seeps were a widespread problem, causing the levee to fail on July 25 (fig. 24).

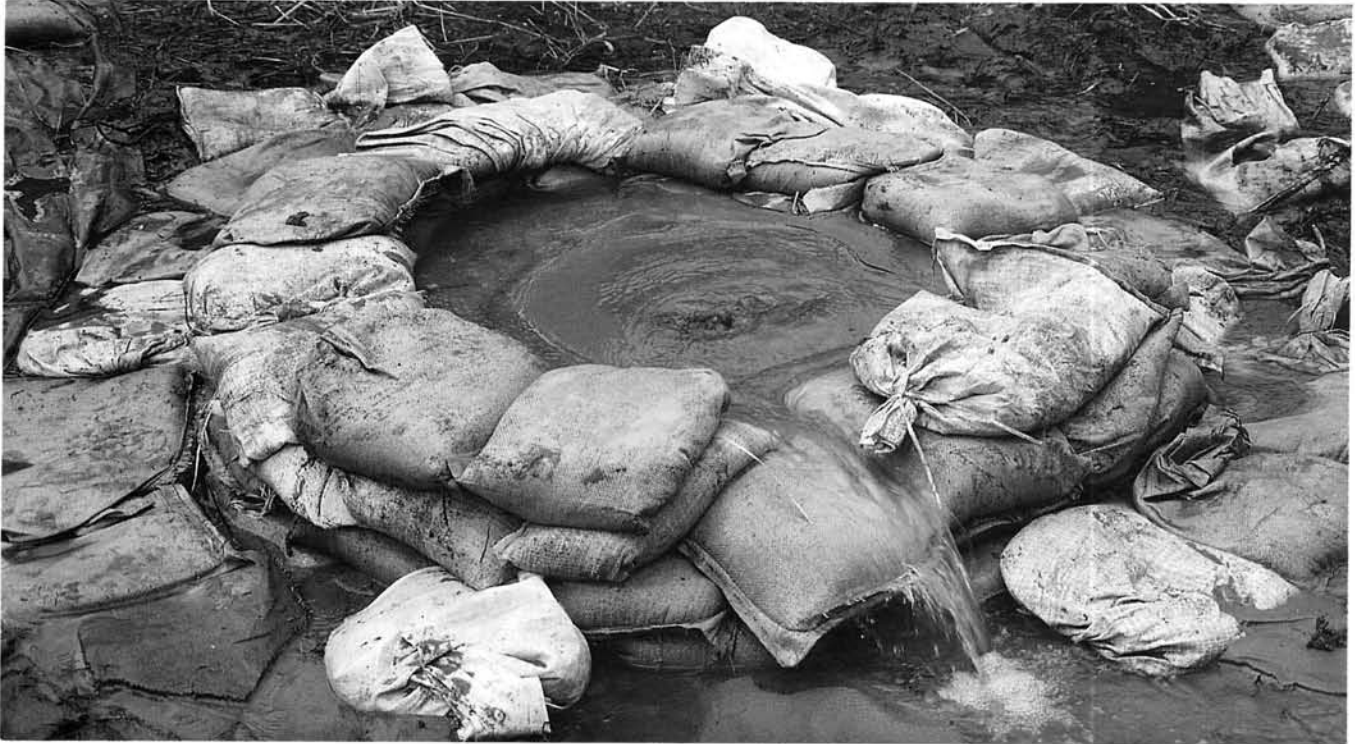
25 *Pike County: Sand boil at the foot of the Sny Island levee. Sandbag ring dike prevents loss of piped sand but lets water flow away, reducing water pressure under the levee (July 21, 1993).*

Sand boils were common on the floodplain adjacent to many levees. They formed where lenses of sand under or within a levee provided a pathway for water to pipe sediment. Unless piping (erosion) of sediment under or within the levee was halted, the flowing water would quickly sap the levee structure and cause a catastrophic failure. Sand boils were counteracted by building a dike of sandbags around the boil (fig. 25) and allowing water to rise within the ring. The rate of flowing water slowed within the ring dike, and the sandbags minimized the loss of sediment by trapping it in place and equalizing water pressure. Allowing the water to flow over the sandbag dike prevented water pressure from building up elsewhere in the levee. Sand boils can develop, then cease activity as changes occur in the flow pathways within the levee. Fine grained materials (silt or clay) transported within the levee may block the flow path and shut off one sand boil while opening a channel for another (fig. 26).

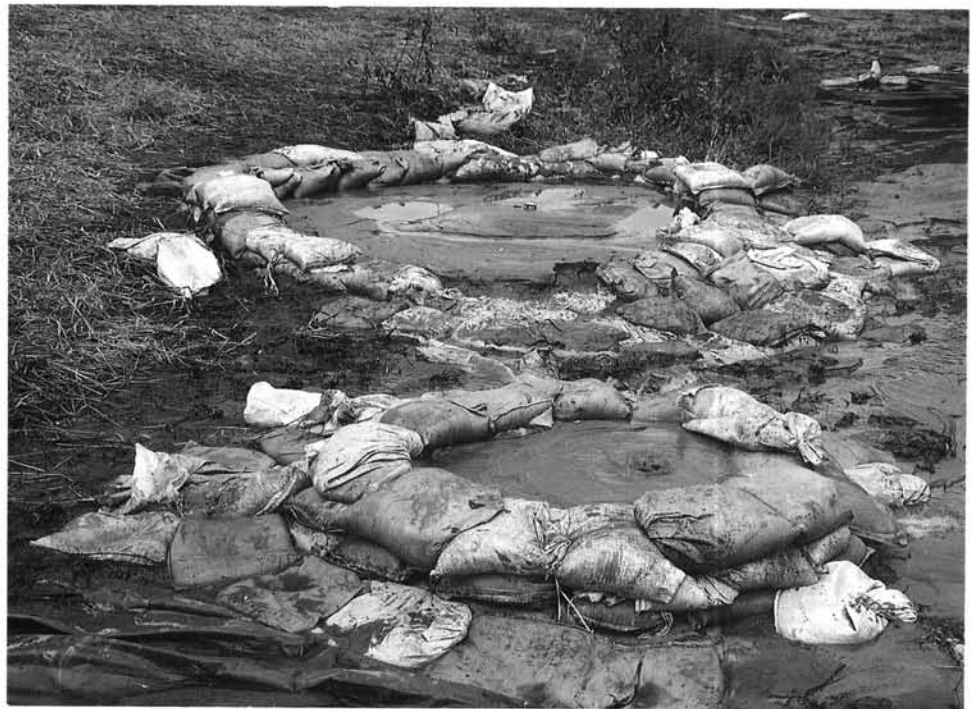
26 *Active and inactive sand boils side by side at the foot of the Sny Island levee. Flow paths to the inactive boil (top) were possibly shut off by internal shifting of sediments (July 21, 1993).*

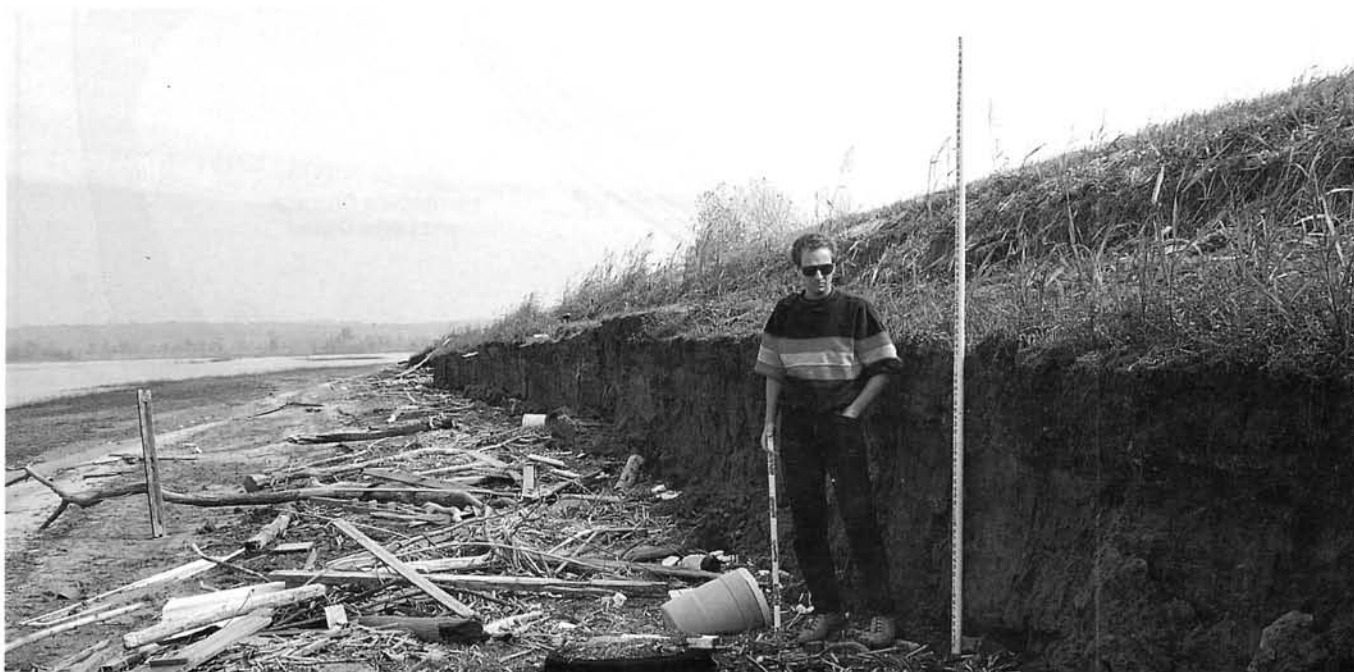
28 Randolph County: Nearly vertical cut made by waves eroding the inner (landward) side of the southern part of the Kaskaskia Island levee. Note the driftwood and debris where ISGS engineering geologist, Robert Bauer, stands at the base of the erosional cut (October 13, 1993).

In some areas, flood water of the Mississippi and Illinois Rivers submerged the floodplain from bluff to bluff. As a result, temporary lakes formed that were several miles wide (see cover photo). Waves on these lakes eroded the land along the high water lines. In many places, a wave-cut notch ranging from a few inches to 1 foot high was eroded along the high water line. Along bluff slopes, the erosion caused the soils overlying the notch to slump and undermined the foundation of trees and shrubs. Some farmers may face considerable expense in leveling their fields, but in general, the wave erosion had no major consequence. Remedial action will be required, however, along the inner side of the Kaskaskia Island levee, where an erosional cut nearly 5 feet high was formed by severe wave action (fig. 28). Apparently, the abundance of sandy materials in this section of the levee accelerated the wave erosion.

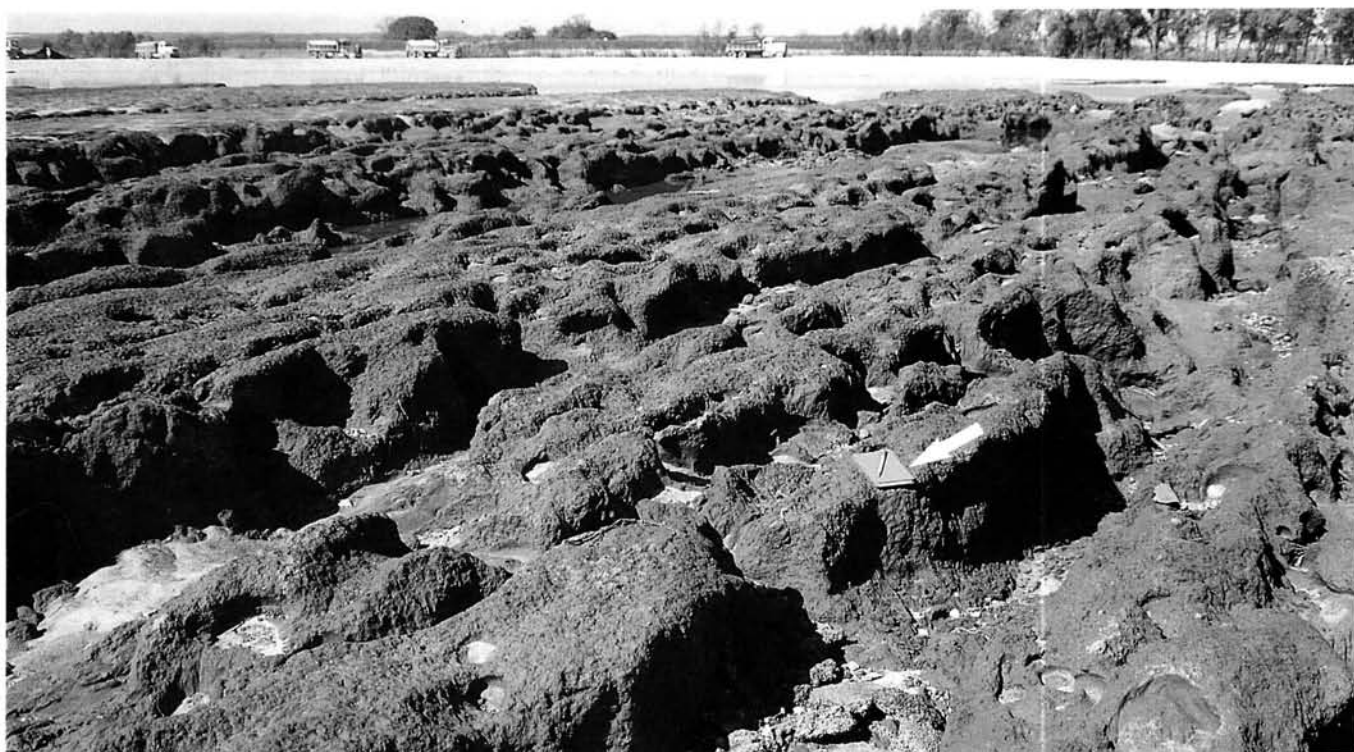
29 Monroe County: Deep erosion in the floodplain near a levee breach (October 12, 1993). The erosional scars may follow old plow furrows; the cuts are about 1 to 2 feet deep. Note pen atop field notebook (arrow) for scale.

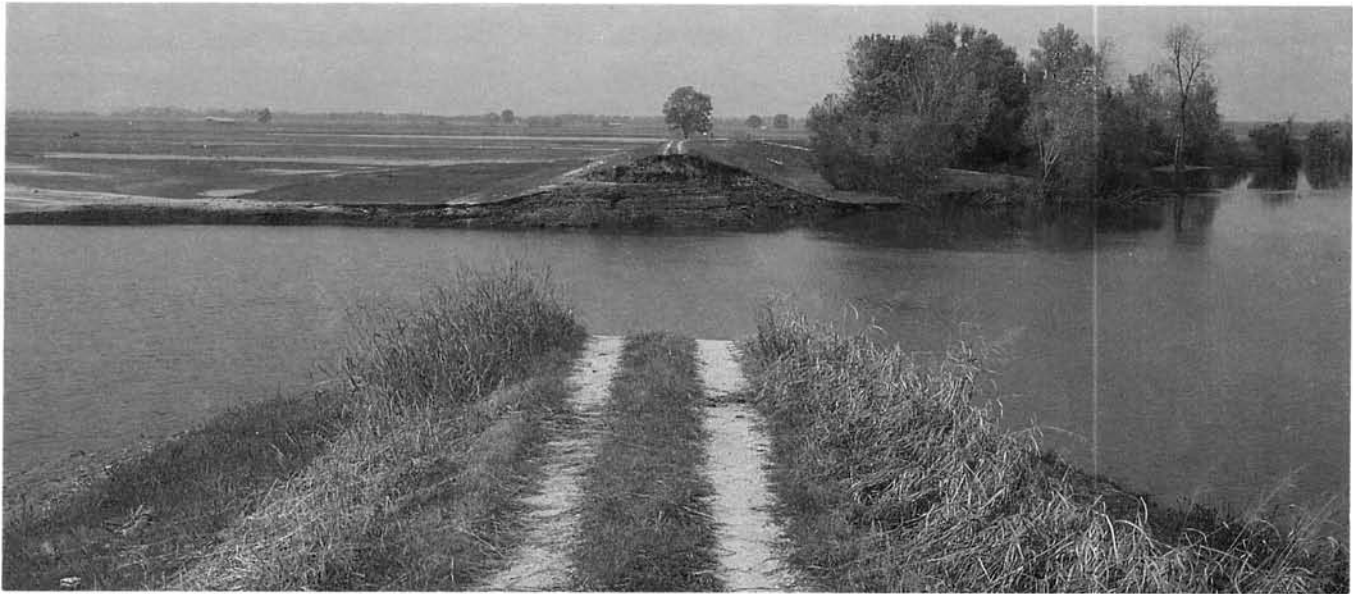
30 Randolph County: Looking northward across the levee breach in the Kaskaskia Island levee. (Figure 31 shows the depth of scour through this breach.) The Mississippi River channel is to the right beyond the range of the photo. (October 13, 1993).

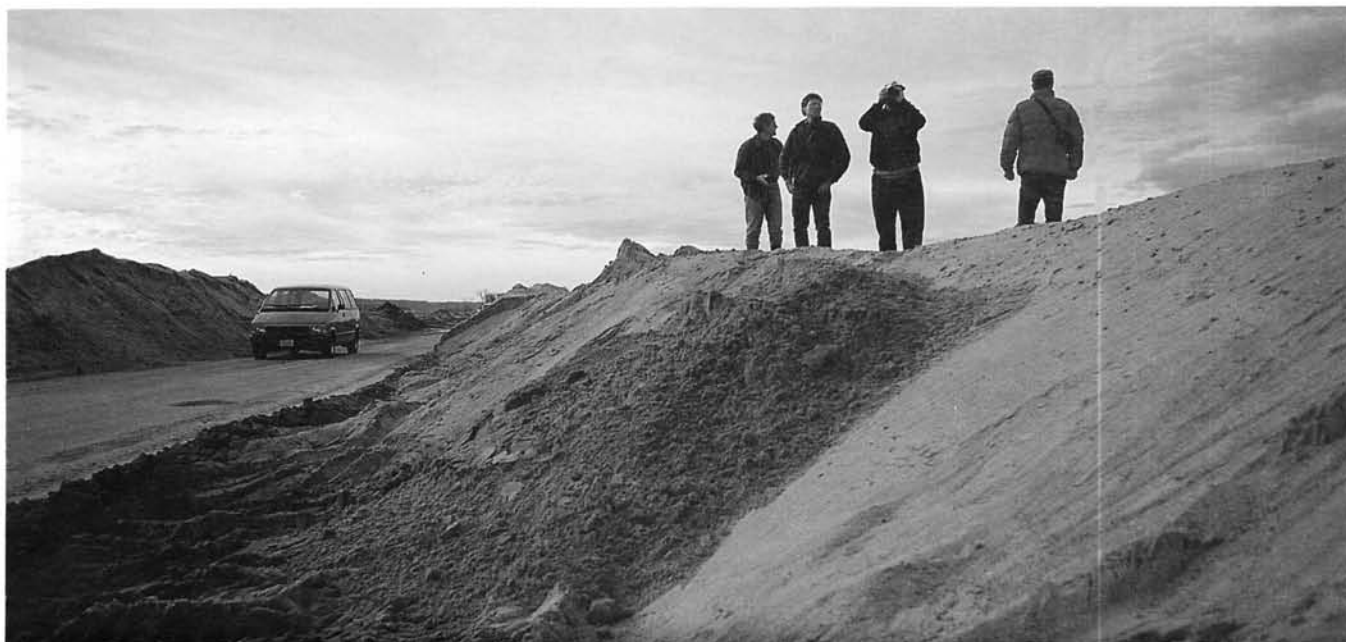
36 *Monroe County: Near the Columbia levee breach, the road cuts through sand 3–6 feet thick, deposited like a large sandbar or river dune commonly found along the bottom of river channels. ISGS geologists head for their minivan after a close look at the dune-like sand that buries fertile farmland (November 23, 1993).*

This sand deposit looks like a snowdrift (fig. 35) or a desert landscape (fig. 36). Its thickness varies, but a maximum of 8 feet was measured. A band of deposition, about 1,500 to 2,500 feet beyond the levee breach, ranges from about 3 to 7 feet thick; it is essentially a large bar or river dune such as that commonly found along the bottom of river channels.
