Final Report: Hydrogeologic Characterization and Stream Assessment at Franklin Creek State Park, Lee County, Illinois

December 31, 2019

Open File Series 2019-2

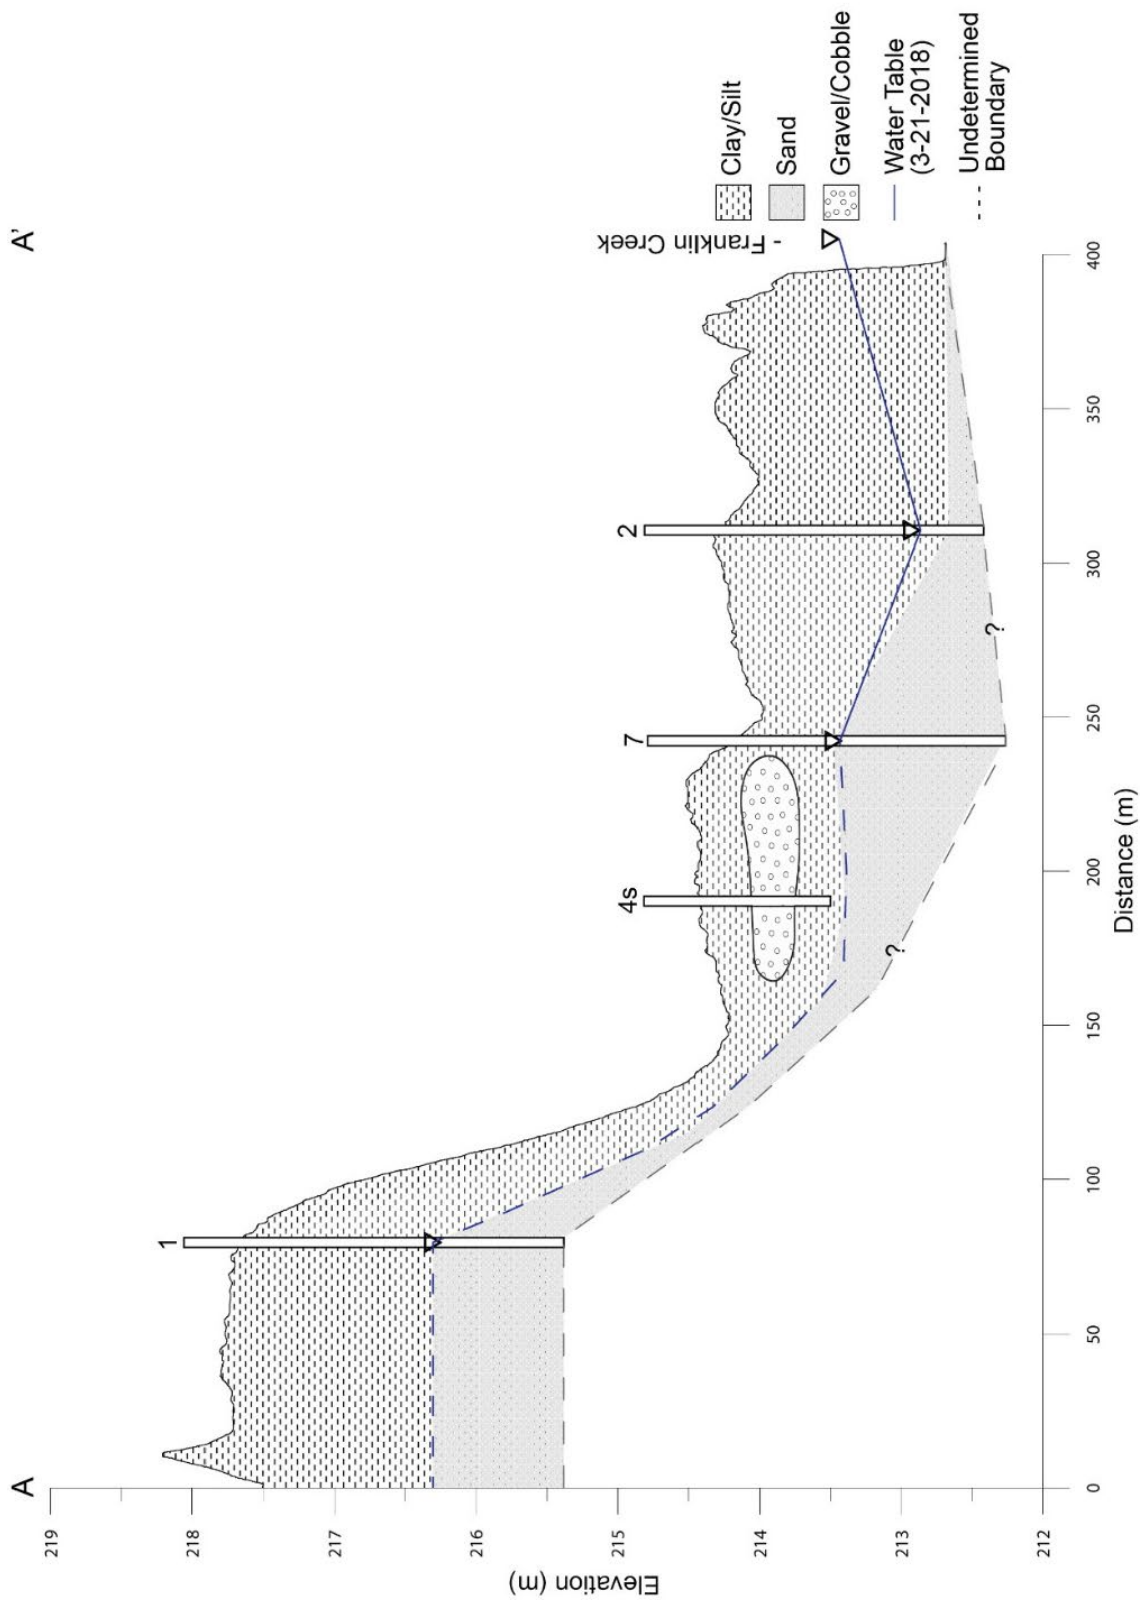
The geologic cross section in Figure 4 depicts deposits found at depth during the installation of the monitoring network. These materials are consistent with those described in the geologic mapping of the region. However, a deposit consisting of gravel with some cobble-sized material was found between wells 4S and 7 at 45 cm (1.48 ft) below surface (see Figure 2 for location). This deposit

Figure 4. Geologic cross section at Franklin Creek State Park, Site 5. Well borings (1, 4s, 7 and 2) were made installing monitoring wells on March 19 and 20, 2018. See cross section location line (A-A') in Figure 2. Vertical exaggeration is 50.

appears to be a lag deposit but could also be a local bedrock high as much of the gravel and cobble material encountered was composed of sandstone similar to the local bedrock. The gravel layer could inhibit or preclude restoration or creation of wetlands due to the high permeability, and the potential for bedrock near the surface may prevent excavation.

Given the infrequent flooding, depth to water table, and existence of a gravel lag deposit, we do not recommend excavation to create wetland areas. A large amount of excavation, ranging from 0.6 to 1.0 m (2.0 to 3.3 ft) based on the 2019 high water table, would be required to intercept the water table and/or capture floodwater on a more frequent basis in order to establish widespread hydrology characteristic of wetland habitat. The amount of excavation required to produce wetland hydrology would remove the native soil and the possibility of utilizing the existing seed bank within the existing soils.

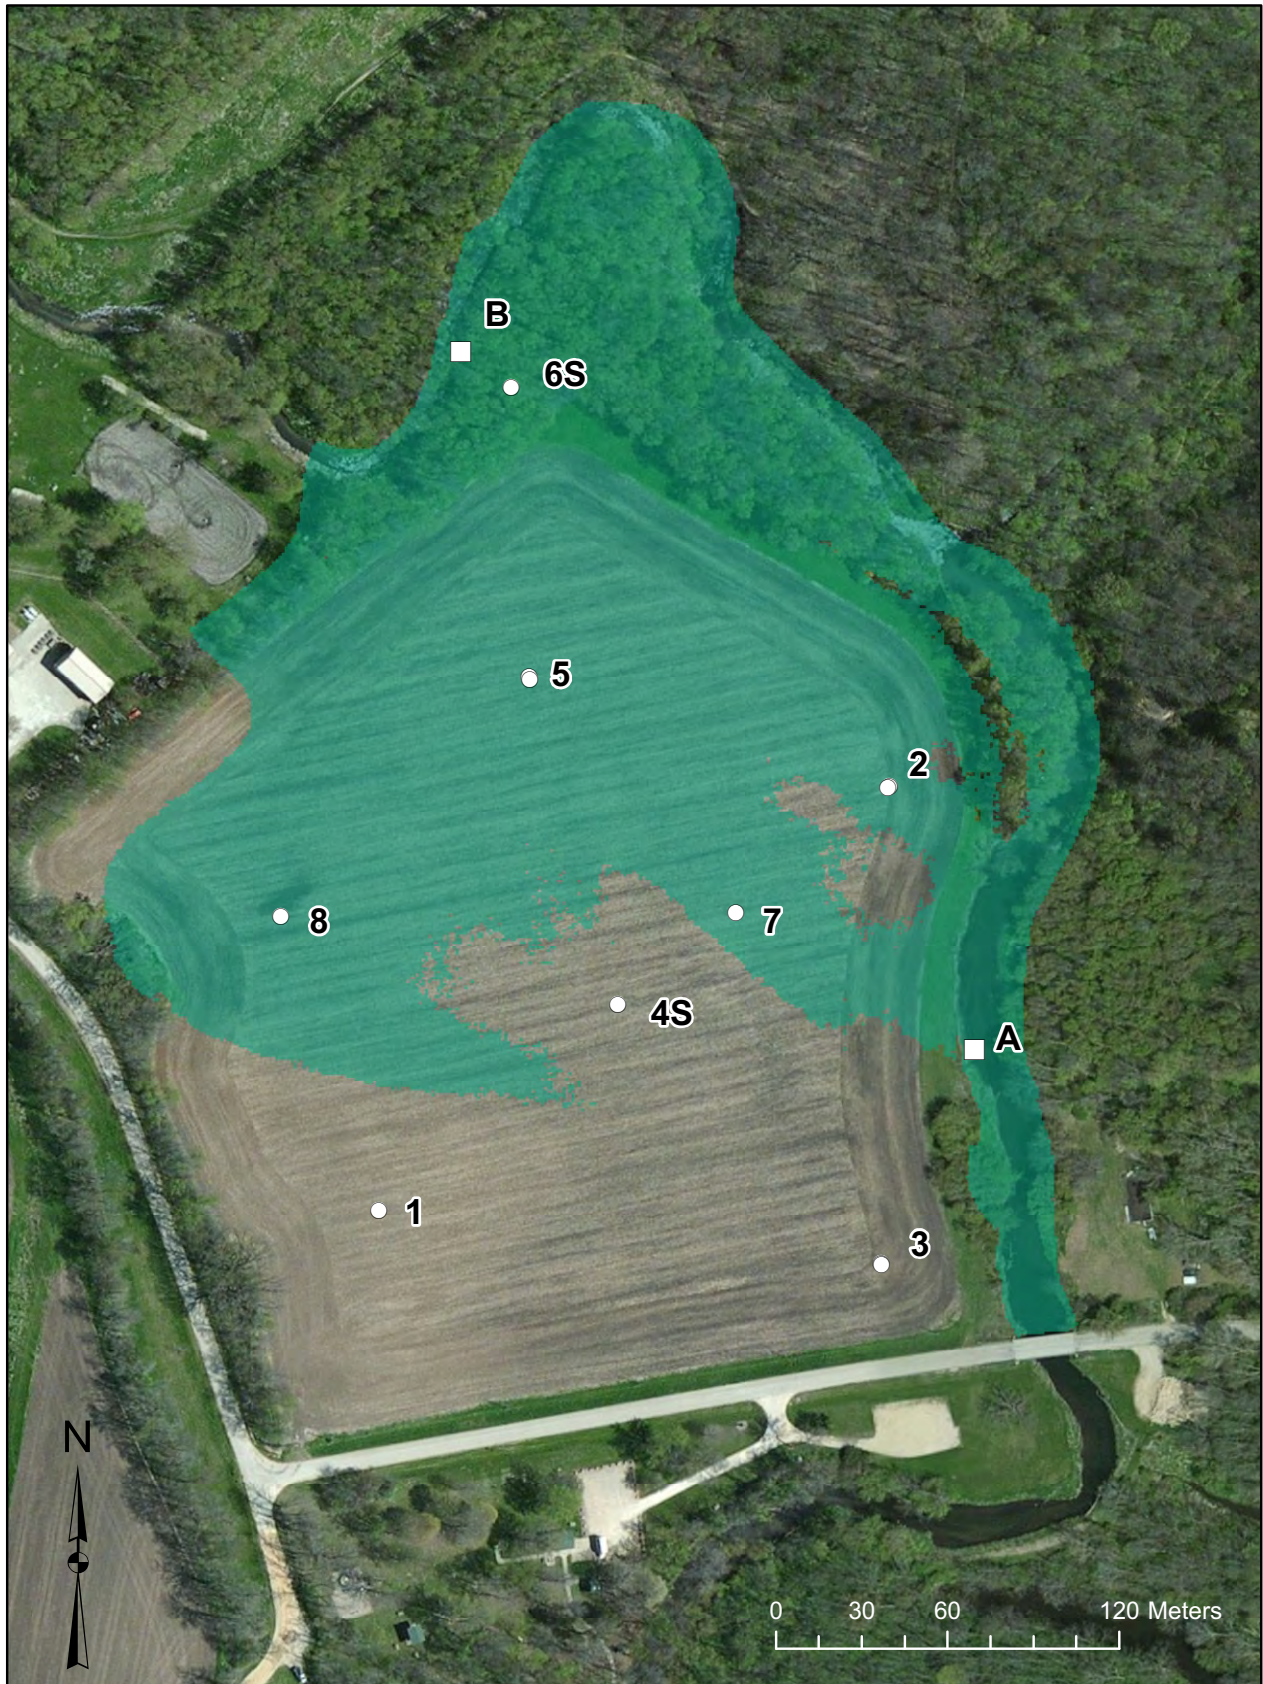
The highest water level elevation from wells showing saturation was used to estimate the maximum extent of saturation during the 2018 growing season. Figure 11 shows the extent of saturation during the June 10, 2018 rain event. Even though this shows a large saturation extent, it was only during a rain event when the site received at least 3.47 inches, and with a rather short saturation duration (18 hours at most). This is not an indication of long-term saturation, but gives a good idea of the extent of root-zone saturation which could limit restoration plantings with species with higher moisture requirements.

Figure 11. Approximate maximum saturation area based on groundwater levels within 30 cm of ground-surface during the June 9-10, 2018 precipitation and flood event.

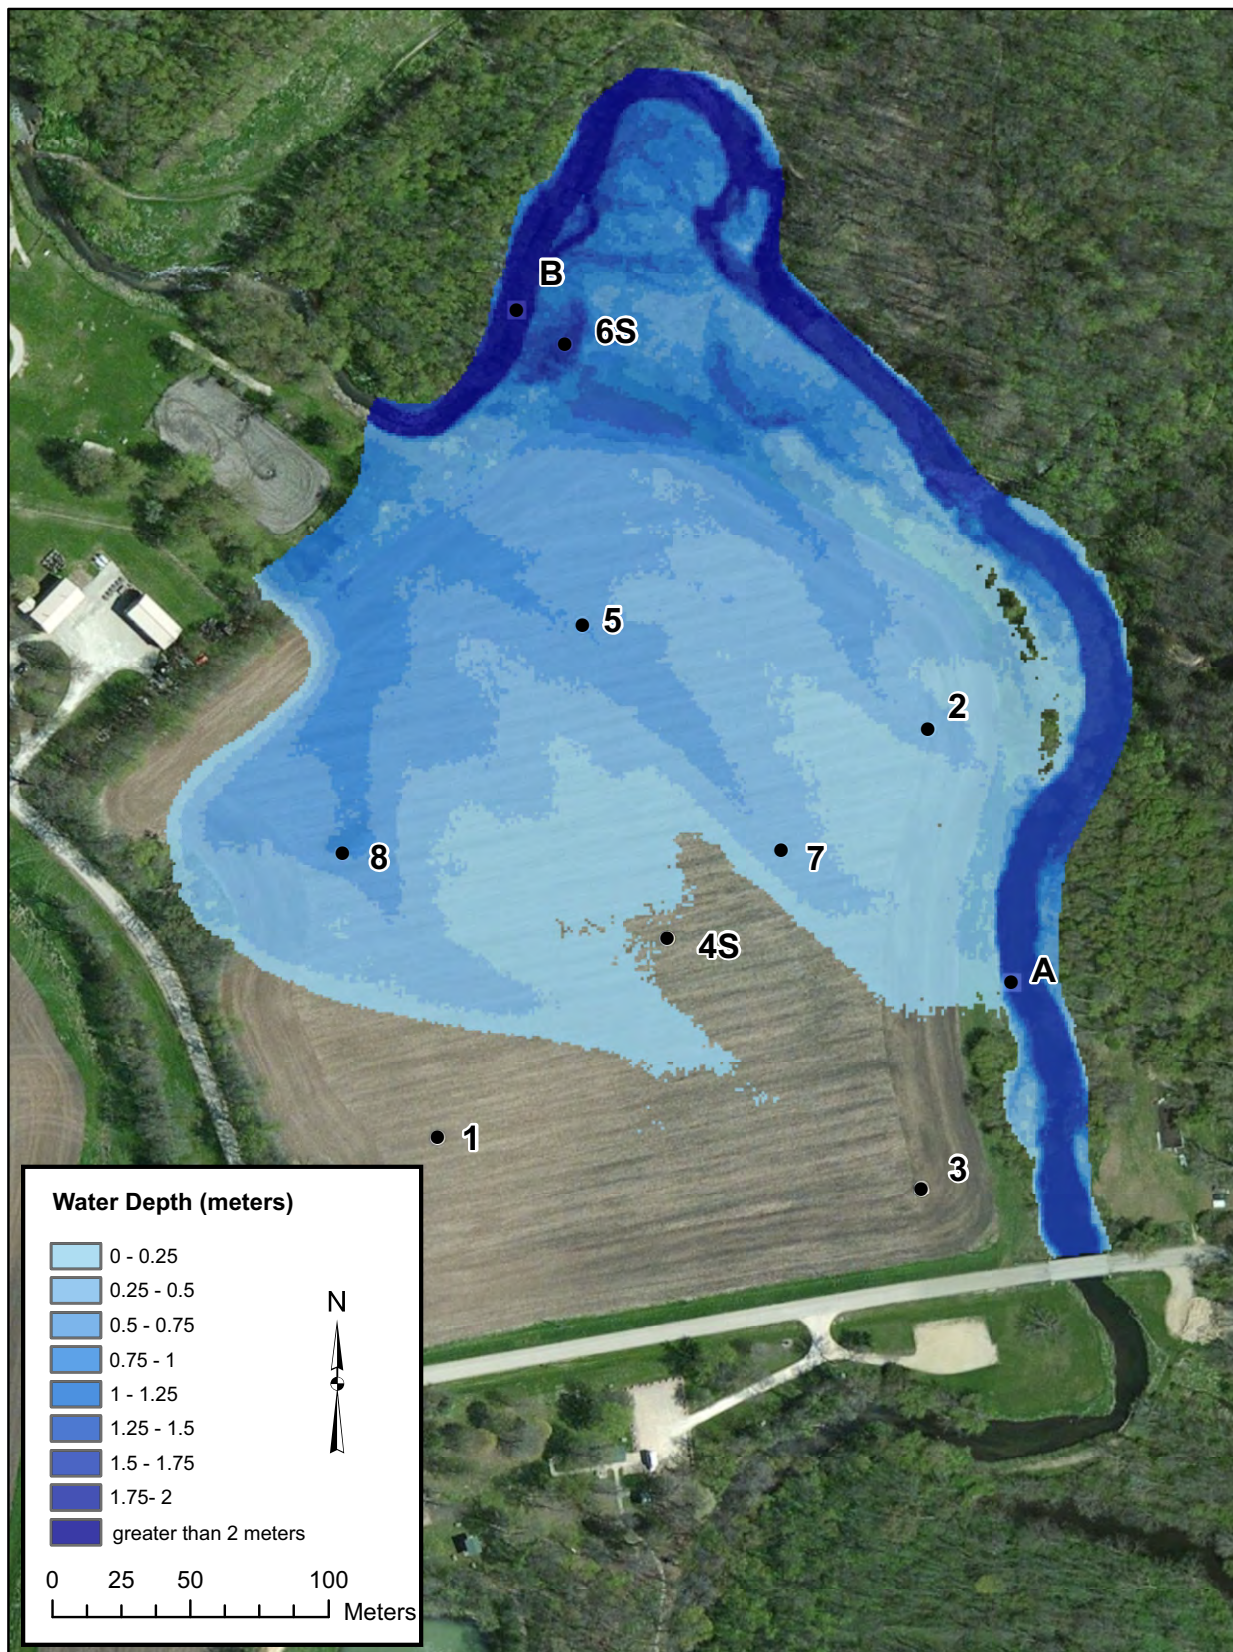
Water level data from monitoring wells are shown in Figures 12 and 13. Wells 2, 2S, 5, 5S, 6S, 7, and 8 were inundated during a flood event on May 30, 2019 that resulted from a storm that produced 2.79 inches of rain at Dixon. While inundation generally lasted less than a day during this event, wells 6S and 8 remained inundated for over three days. Figure 14 shows the maximum water depth across the site during the May 30 event and was calculated using the water-level elevation from the wells showing saturation.

Figure 14. Approximate maximum flood inundation depth during the May 30, 2019 flood event.

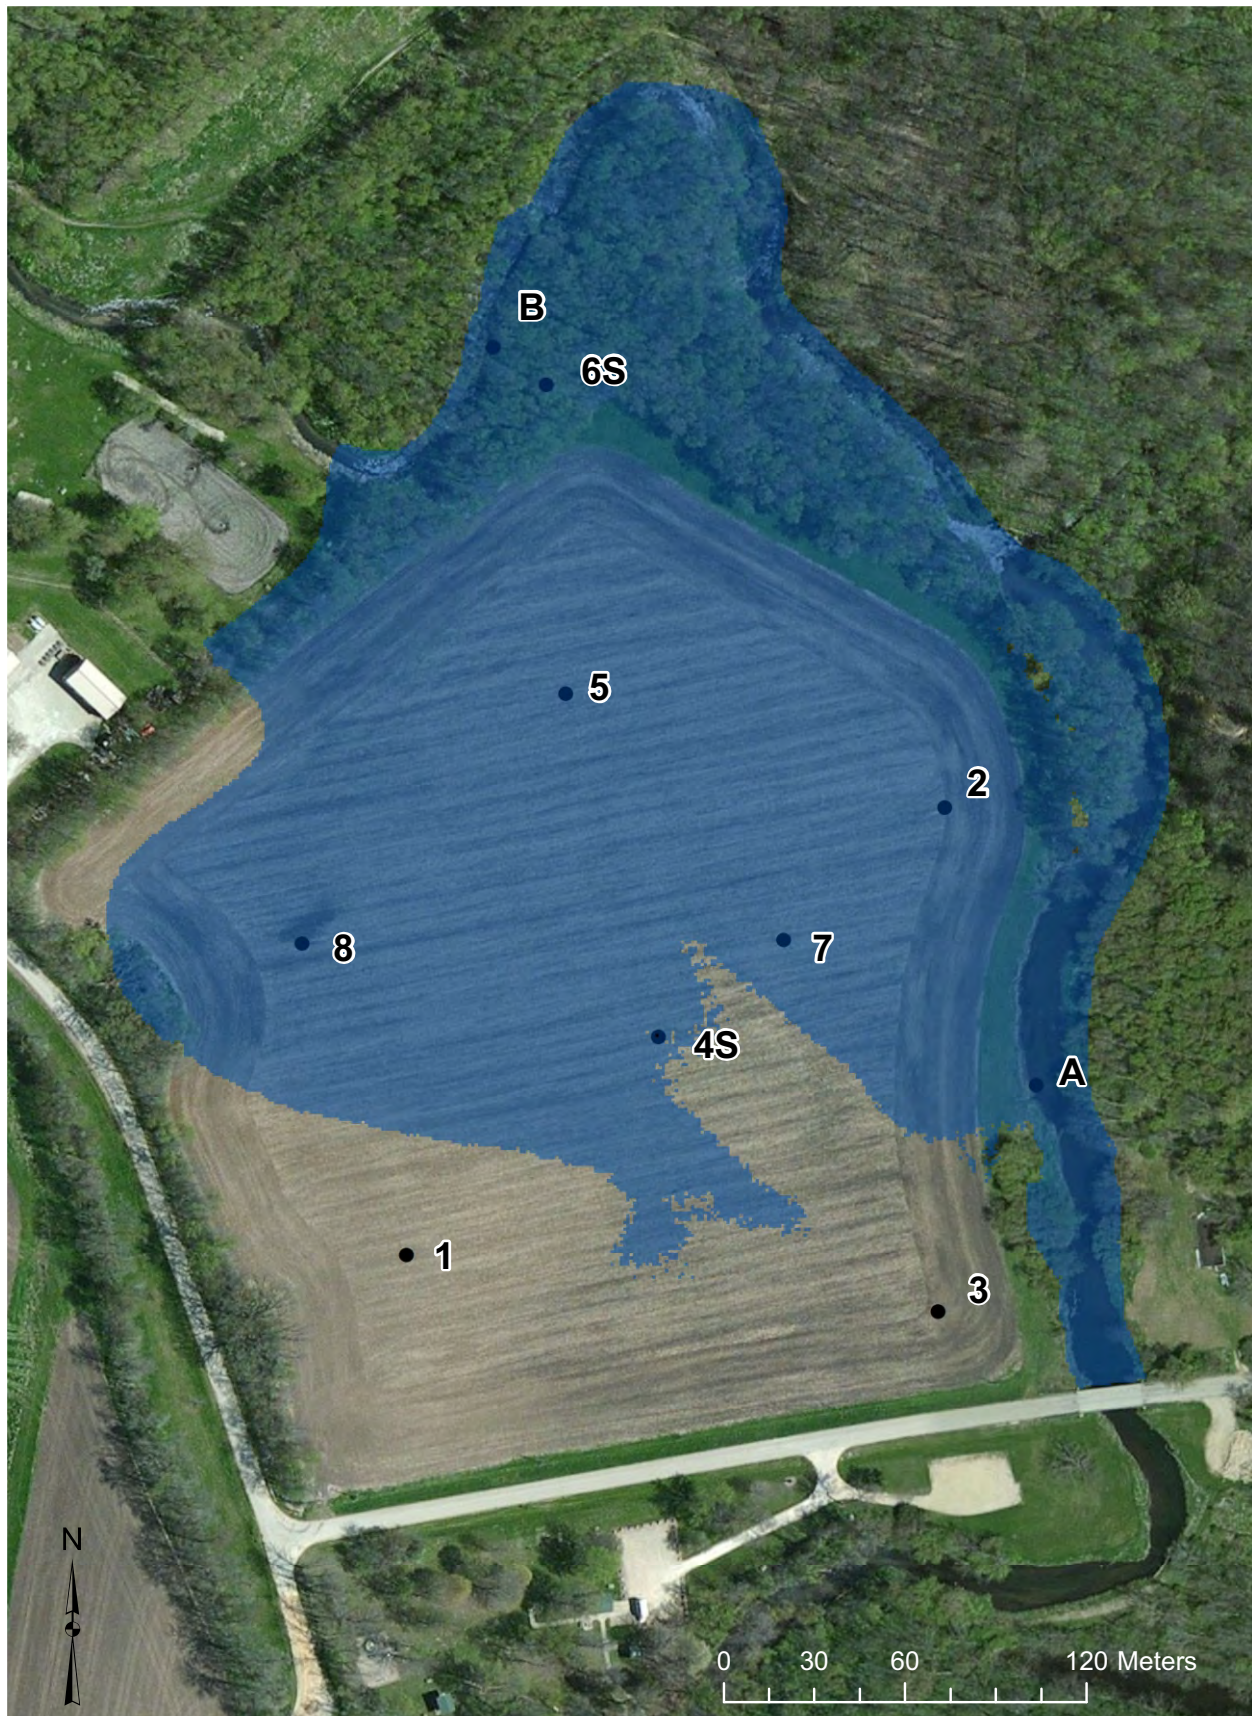
The maximum extent of saturation during the May 30, 2019 event is shown in Figure 15. Saturation was evident in all wells that were inundated, and was also evident in Well 4S. Saturation occurred at an increased frequency and duration as compared to inundation. Wells 6S and 8 had the longest periods of saturation. Well 6S was saturated over 25 days and well 8 was saturated over 28 days. The increased frequency of precipitation events likely led to the extended period of saturation seen in 2019 in contrast to the shorter saturation period seen in 2018 as a result of one large precipitation and flood event.

Figure 15. Approximate maximum saturation area based on groundwater levels within 30 cm of ground-surface during the May 30, 2019 precipitation and flood event.

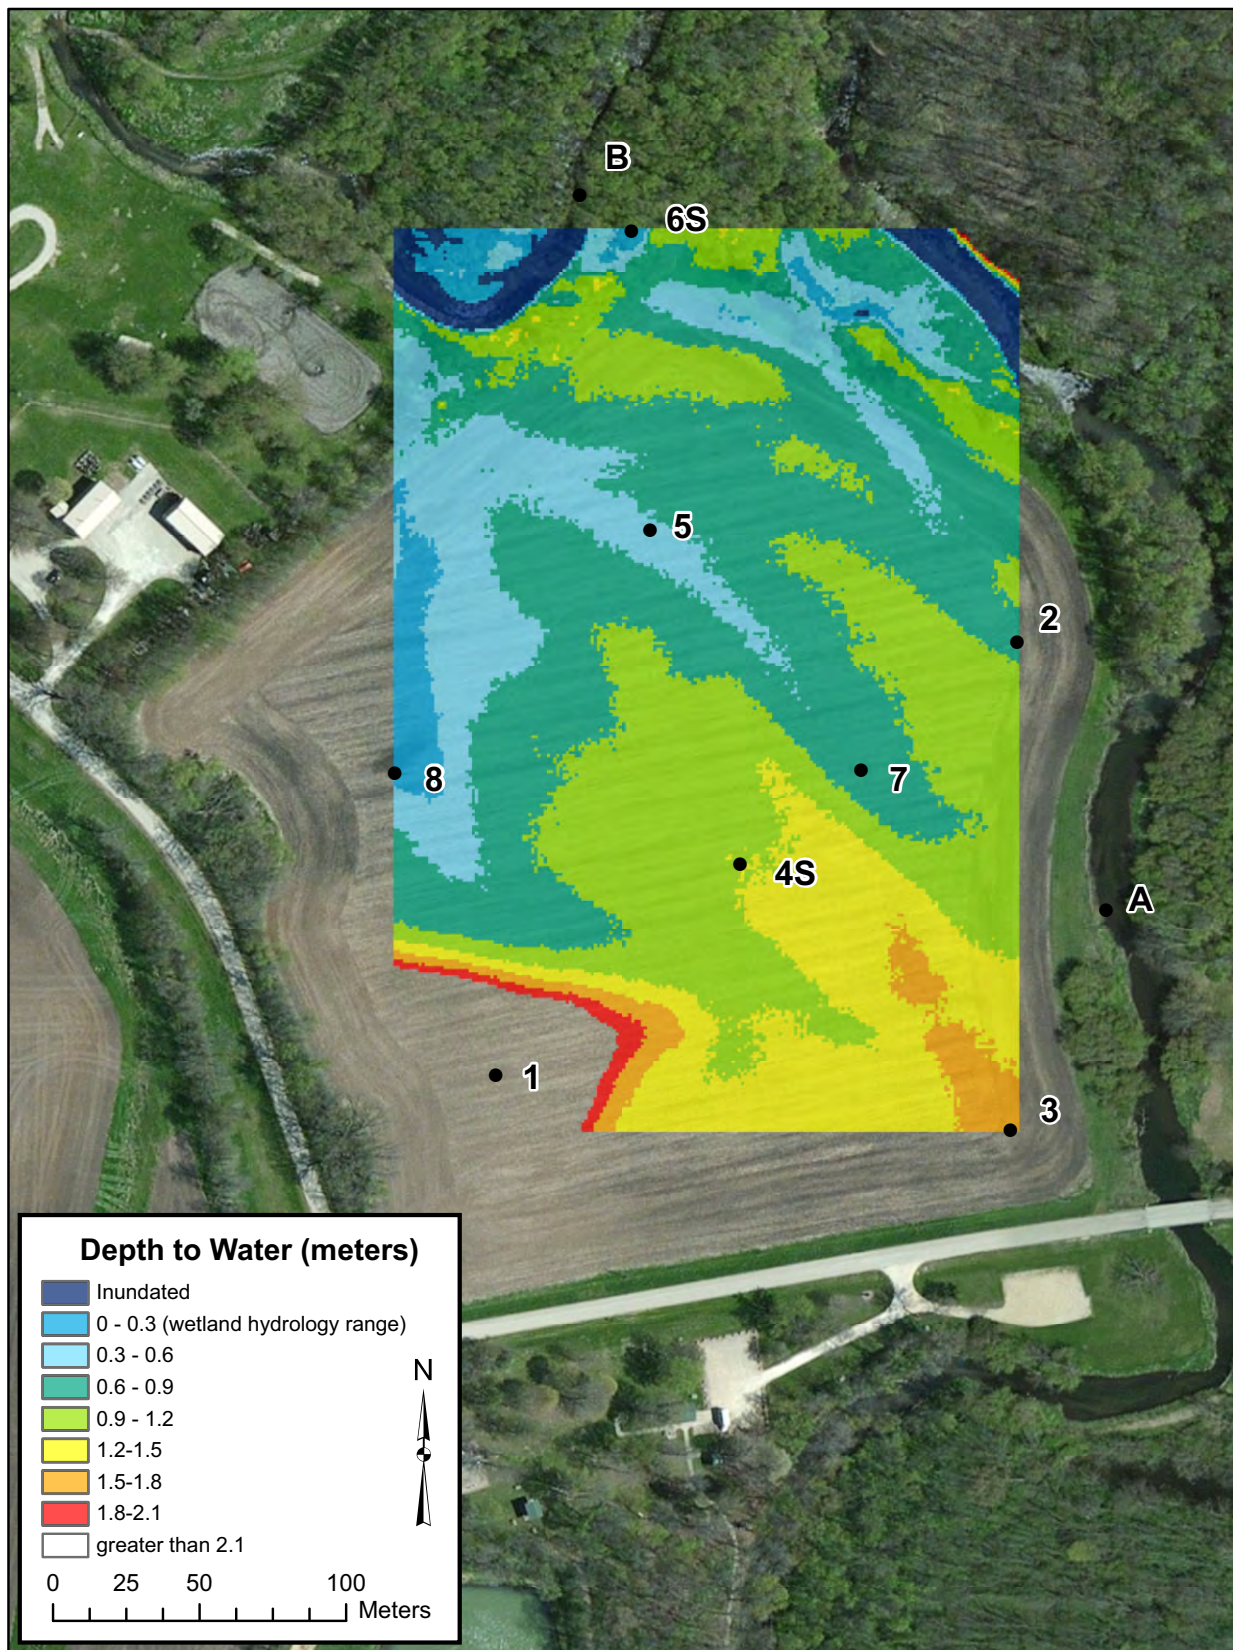
Figure 16. Approximate depth to water during the 2019 maximum 14-day hydroperiod. Areas with a depth to water less than 0.3 m would meet the USACE Midwest Regional Supplement's criteria for wetland hydrology.

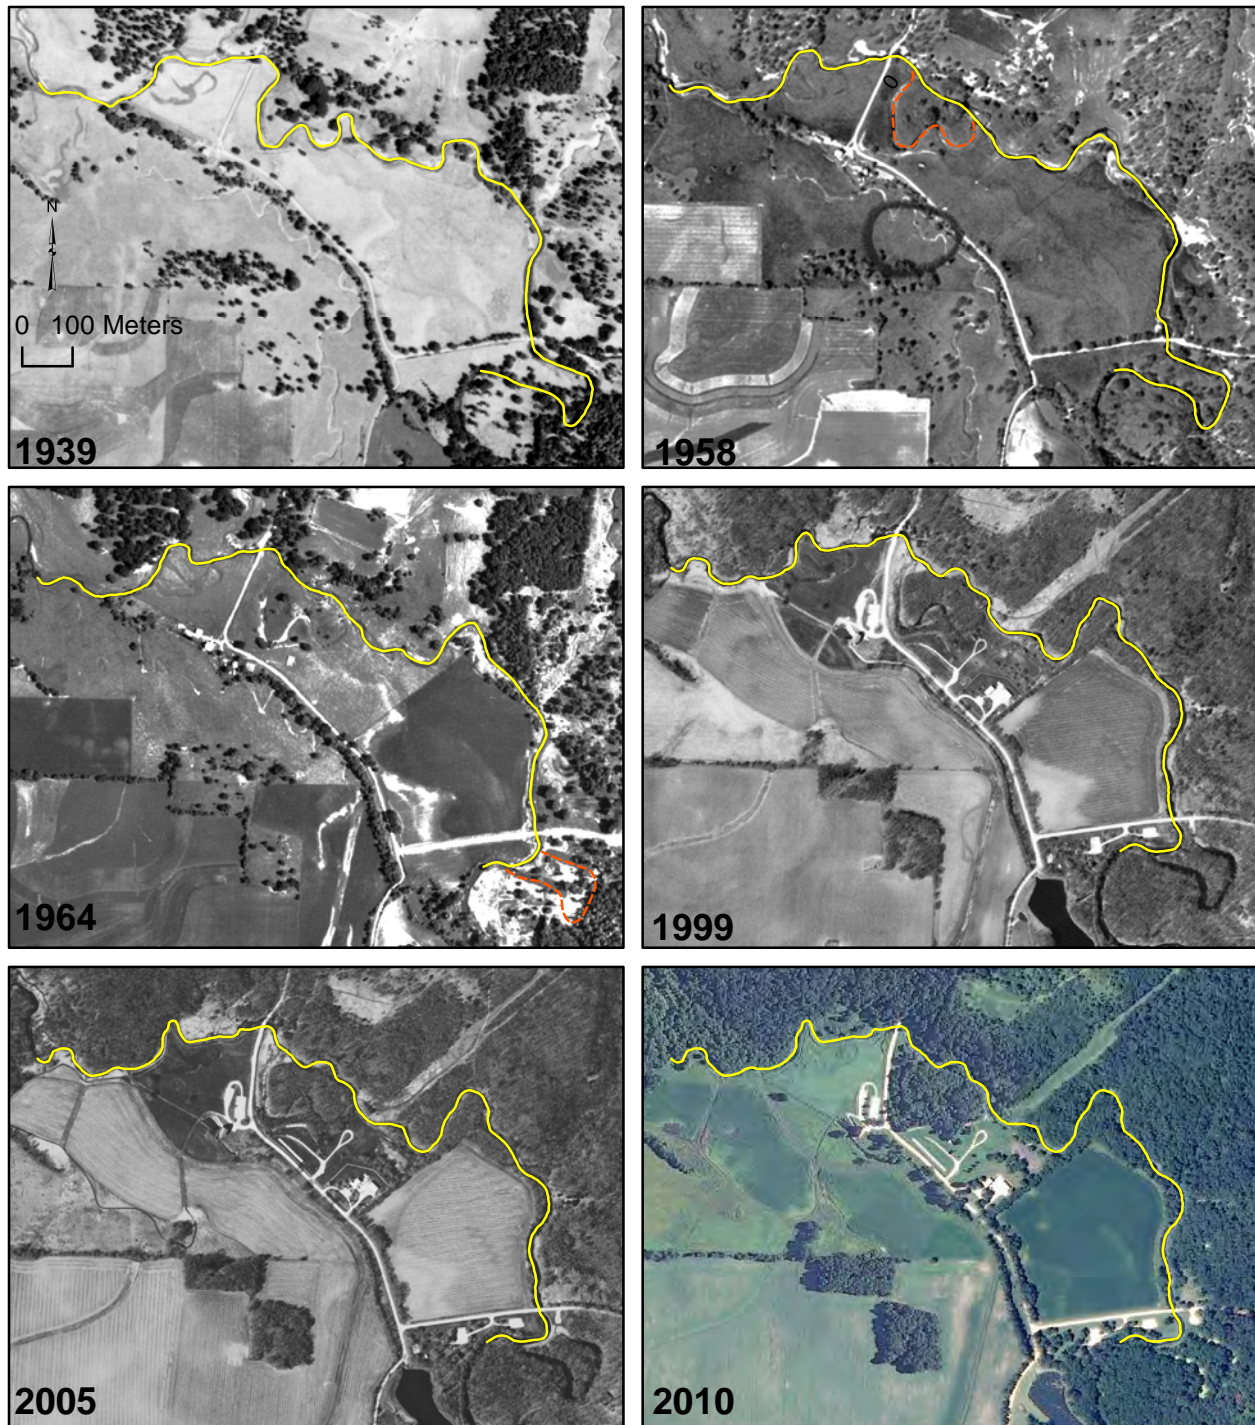
Franklin Creek channel migration between 1939 and 2010 shows that change in channel position was consistent and gradual with two notable exceptions (Figure 18). Channel migration rates along the entire channel segment ranged from near 0 to 25.83 m/yr (84.74 ft/yr). However, for most intervals rates ranged between 0 and 1.41 m/yr (4.63 ft/yr)(Table 1). Lower rates were associated with gradual lateral and downstream migration associated with typical stream meandering. Higher migration rates were atypical and associated with abrupt channel cutoff or channelization.

Figure 18. Photo sequence of historical aerial photography used for stream migration analysis. Channel centerlines for each year are shown as solid yellow lines. Channel cutoffs are shown as dashed orange lines. Scale and orientation are shown in the 1939 photo.

During the 1939-58 interval, a 195-m (640-ft) channel segment was cut off immediately upstream Twist Road Bridge. During the 1958-64 interval, a 320-m (1050-ft) channel segment was cut off immediately upstream of the Old Mill Road Bridge. These cutoffs likely increased sediment mobility and migration rates immediately downstream by increasing the channel gradients, although this cannot be determined directly from aerial photo evidence.

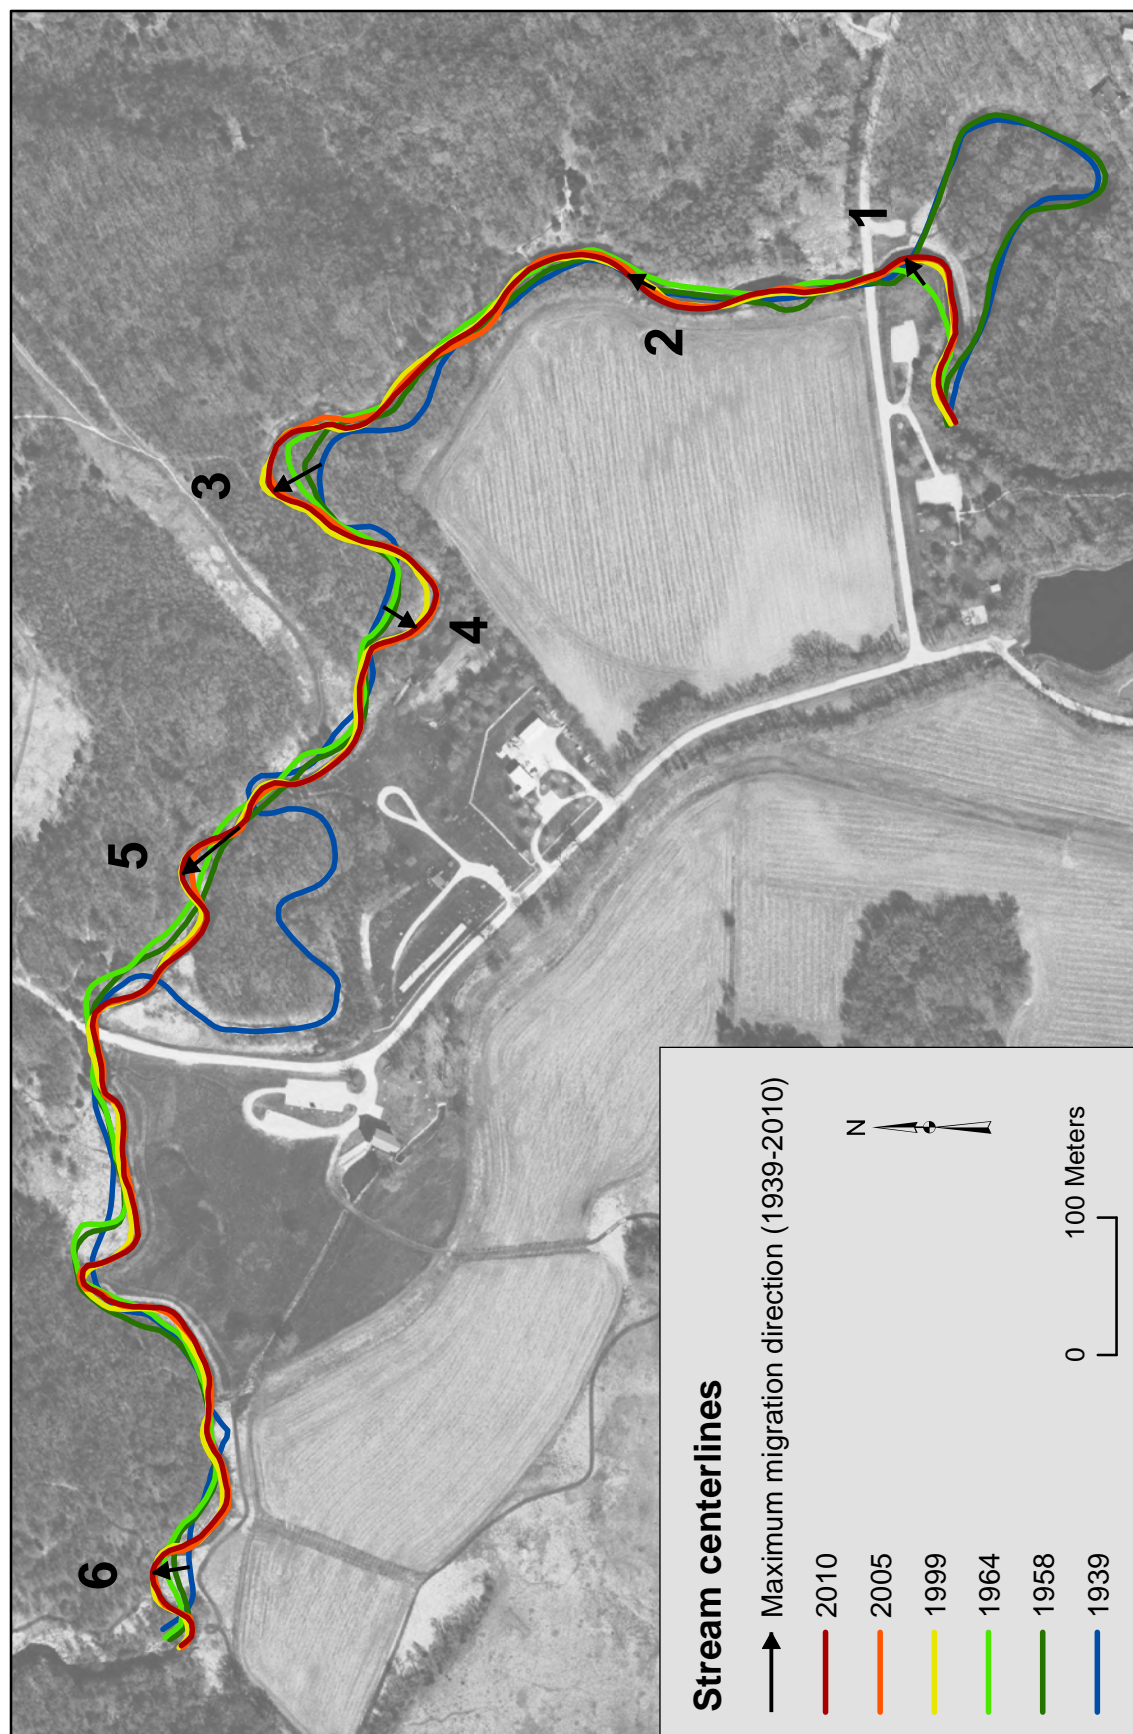
Figure 20. Overlay of stream channel centerlines from each year in the photo sequence. Background layer is the 2005 DOQ imagery (ISGS 2019). Bold black numbers indicate stream bends that were selected for the historical migration analysis. Bend 2 is the subject bend for proposed stream restoration.

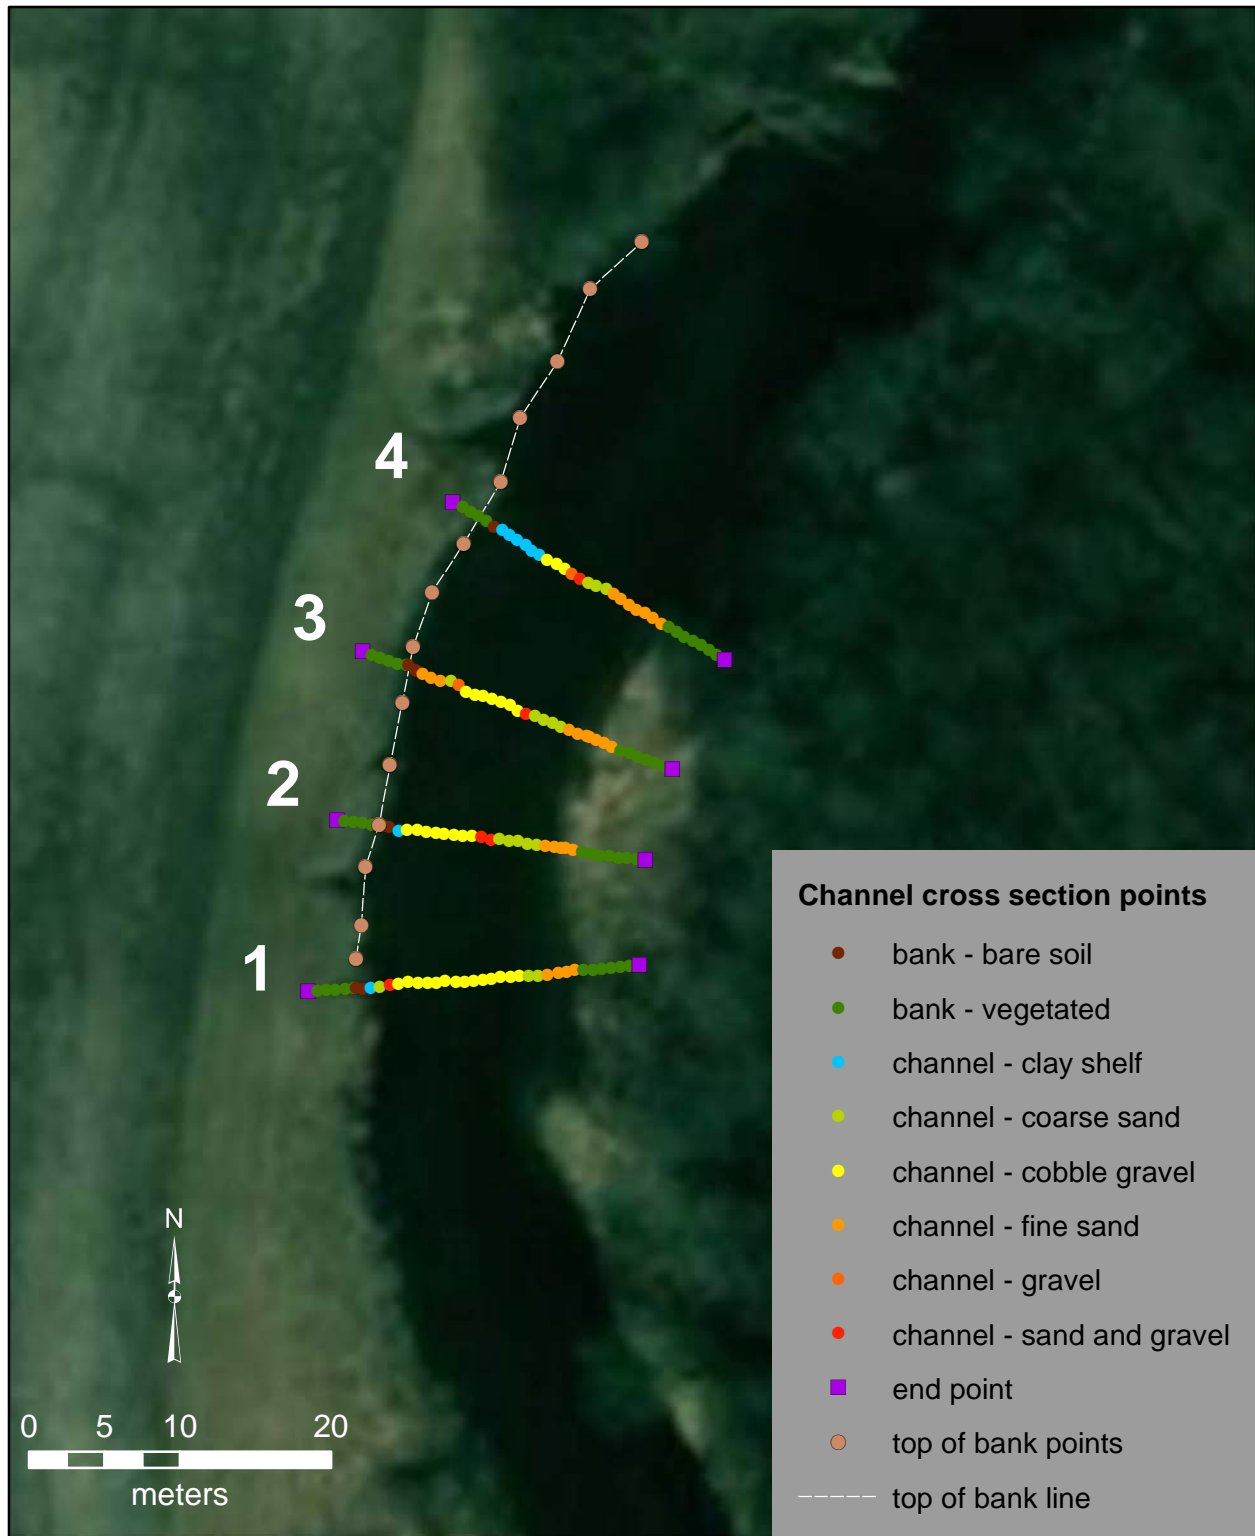
Figure 21. Cross section and bankline data point locations from March 2018. Cross section points were qualitatively categorized according to general grain size characteristics and vegetation cover. Cross sections are labeled 1 through 4 upstream to downstream corresponding with Figures 22a-d.

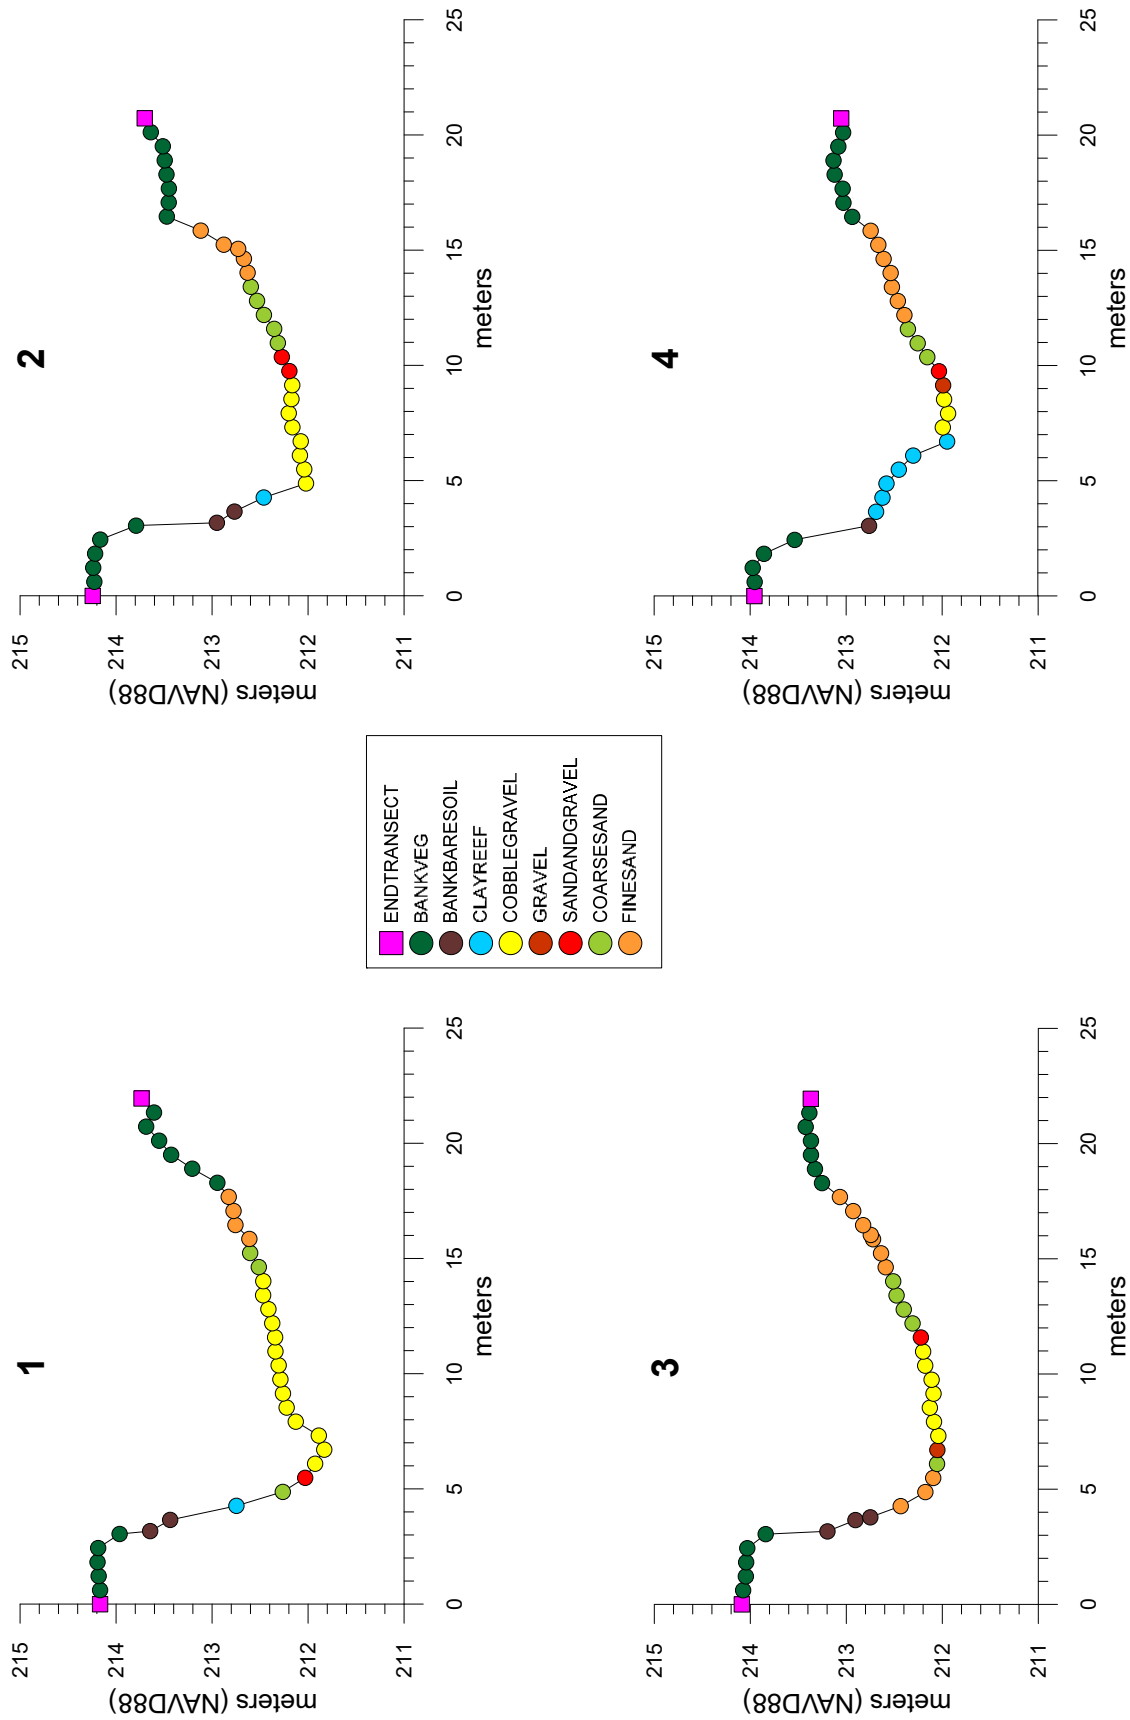
Figure 23. Channel cross sections of Franklin Creek at Site #5. Cross section numbers 1-4 are upstream to downstream and correspond to the map in Figure 2.

Cross-sections also show that the position of the top of the bank line did not change between March 2018 and May 2019, however, there were indications of erosion from the cut bank face. This may reflect the process of bank mass failure, which often happens in episodes. As the bank face and bed is eroded more gradually and directly by channel flow, the top of the bank is undermined

but remains intact until it becomes unstable and falls into the channel. This bank failure process tends to occur at higher rates where the banks have shallow rooted or little to no vegetation. Cross-section 4 shows atypical channel symmetry for its position within the meander bend. The shape of the channel at this cross-section indicates the presence of a resistant clay rich deposit in the bed and banks. The clay-rich deposit along with active deposition on the point bar constricts flow in the downstream portion of Bend 2. The flow constriction likely causes local increases in stream flow velocity and turbulence near the bed and banks. This effect is likely enhanced at higher stream stages leading to increased erosion of less resistant material around the clay deposit and just downstream. This effect is particularly evident from the deep scour hole observed in the downstream portion of the bend and the bank failure immediately downstream.

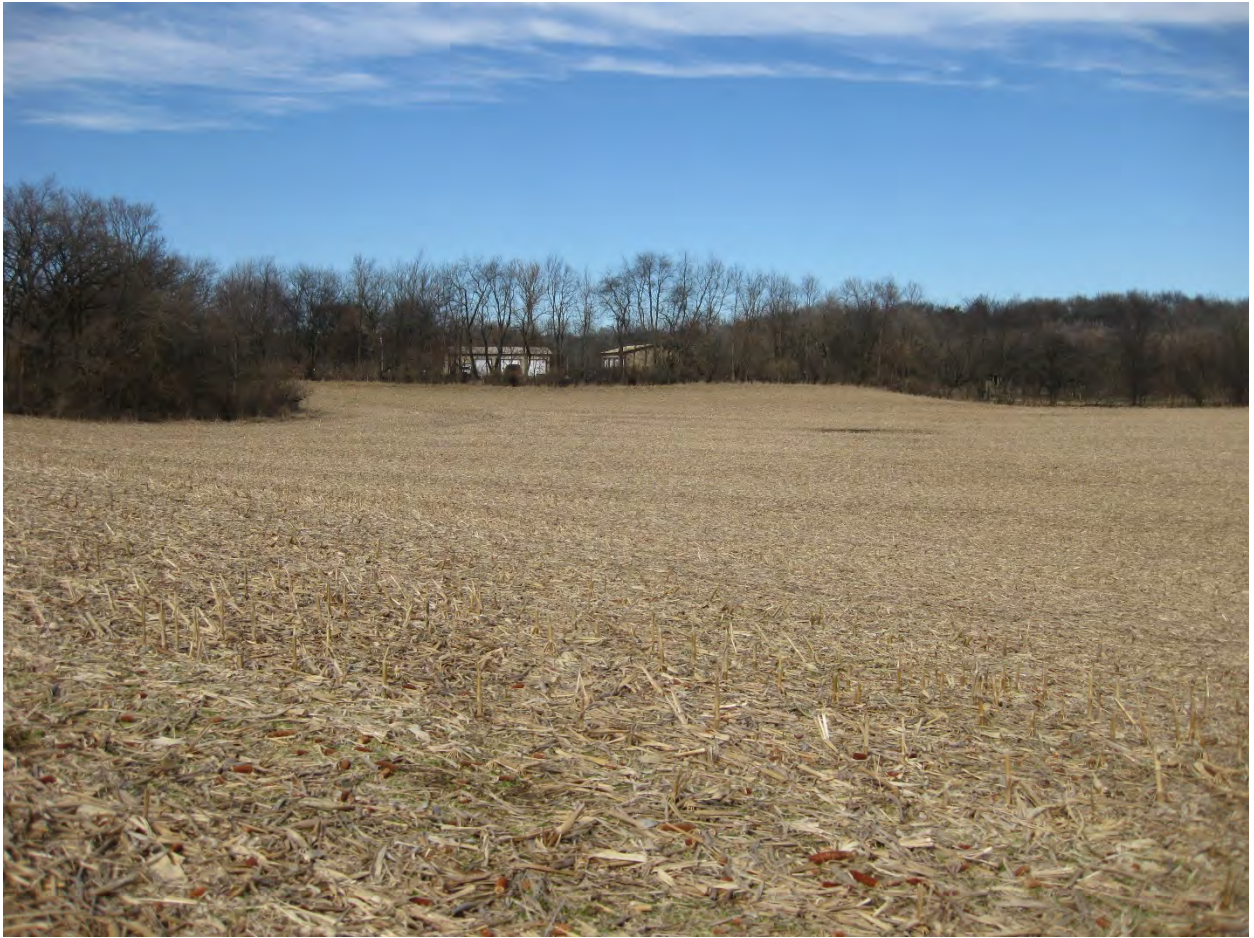
A1. Photo of restoration site, looking northeast. Photo taken February 21, 2017.

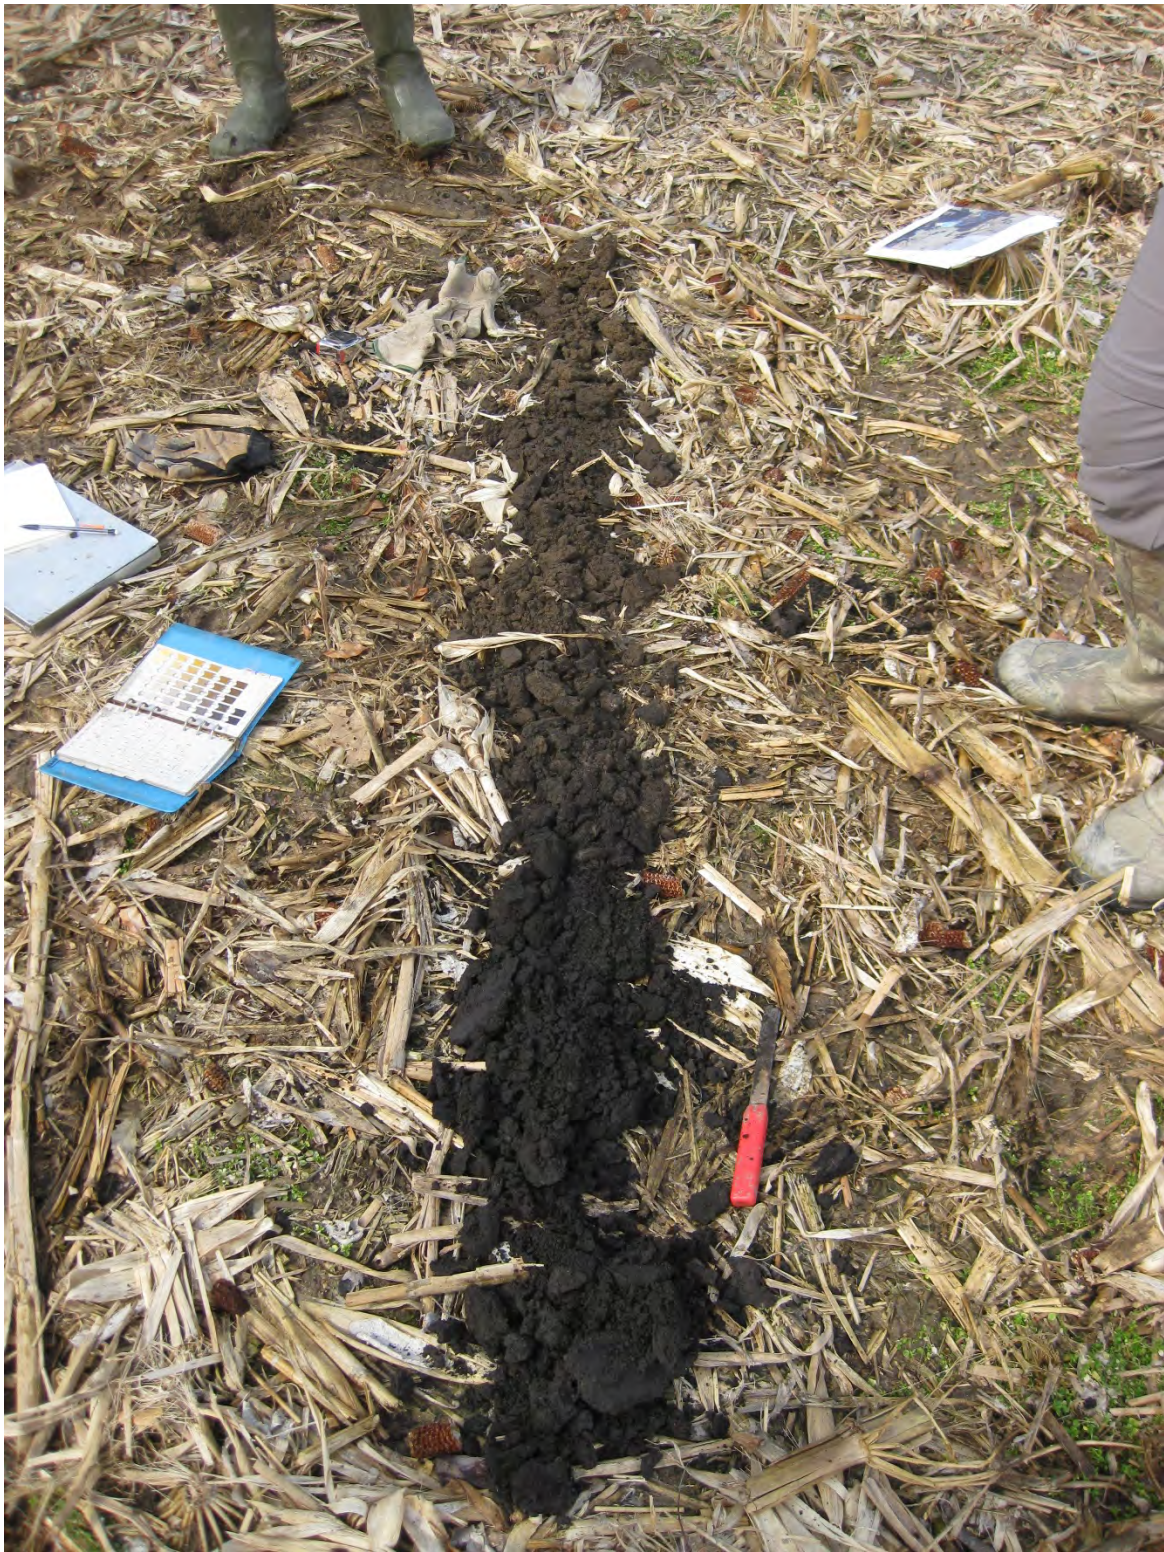
A2. Soil boring from initial site evaluation on February 21, 2017.
