Final Report: Hydrogeologic Characterization and Stream Assessment at Franklin Creek State Park, Lee County, Illinois

December 31, 2019

Open File Series 2019-2

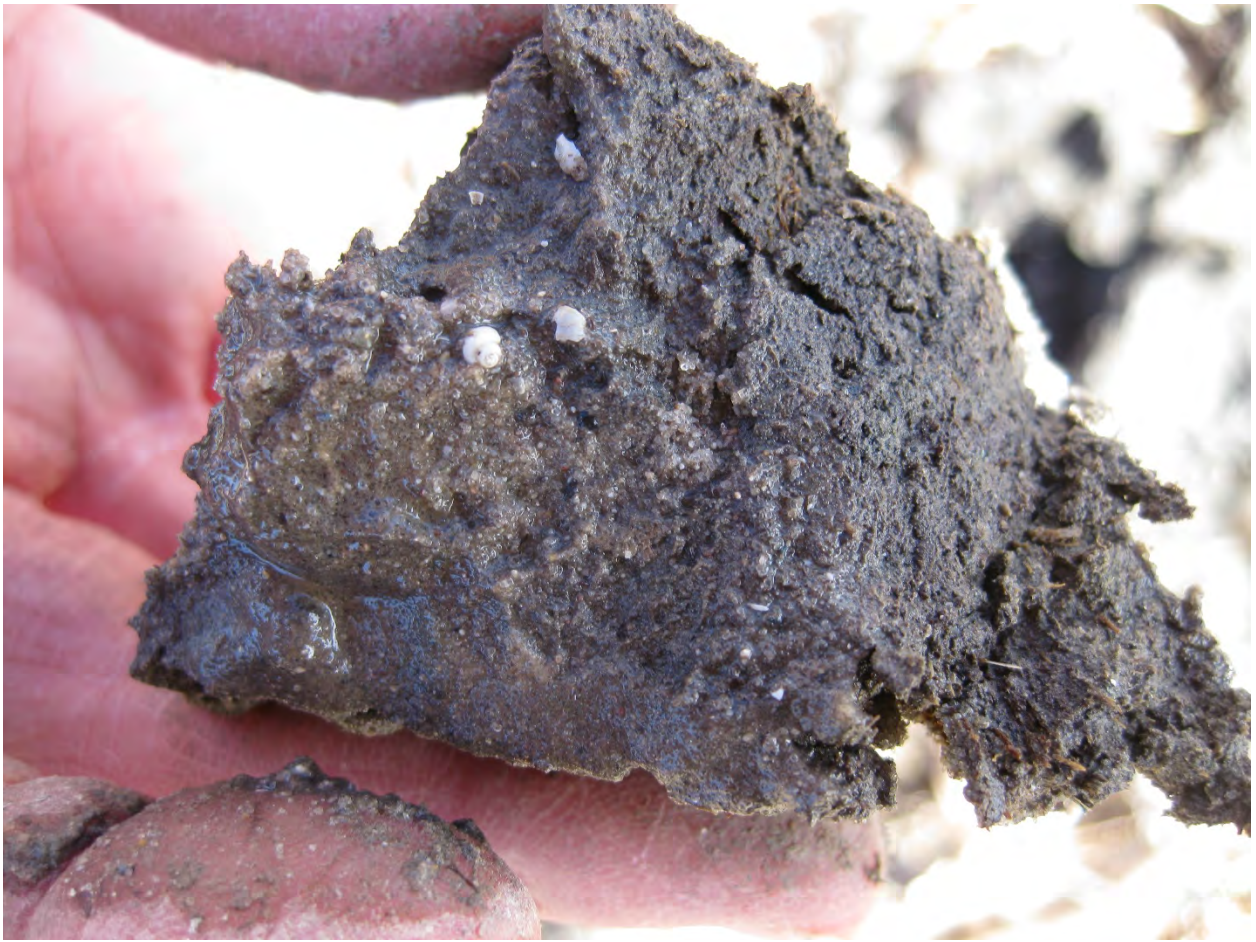
A3. Shells found in soil borings on February 21, 2017.

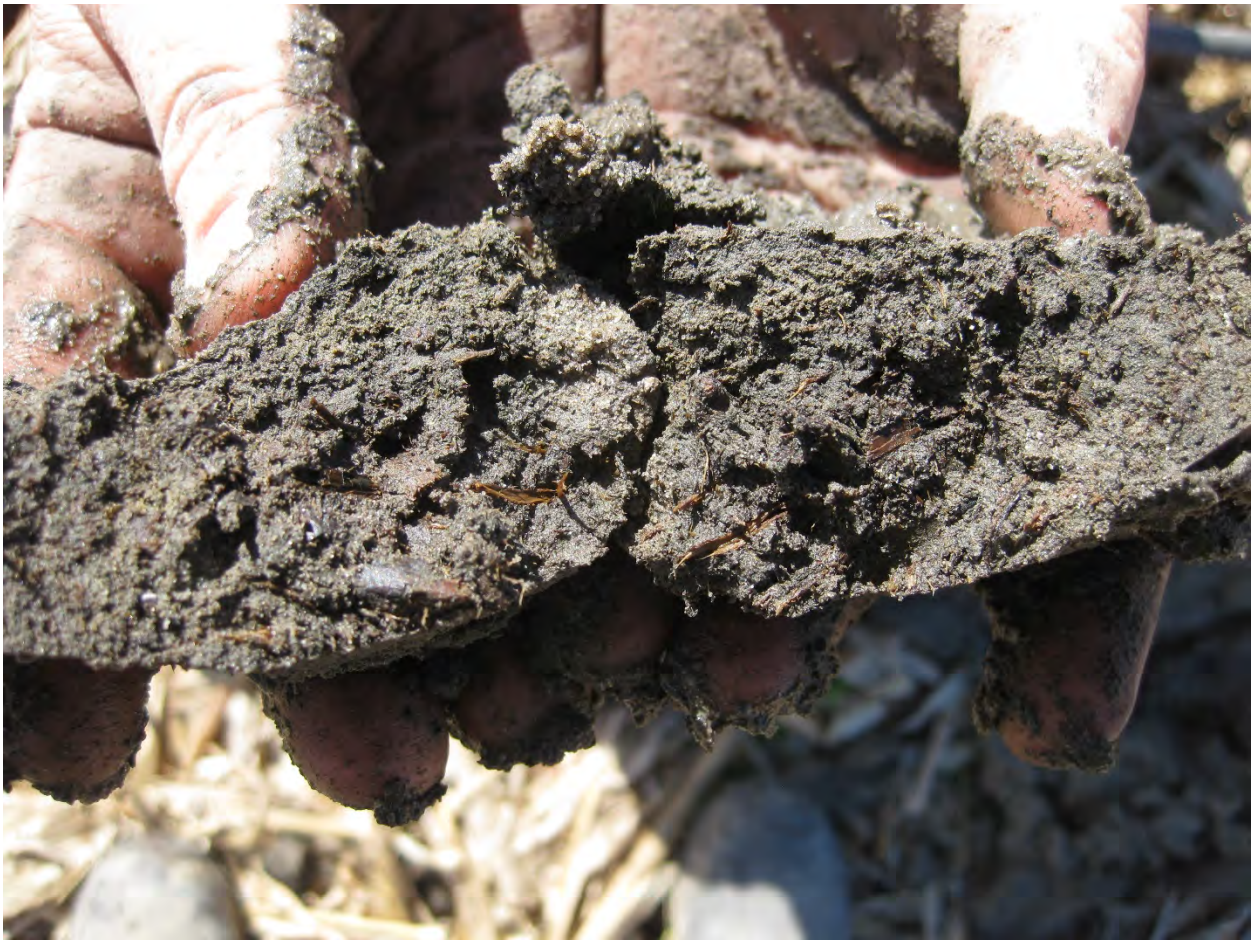
A3. Organic material found in soil borings on February 21, 2017.

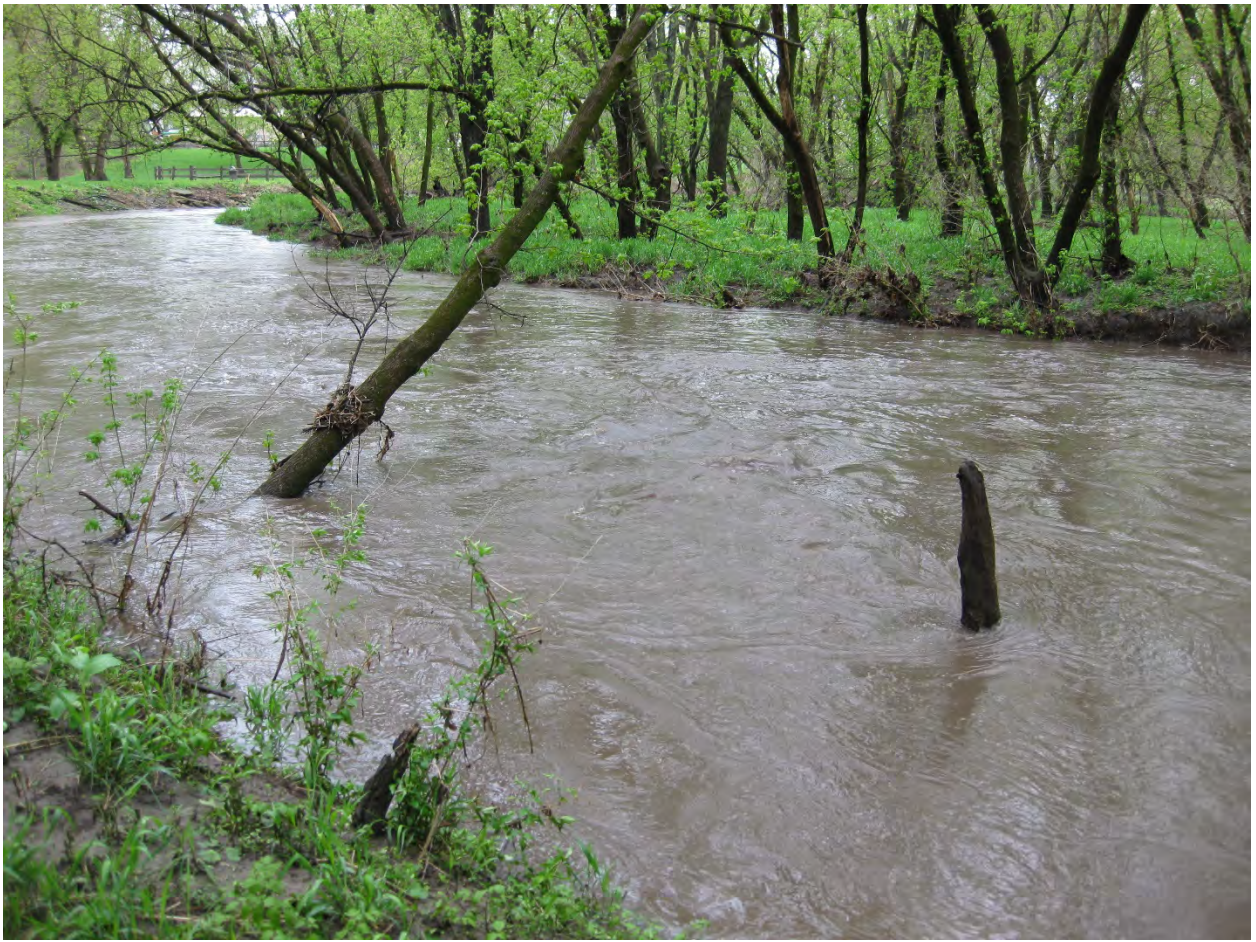
A5. Franklin Creek near Gauge B on the April 29, 2019 site visit.

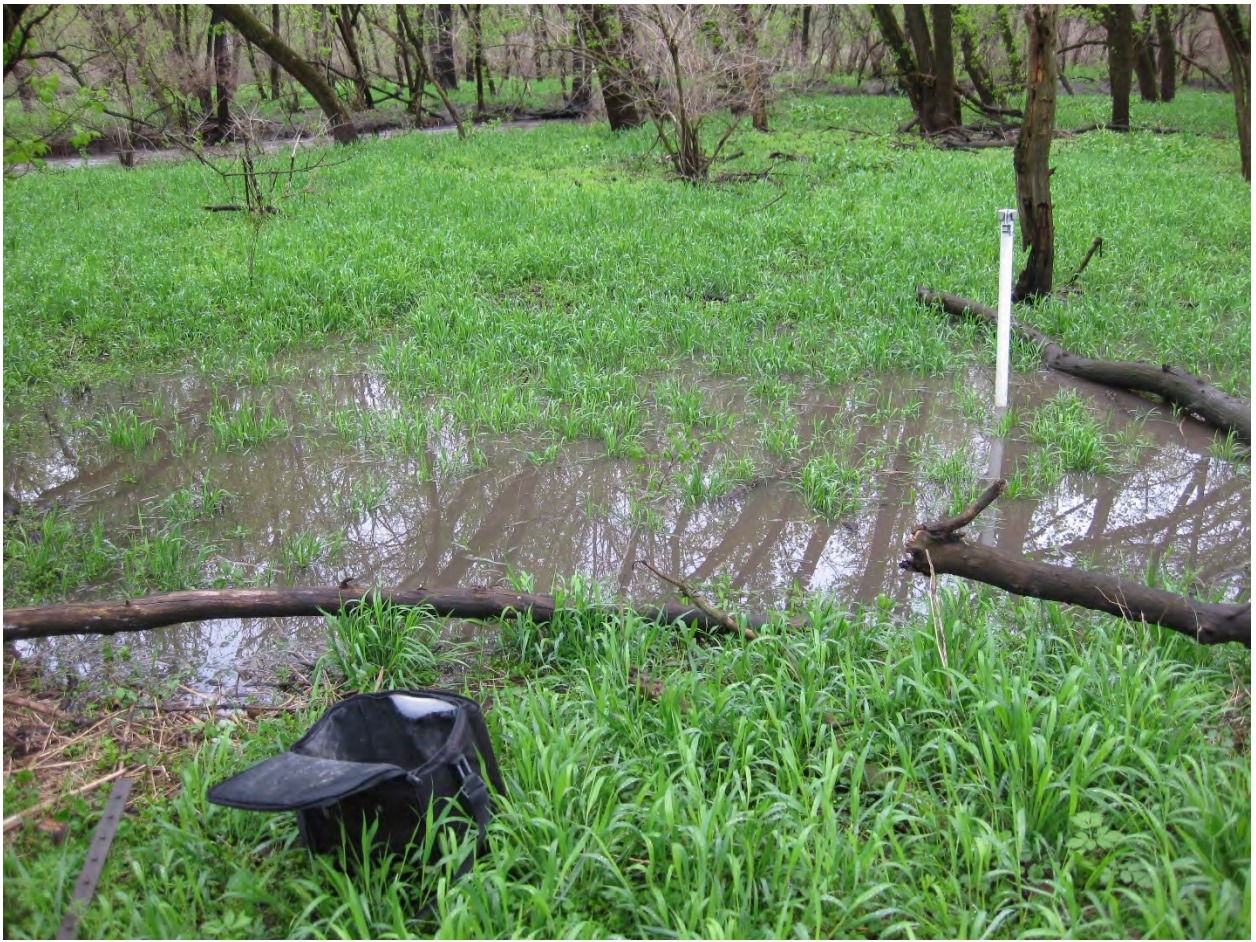
A6. Well 6 during the April 29, 2019 site visit.

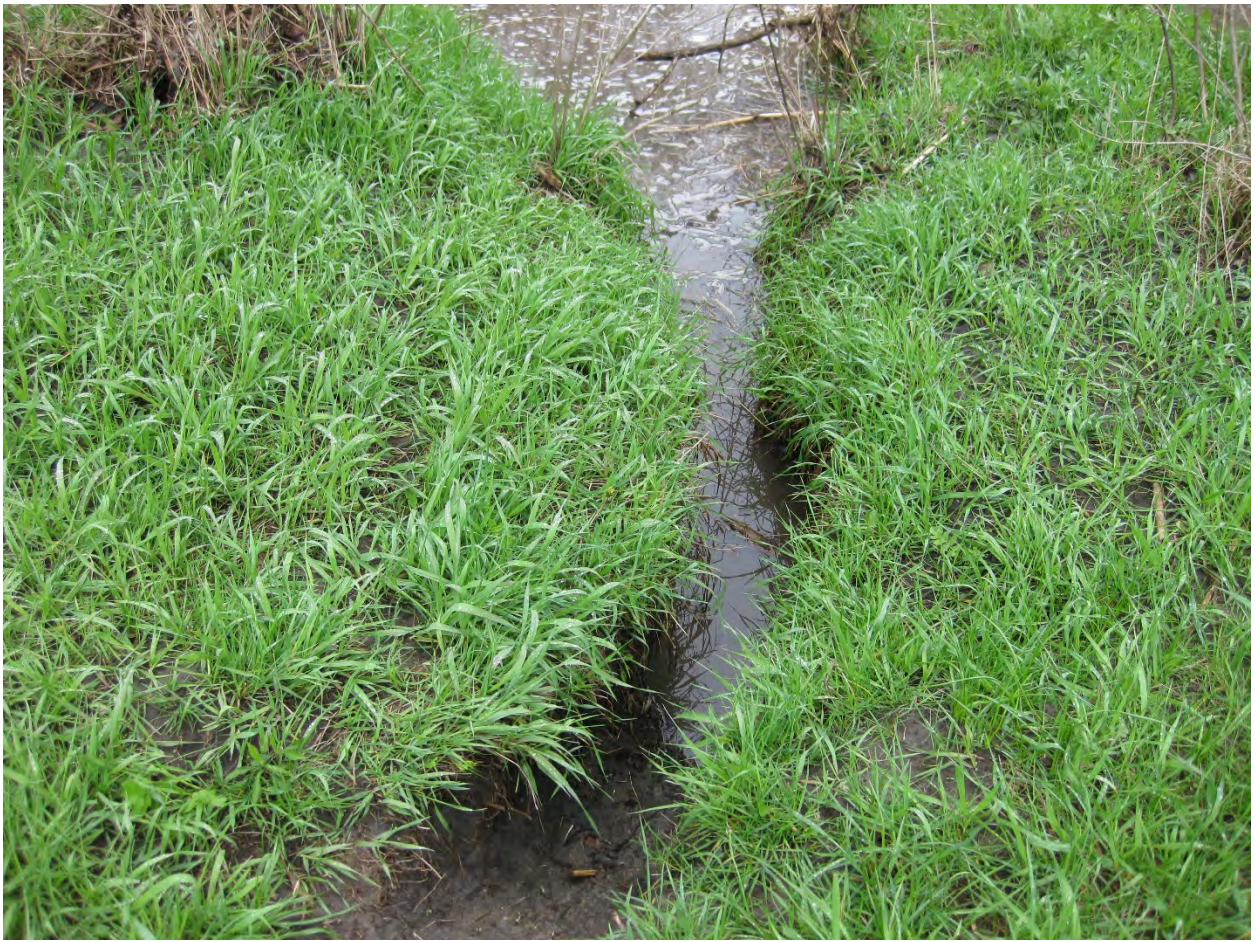
A8. Rivulet near Gauge A during the April 29, 2019 site visit.

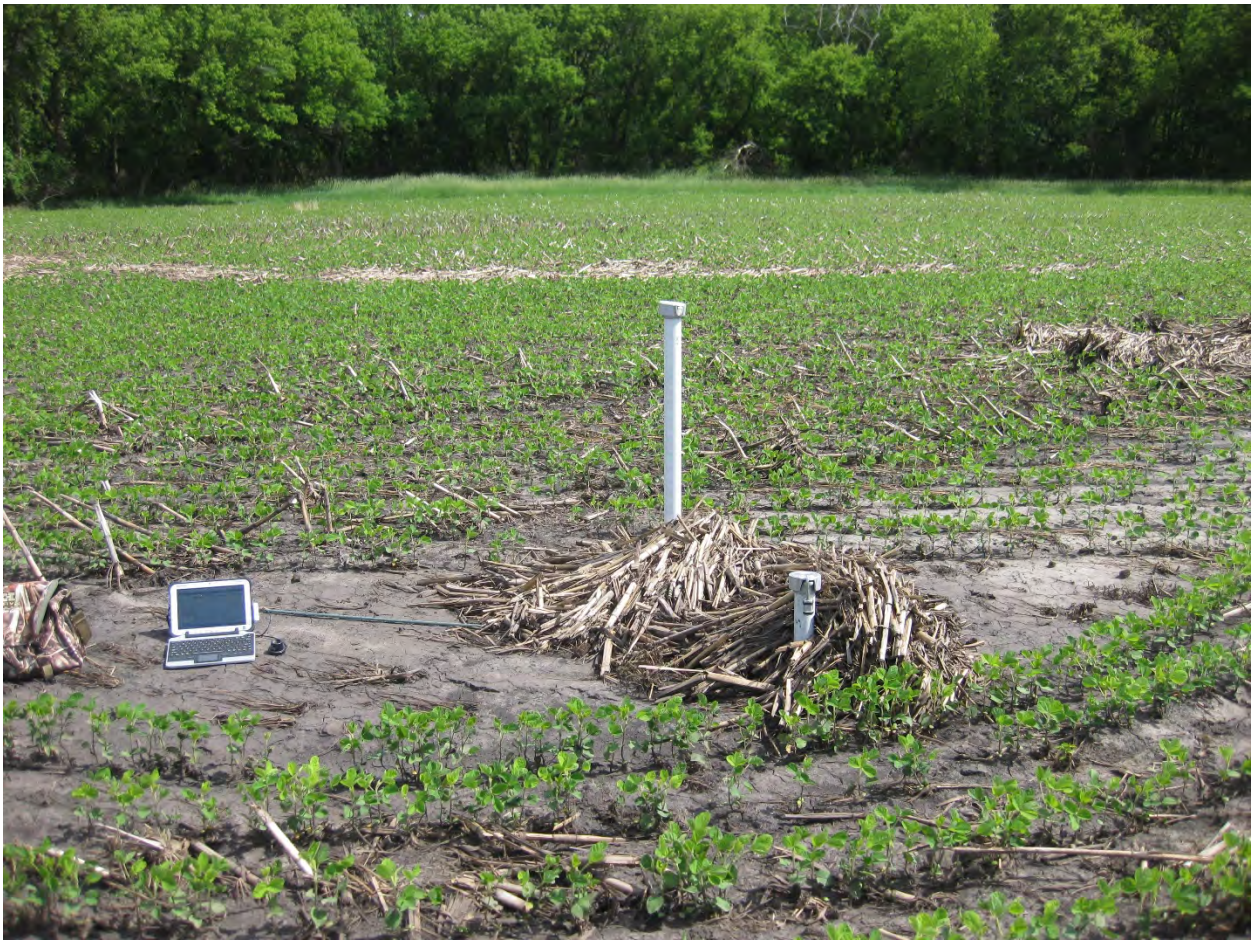
A10. Corn stubble around Wells 5 and 5S during the June 11, 2019 site visit.
