SINKHOLE DISTRIBUTION AND DENSITY OF RENAULT QUADRANGLE MONROE COUNTY, ILLINOIS

Illinois Geologic Quadrangle Map
IGQ Renault-SD

Samuel V. Panno, Julie C. Angel, Dan O. Nelson, C. Pius Weibel, Donald E. Luman, and Joseph A. Devera
2008

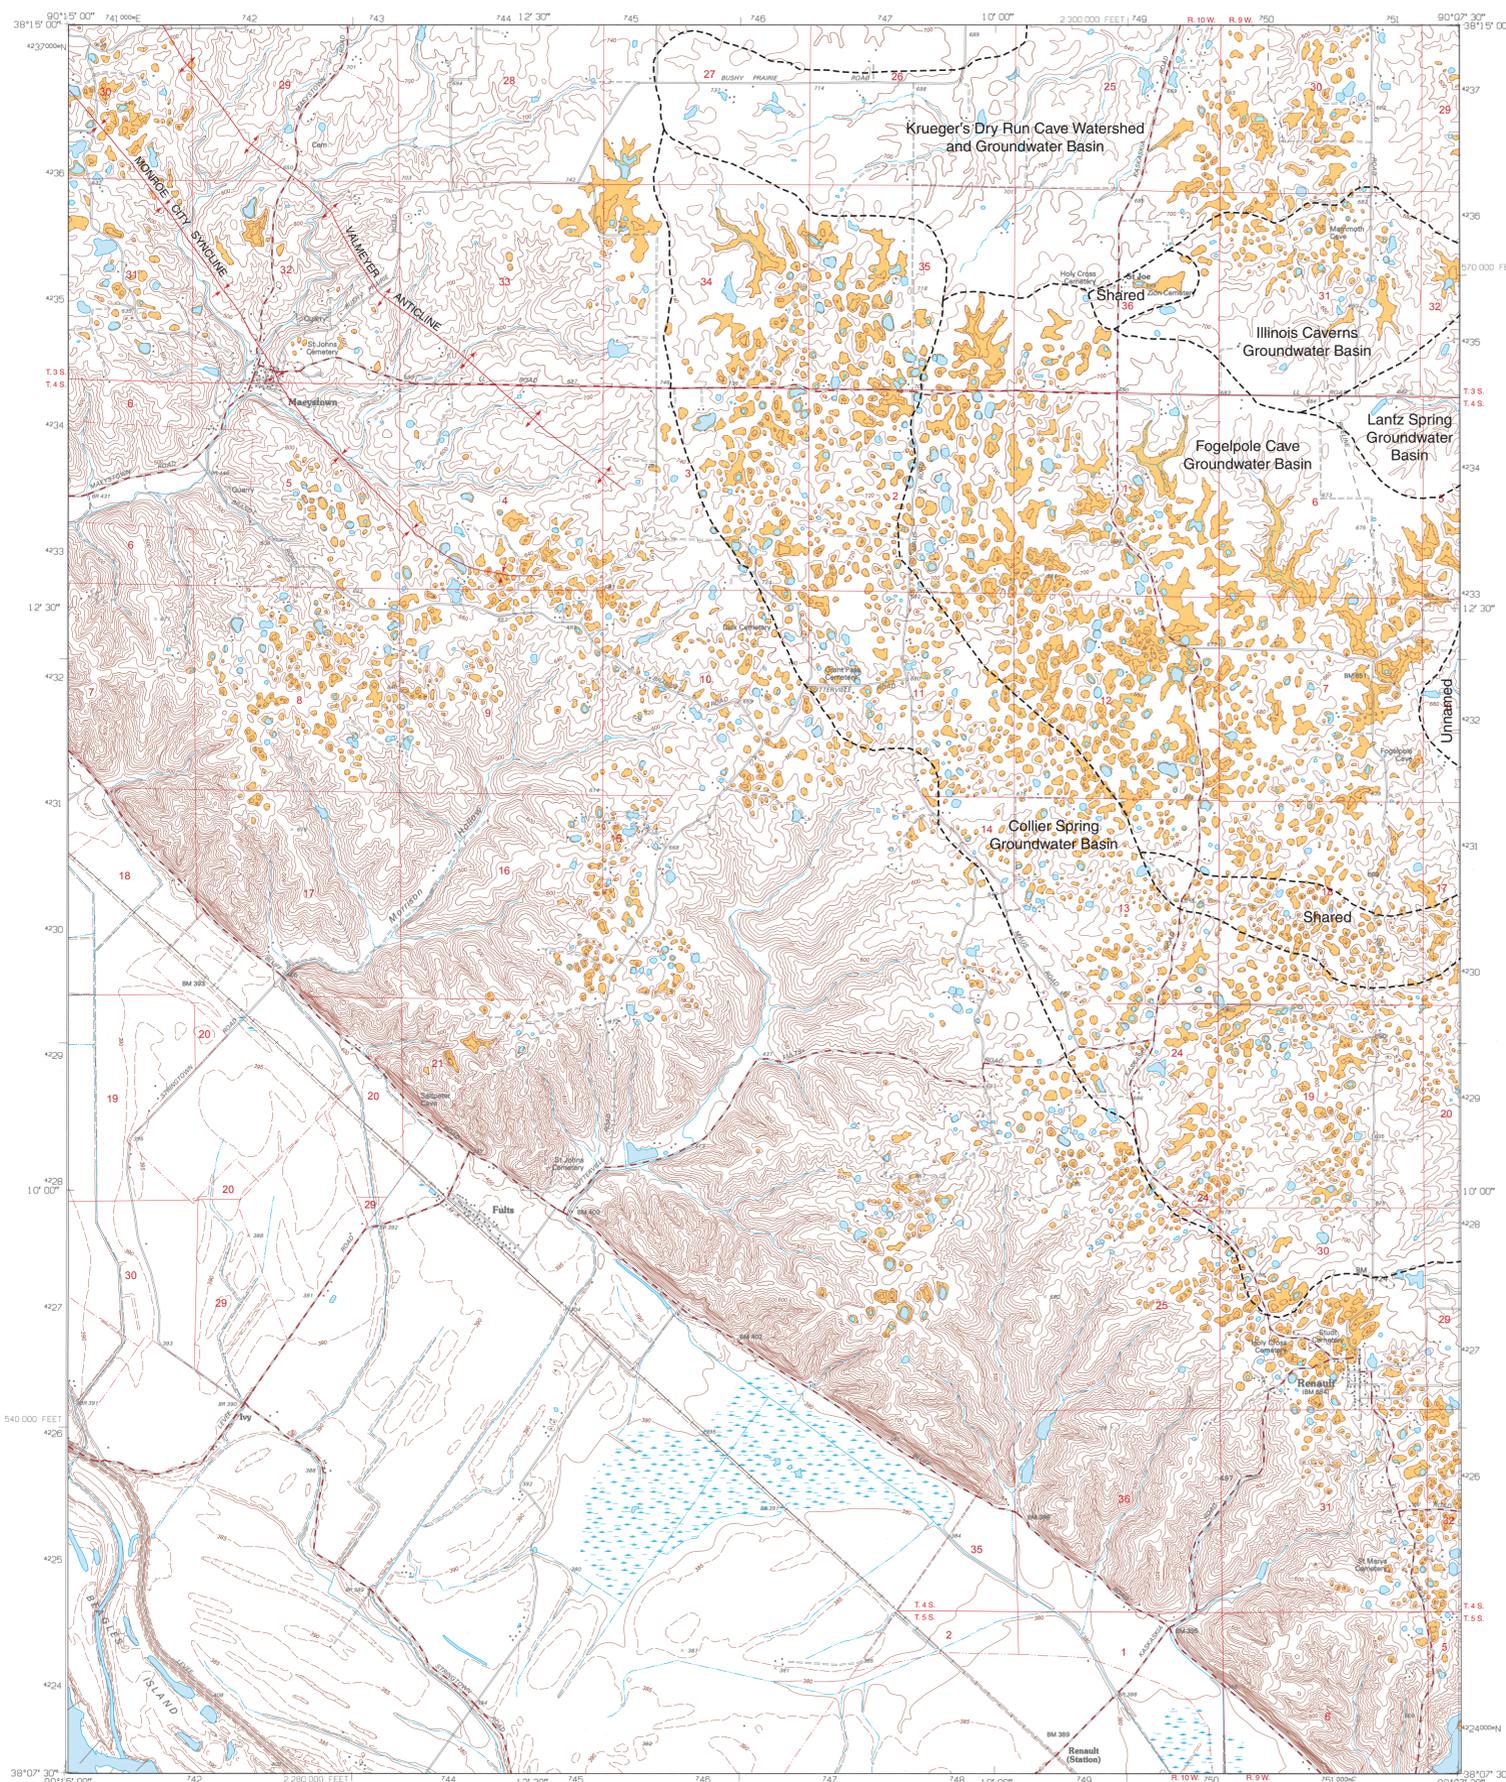
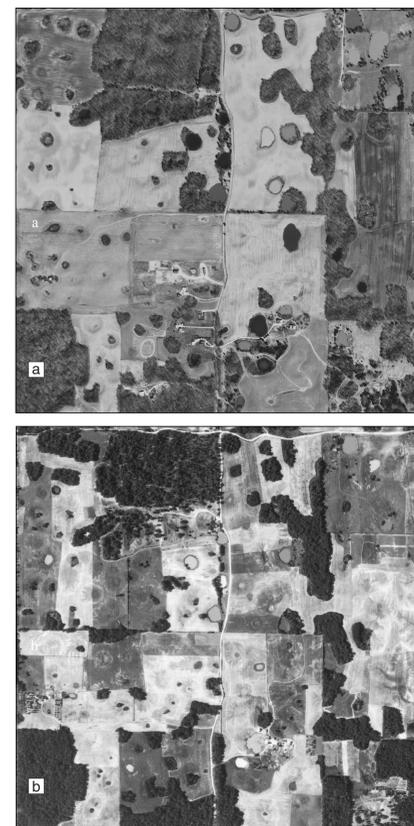
Figure 1 Aerial photographs of a particularly karstified section of the Renault Quadrangle, taken over half a century apart, show how agricultural activities have changed the terrain. Figure 1a is derived from a U.S. Geological Survey Digital Orthophoto Quarter Quadrangle (DOQQ) produced from aerial photography acquired on March 6, 2005, showing Section 2, T4S, R10W. Figure 1b is from a digitized U.S. Department of Agriculture aerial photograph taken on July 13, 1940, and illustrates the same one-square-mile area. Comparison of these two images reveals a number of changes that have occurred on the landscape during the 65-year interval. The 2005 image shows sinkholes that have been remediated using stand pipes and then later filled in to increase cropland area. It is interesting to note that because of the early, leaf-off acquisition date of the 2005 image, sinkholes can be discriminated within many of the wooded areas. In comparison, subtle, near-surface circular patterns diagnostic of sinkholes are quite apparent in the 1940 image in many of the agricultural fields on this image. Note how these distinctive patterns have largely been erased in the 2005 image because of decades of use with modern, large-scale farming equipment and further obscured by the widespread adoption of conservation tillage methods. Scale 1:12,000.
