MACINAW RIVER
MACINAW DELLS DAM SITE
REFERENCE 17
IN 3 SHEETS - SHEET NO. 1

MINERAL RESOURCE
RECORDS DIVISION
Ekblaw, G. E.
Ms. 208
ILLINOIS STATE
GEOLOGICAL SURVEY

Report on
General Geology along Mackinaw River
as related to proposed damsite

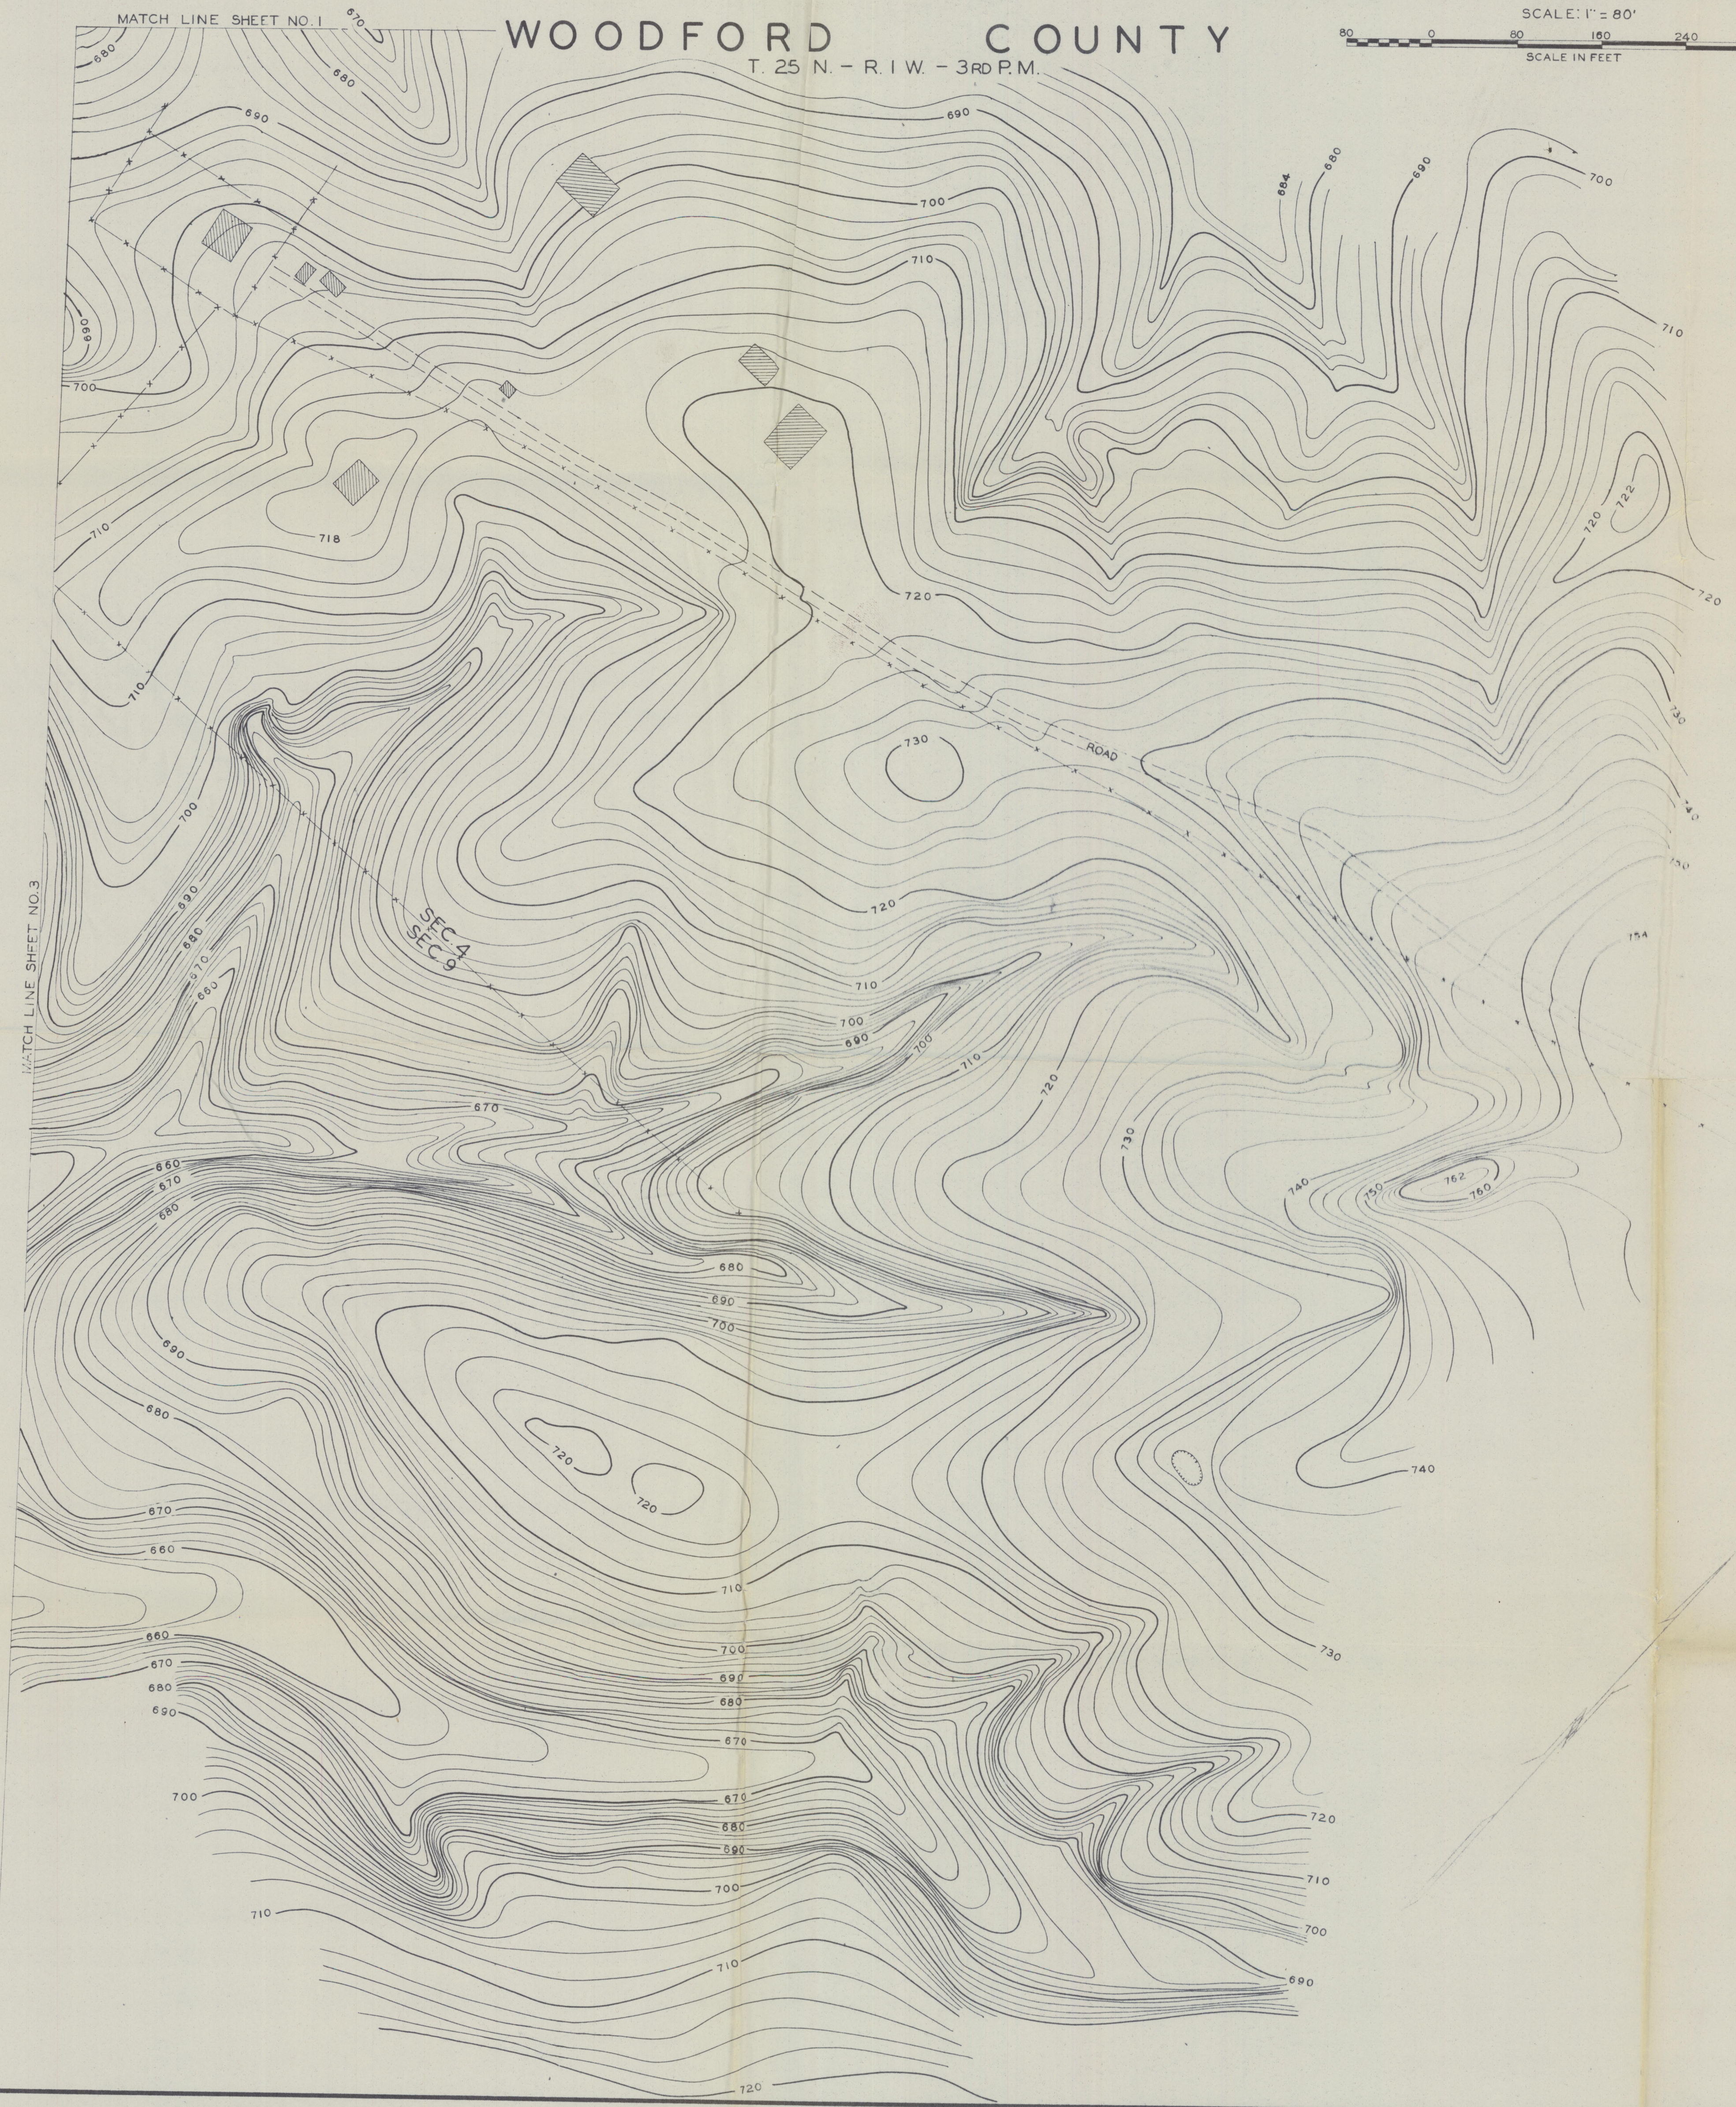
WACKINAW RIVER
WACKINAW BELLS DAM SITE
REFERENCE H
IN 2 SHEETS - SHEET NO. 2

SCALE: 1" = 80'
SCALE IN FEET
