# **DISCHARGE CHARACTERISTICS AT BIOSWALE INSTALLATION SITES ALONG I-294 IN NORTHERN COOK COUNTY, ILLINOIS**

Kathleen E. Bryant, James J. Miner, Keith W. Carr, Jessica R. Ackerman, and Eric T. Plankell

Open File Series 2016-2e 2016

**ILLINOIS STATE GEOLOGICAL SURVEY**  
Prairie Research Institute  
University of Illinois at Urbana-Champaign

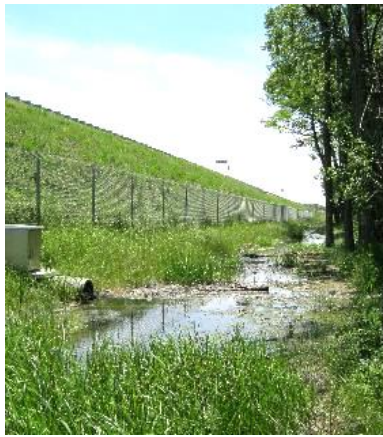
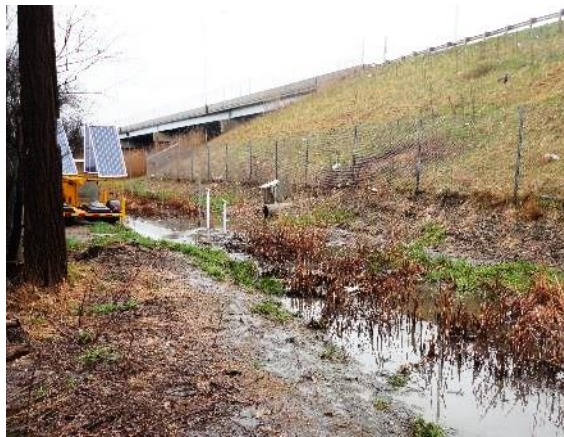
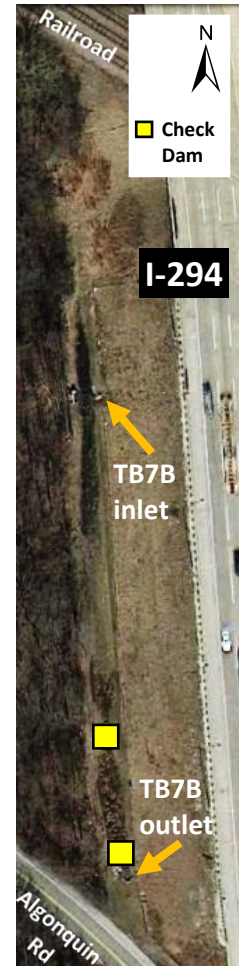
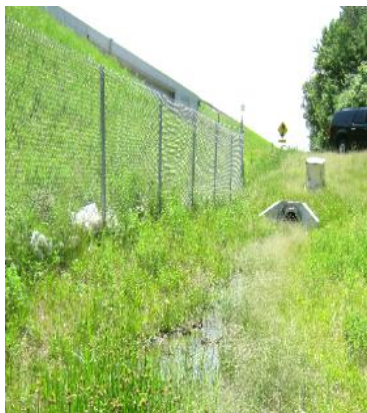
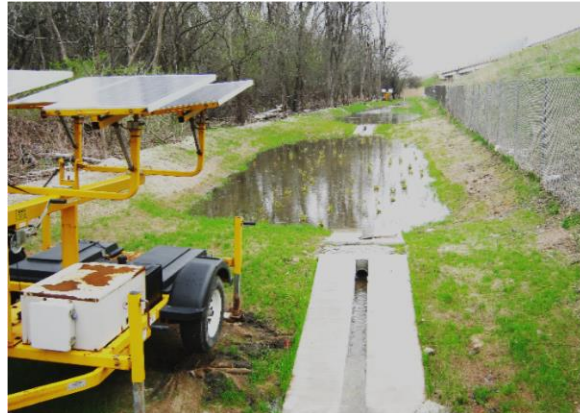
Figure 3. TB7B monitoring site locations (Aerial photo: Google Earth)

TB7B was a short, 360-ft long bioswale at the bottom of a 35-ft high roadway embankment, bordered by Algonquin Road to the south and a railroad right-of-way to the north (Figure 3). This bioswale had the most direct input and output discharge correlations, having a single input pipe directly from the elevated roadway and a single output monitoring location in a relatively well-defined drainage area. The input monitoring location at TB7Bin was located in a 1.5-ft diameter culvert at the north end of the bioswale during both pre- and post-construction monitoring (Figure 3a-b). The output monitoring station at TB7Bout was located in a 2-ft diameter culvert that extended under Algonquin Road at the south end of the bioswale during pre-construction and Years 1 and 2 of post-construction monitoring (Figure 3c). To improve capture of measured runoff, the output monitoring location was moved at the end of Year 3 from the 2-ft diameter culvert pipe to a location just upstream in the southernmost concrete check dam (Figure 3d). This site also had the only continuously monitored input location in the study, which provided runoff data channeled directly from a roadway area and was used to evaluate bioswale outputs at all study locations.

The post-construction bioswale was widened and deepened, and two check dams were installed to impound runoff. Erosion control mats and fill material were placed under the input pipe to reduce scouring and ponding. These erosion control measures were reinforced in Year 2, and were effective until ponding started to increase again in Years 4 and 5 due to scouring and accumulation of sediment near the TB7Bin inlet pipe.

3a. Pre-construction inlet - view to south

3b. Post-construction inlet - view to north

3e. Bioswale site TB7B

3c. Pre-construction outlet - view to south

3d. Post-construction outlet - view to north

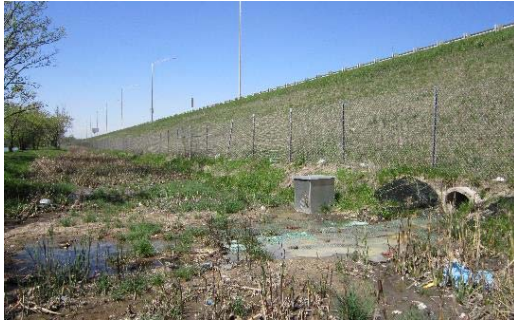
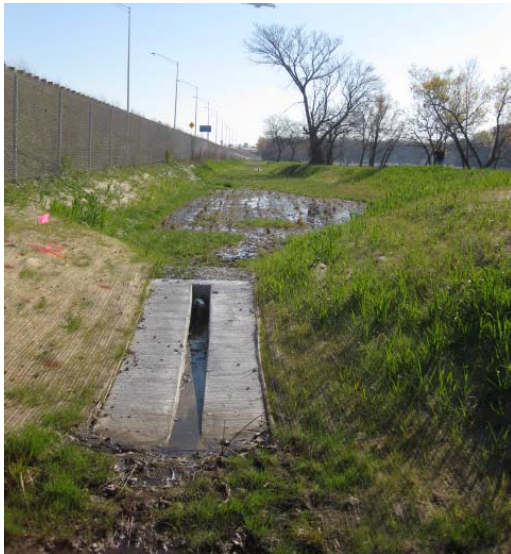
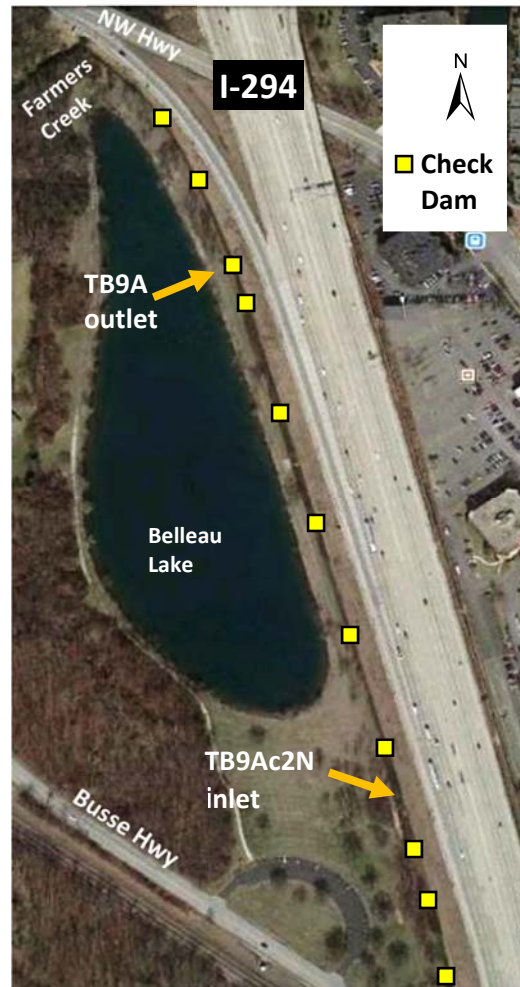
Figure 4. TB9A monitoring site locations (Aerial photo: Google Earth)

TB9A was the longest bioswale monitored, and had the largest roadway area contributing runoff. The monitored bioswale was 2,060-ft long and consisted of three connected bioswale areas: 7C, 8, and 9A (Figure 4). The bioswale contained numerous check dams and ponded segments, and was located between a steep, 25-ft high roadway embankment and Belleau Lake. The bioswale drained into Farmers Creek about 0.65 miles upstream from its confluence with the Des Plaines River. Five input culverts entered the bioswale from the elevated roadway. One input culvert was monitored post-construction (TB9Ac2N), and one output area was monitored before and after bioswale construction (TB9A) approximately 670 ft upstream from Farmers Creek.

The post-construction bioswale was widened and eleven check dams were installed. The site continued to have occasional backwater conditions near the monitored outlet. The output monitoring instruments (TB9A) were located in the ninth check dam north of Busse Highway (Figure 4b). The area downstream from the TB9A monitoring point was re-graded after bioswale installation in October 2013 in an attempt to reduce minor backwater conditions and ponding during smaller precipitation events. One input culvert, TB9Ac2N (culvert 2 North - the second culvert north of Busse Highway), was monitored during Years 4 and 5 (Figure 4a) in an attempt to verify similarities with the TB7B bioswale input location (TB7Bin), which was a similar culvert draining directly from an adjacent section of elevated roadway.

4a. Post-construction inlet TB9Ac2N,  
view to north

4b. Post-construction outlet TB9A,  
view to south

4c. Bioswale site TB9A

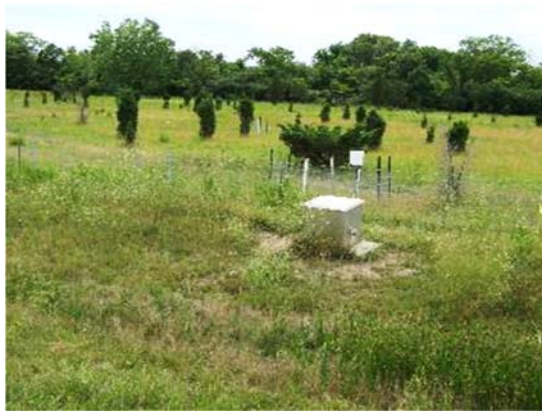
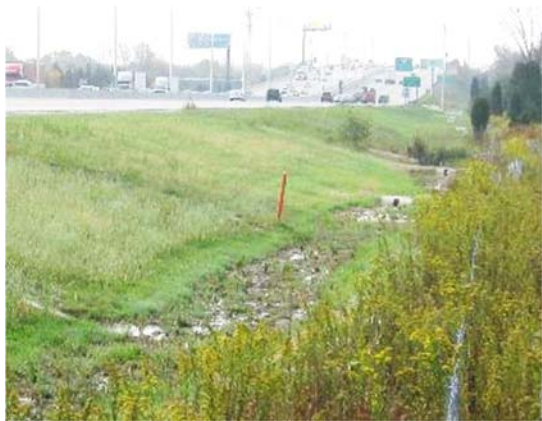
Figure 5. TB15B monitoring site locations (Aerial photo: Google Earth)

TB15B was located along a straight stretch of roadway at the bottom of a short embankment. Three discrete culvert inputs drained into the approximately 1400-ft long bioswale augmented by direct runoff from the roadway shoulder (Figure 5).

The pre-construction site was a vegetated ditch that was regularly mowed (Figure 5a). No input culverts were monitored before bioswale construction, and one output location (TB15B) was monitored in the open ditch.

The post-construction site at TB15B was widened with one check dam installed at the downstream end of the monitored dry bioswale area (Figure 5b). A second check dam was installed further downstream from the dry bioswale area, and the groundwater pipe exited at this second check dam. Post-construction output was monitored at two locations, the underdrain output pipe (TB15B<sub>gw</sub>) and the check dam at the surface-water exit in the dry bioswale (TB15B<sub>sw</sub>). The surface-water monitoring site often did not have regular flow because most water infiltrated to the subsurface underdrain pipe, except during higher intensity precipitation events where the infiltration capacity was exceeded. The underdrain outlet pipe had near-constant flow that exited into a wet bioswale area downstream from the pipe, and the outlet area was occasionally ponded during high intensity precipitation events. One input culvert, TB15Bc1N (culvert 1 North), was monitored in Years 4 and 5 in an attempt to verify similarities between dry bioswale inputs and wet bioswale inputs at TB7B and TB9A.

5a. Pre-construction outlet TB15B

5b. Post-construction bioswale TB15B

5c. Bioswale site TB15B

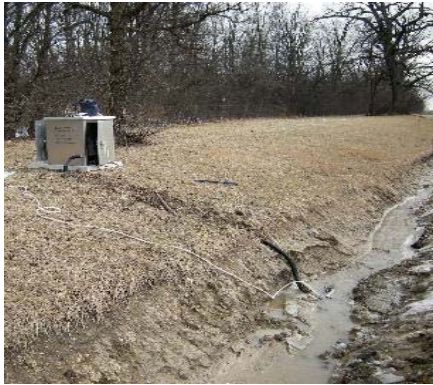
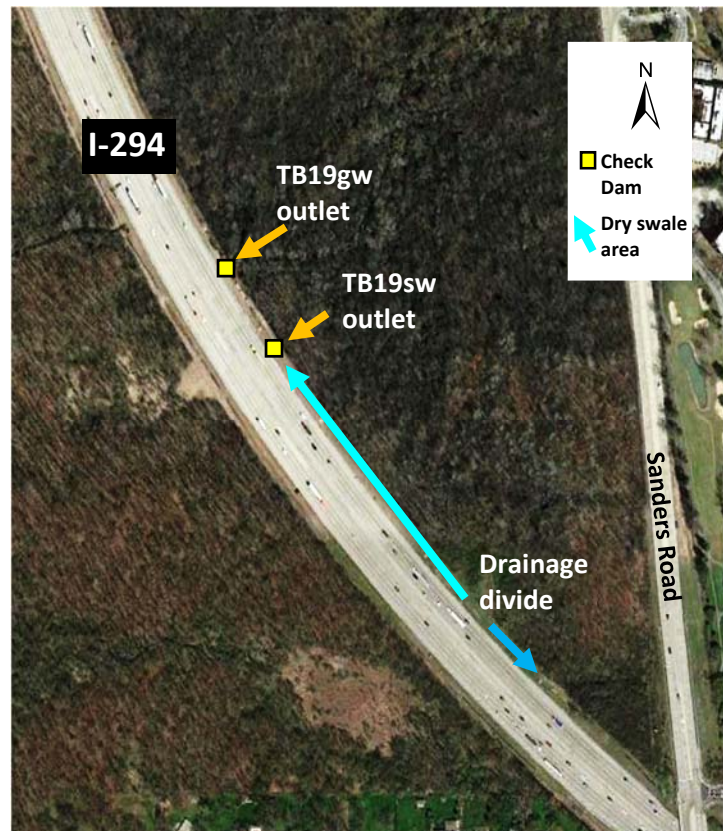
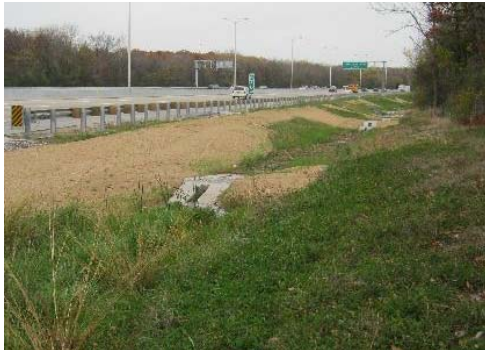
Figure 6. TB19 monitoring site locations (Aerial photo: Google Earth)

The surface-water monitoring site did not flow very often because most water infiltrated to the underdrain pipe, except during high intensity precipitation events. The underdrain outlet pipe exited into a wet bioswale that drained into a local creek. This underdrain pipe did not have ponded conditions at the outlet location.

6a. Pre-construction outlet TB19, view to south

6c. Bioswale site TB19

6b. Post-construction bioswale at TB19sw, view to north

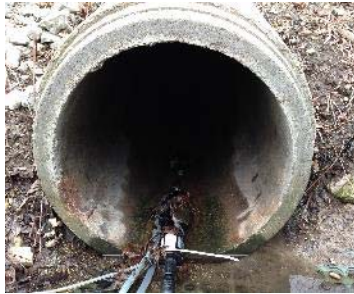
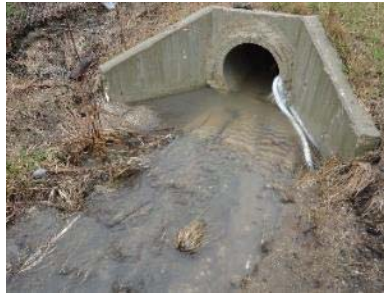
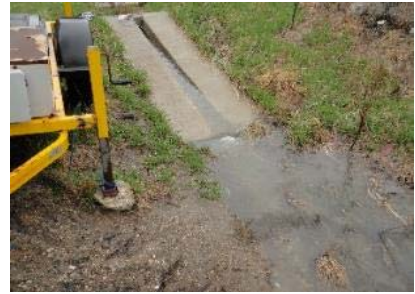
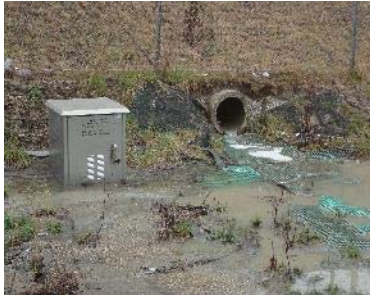
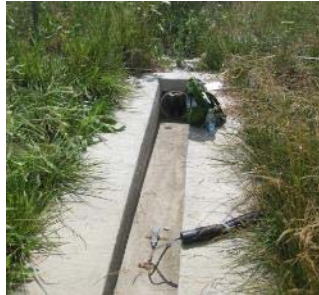
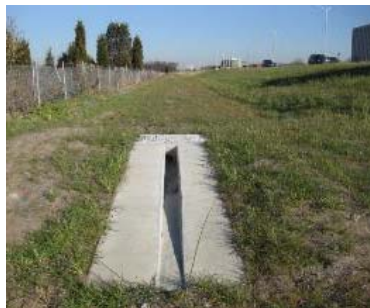
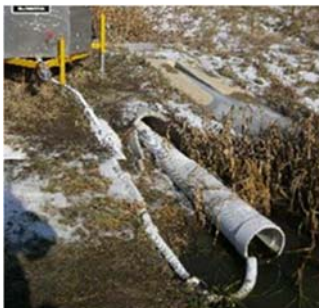
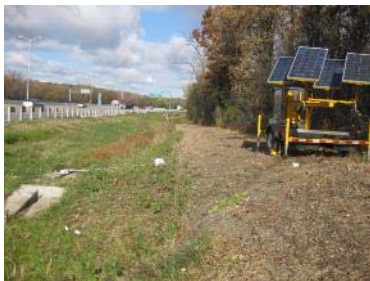
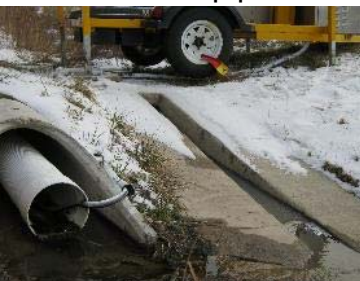
Figure 7. Instrument installations

Velocity data were collected with the Isco 750 AV modules using a Doppler velocity sensor recording data in time-averaged intervals. Velocity measurement accuracy was  $\pm 0.1$  ft/s between -5 ft/s and 5 ft/s, and resolution was 0.024 ft/s. Accurate sensor measurements were obtained at a minimum water depth of 0.083 ft and minimum velocity of 0.1 ft/s, and also when internal sensor and signal checks indicated there were no errors in the Doppler signal returns. Instrument installations for all sites are shown in Figure 7.

7a. TB7Bin 1.5-ft culvert

7b. TB7Bout 2-ft culvert

7c. TB7Bout check dam

7d. TB9Ac2N 1.5-ft culvert

7e. TB9A check dam

7f. TB15Bsw check dam

7g. TB15Bgw 8-in.  
underdrain pipe

7h. TB19sw check dam

7i. TB19gw 8-in.  
underdrain pipe
