Effects of Coal-bound Chlorine on Furnace-Wall Corrosion Under Low-NO_x Conditions

M-I.M. Chou and W.R. Roy Illinois State Geological Survey

Illinois Minerals 123 2002

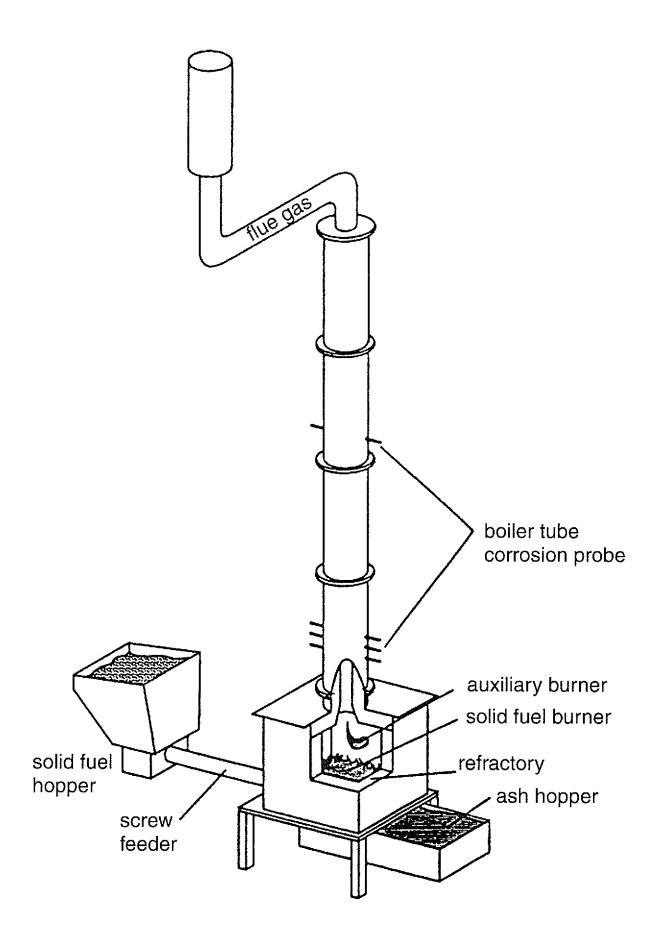
Figure 1 Overall schematic of the fireside corrosion testing facility.

This 2-year project focused on determining the effect of Cl in coal on furnace-wall corrosion under substoichiometric combustion conditions. During the first year, a stoker boiler system (figs. 1 and 2) at MTI was specifically modified for conducting corrosion-rate studies that could be related to sub-stoichiometric (low-NO_x) conditions. The first pilot-scale combustion corrosion test was conducted on the low-Cl coal, and the second test was conducted on the high-Cl coal.

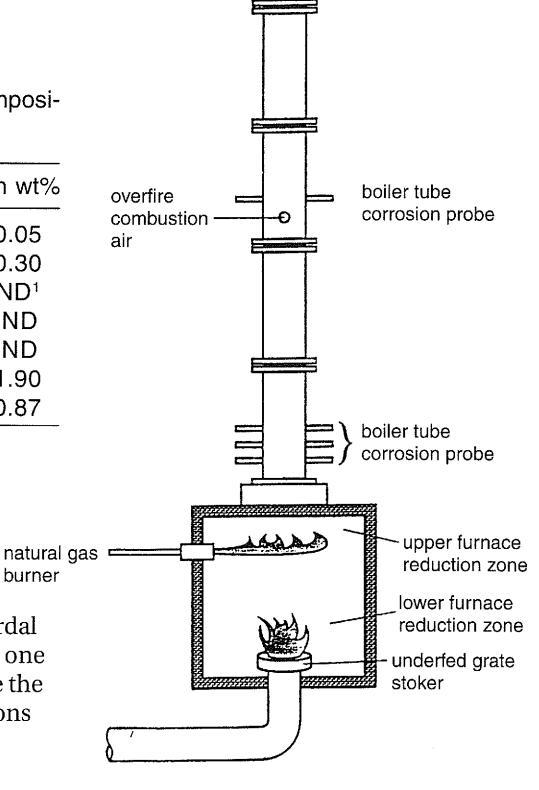
flue gas exit

Figure 2 Schematic of the stoker-fired furnace in the fireside corrosion testing facility.

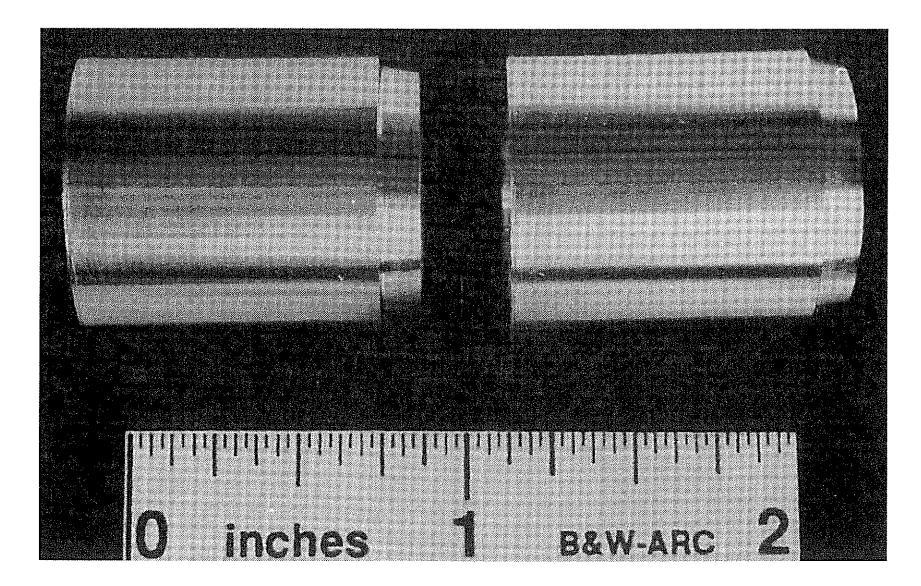
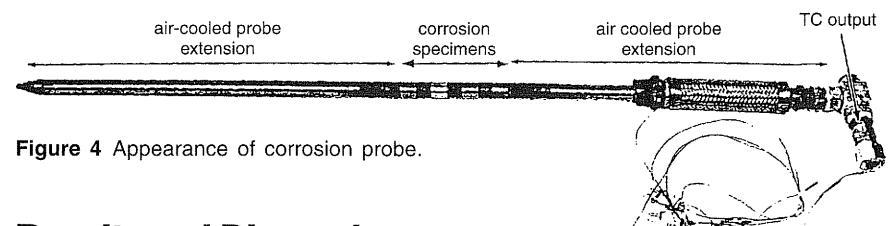
A special corrosion probe (figs. 3, 4, and 5) was designed for this study. The water-wall alloy T22 was assembled to form tube segments with 1-inch o.d. \times 1-inch length. The end of each segment was shaped to contain extruded and indented chamfers at 10° and 45°, respectively. The chamfers allowed multiple segments of samples to be connected to the probe without leakage of the cooling air. **Table 2** Nominal chemical composition of metal alloy T22.

Mechanical pressure was applied from both ends of the probe so that a tight fit could be achieved during the sample segment installation. Type K chordal thermocouples were attached to one of the tube segments from inside the probe. The thermocouple junctions were embedded in the tube wall in a hole drilled in the sample's inner surface and secured by silver soldering.

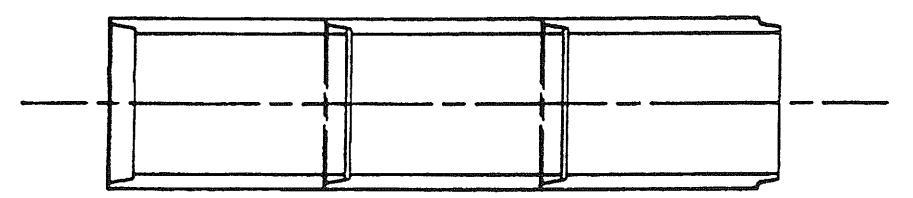
Figure 5 Arrangement of chamfered test samples on the probe.

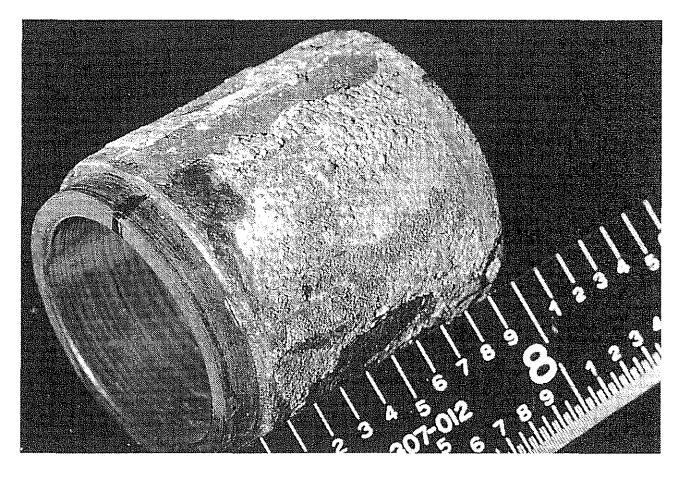
Figure 6 Appearance of test sample after exposure to low-Cl coal combustion.

Photographs of the corrosion samples obtained from the first test of the low-Cl coal and the second test of the high-Cl coal are shown in figures 6 and 7. The corrosion sample from the test firing with the low-Cl coal (fig. 6) had a much thicker surface deposit than did the sample (fig. 7) obtained from the test firing with the high-Cl coal. One sample from each of the tests was chemically cleaned to remove scale before the wall thickness was remeasured. Photographs of these two chemically cleaned samples are shown in figures 8 and 9. The wall thickness measurements before and after the combustion tests are compared in table 3.

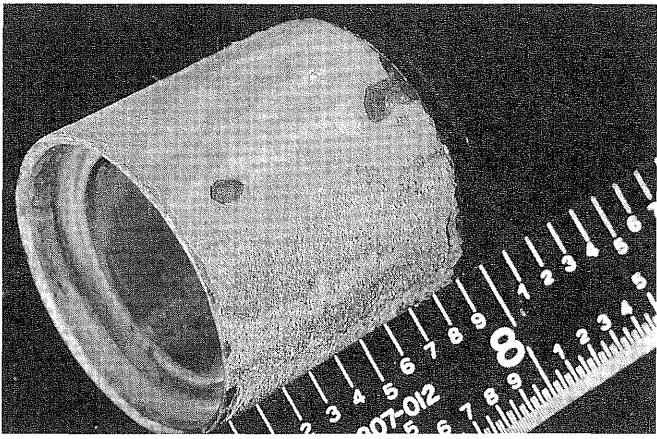
Figure 7 Appearance of test sample after exposure to high-Cl coal combustion.

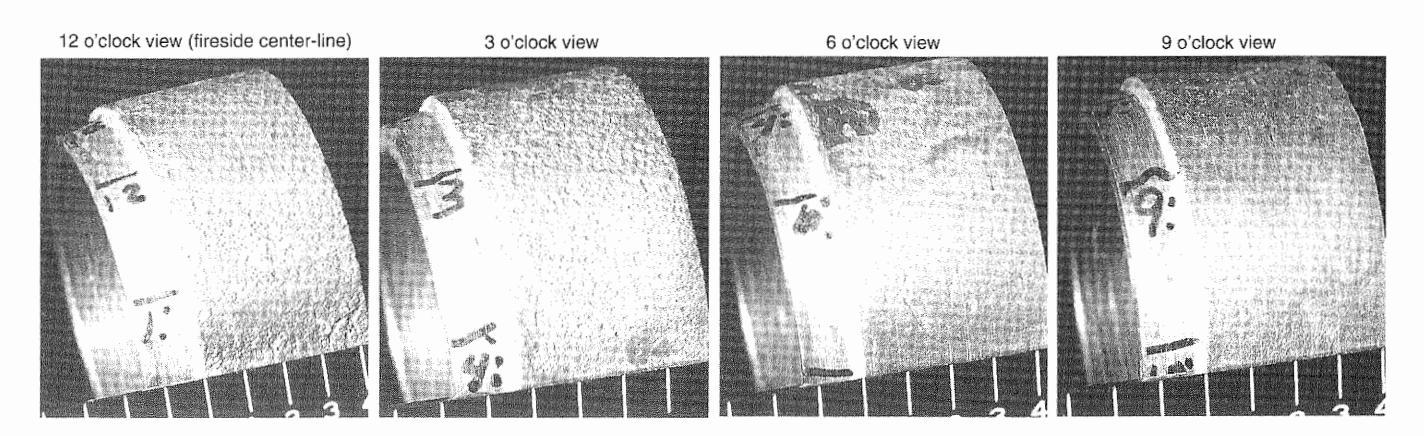
Figure 8 The low-CI coal combustion sample after chemical cleaning.

For both tests, the thickness of metal tube wall lost on the hot-side centerline was 1 mil, and the maximum wall thickness lost was 3 mils, which would extrapolate to 33 mils per year of continuous running. The average wall thickness lost for the sample from the low-Cl coal test was 1.88 mils, which would extrapolate to an average of 20 mils per year. The average thickness lost for the sample from the high-Cl coal test was 1.13 mils, which would extrapolate to 12 mils per year. The data indicated that the maximum corrosion rate of the T22 samples was the same whether burning the low-Cl or high-Cl coal. However, the average corrosion rate obtained from burning the low-Cl coal was slightly greater than that for the high-Cl coal.

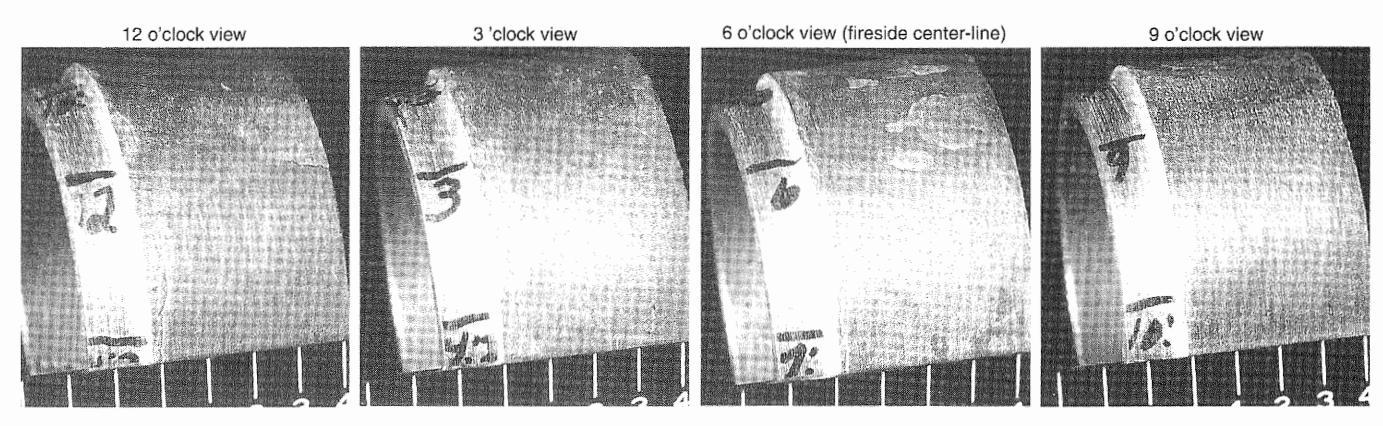
Figure 9 The high-CI coal combustion sample after chemical cleaning.

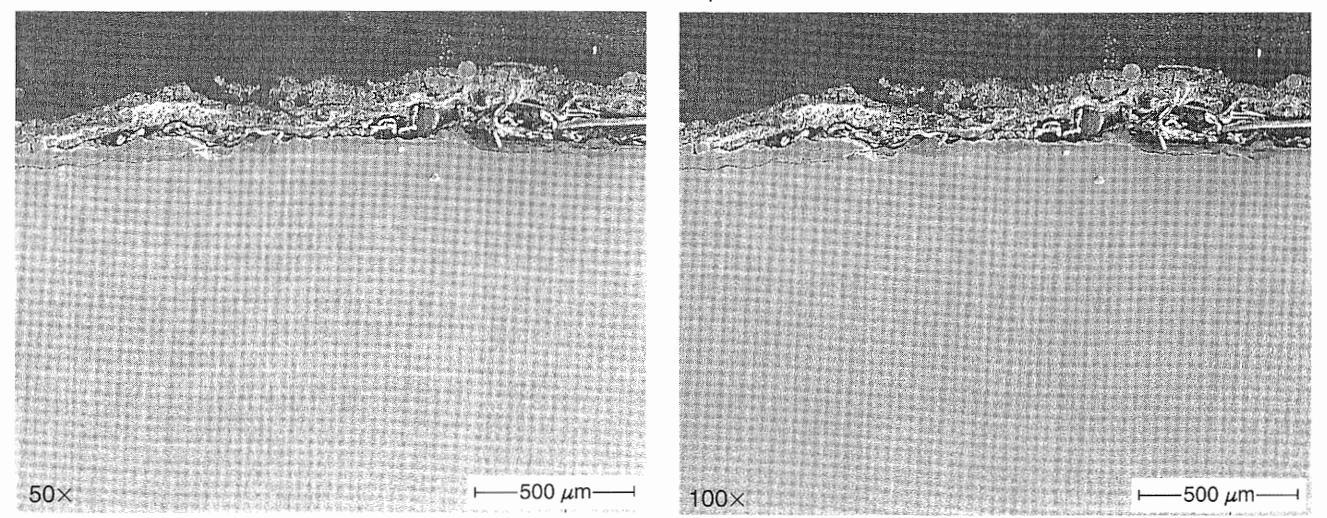
F22-3 sample

Figure 10 SEM of a polished cross section at the external surface of the low-Cl coal combustion sample.

Examination of polished cross sections of the sample from the test with the low-Cl coal (figs. 10 and 11) showed that the sample had a coherent scale at the interface with the underlying metal. The average thickness of this scale was approximately 2.5 mils. Coal ash and other combustion deposits were found attached to, and above, the coherent scale.

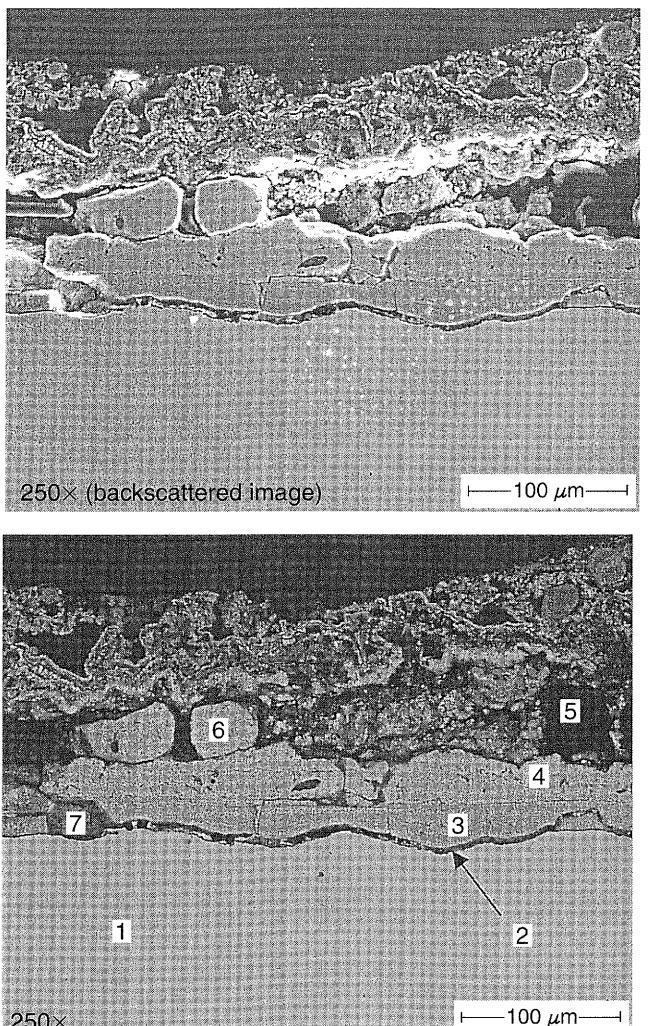
F22-3 sample showing EDS locations 1-7

Figure 11 Appearance of scale and deposit on the low-Cl coal combustion sample.

The EDS was used to provide a semiquantitative analysis of the metal composition. The tube metal composition of the sample from the low-Cl coal test was examined. The data obtained at location 1, shown in figure 11, are given in table 4. The composition of the deposit at the interface between the scale and the underlying metal was also determined (table 5). At that location, the sulfur content was 5.36 wt%, and no chloride deposition was observed. An additional investigation was undertaken to determine whether chloride deposition might be found elsewhere at the interface. Some small, isolated pockets containing chloriderich deposits were found, and one of the pockets (fig. 12) showed a Cl content of about 0.73 wt% (table 6).

Table 4 EDS analysis of the chemical composition ofthe tube metal (at location 1, shown in fig. 11) of asample from the low-Cl coal test.

Table 5 EDS analysis of the chemical composition ofthe tube-scale interface (at location 2, shown in fig. 11)of a sample from the low-Cl coal test.

Table 7 EDS analysis of the chemical composition ofthe coherent scale deposits (at location 3, shown in fig.11) of a sample from the low-Cl coal test.

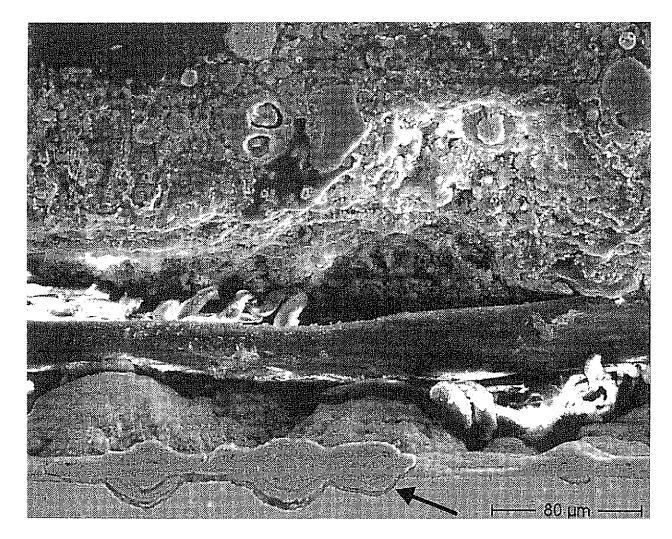
Figure 12 Isolated chloride-rich deposits found at the tubescale interface of the low-Cl coal combustion sample.

Table 6 Analysis of combustion deposits (pocket location indicated by arrow in fig. 12).

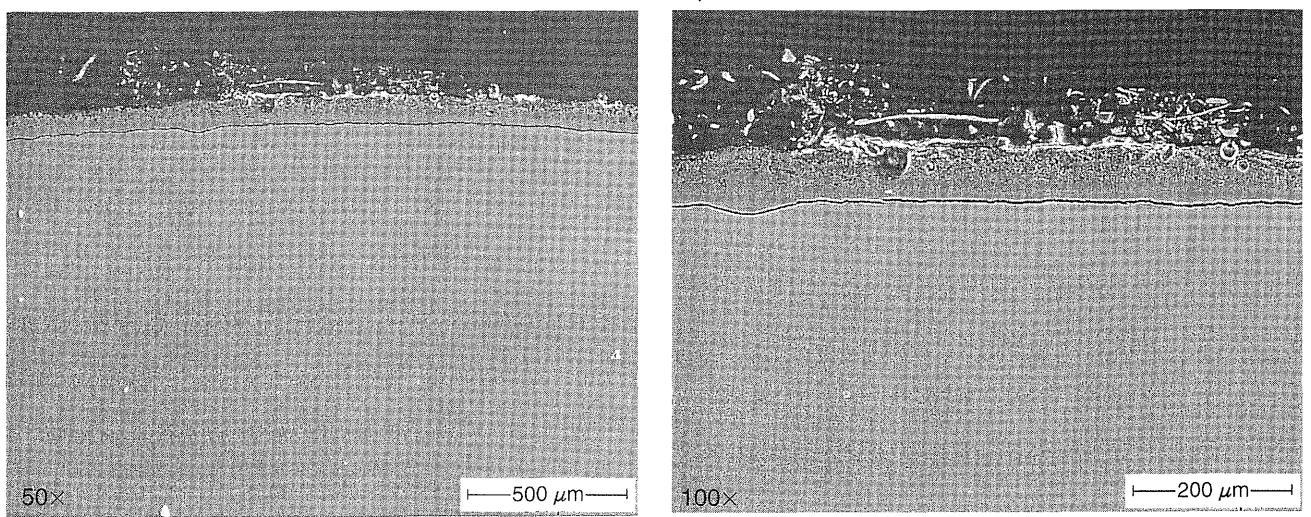
F22-2 sample

Figure 13 SEM of a polished cross section at the external surface of the high-Cl coal combustion sample.

Polished cross sections through the tube-metal sample exposed to test firing with the high-Cl coal (figs. 13 and 14) were also examined. This sample had a coherent scale that was somewhat thinner than the sample obtained from the low-Cl firing test (1.0 mil instead of 2.5 mils). Much less coal ash and smaller other deposits were found on top of the coherent scale. The transition to these deposits was more gradual than that for the sample from the low-Cl coal test. Again, the EDS analysis was used to provide a semiquantitative measure on the metal tube

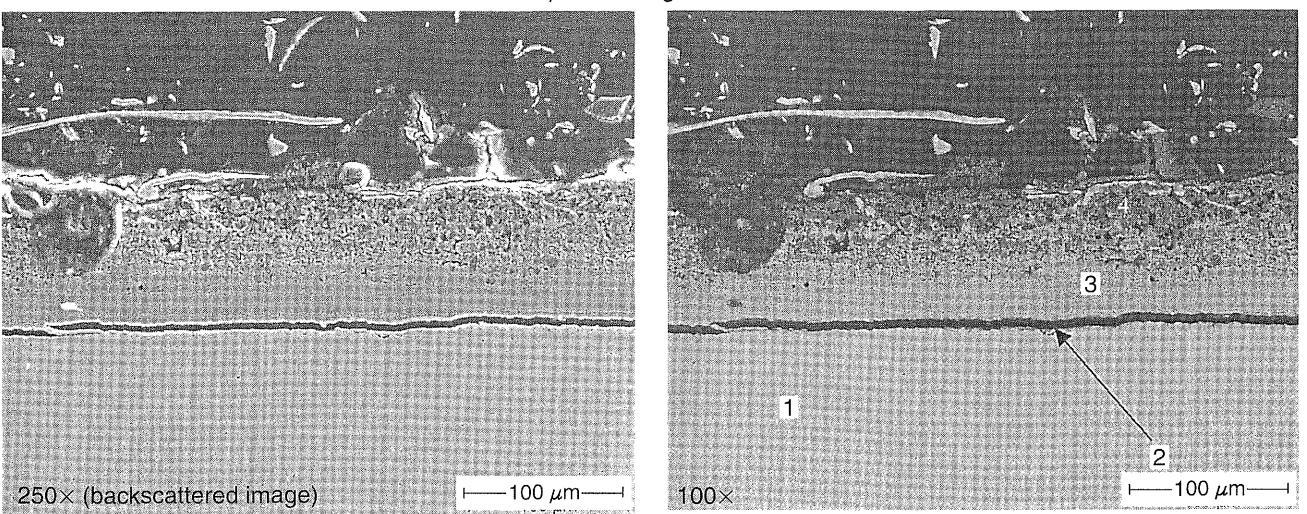
F22-2 sample showing EDS locations 1-4

Figure 14 Appearance of coherent scale and deposit on the high-Cl coal combustion sample.

Table 8 EDS analysis of the chemical composition ofthe tube metal (at location 1, shown in fig. 14) of asample from the high-Cl coal test.

Table 9 EDS analysis of the chemical composition ofthe tube-scale interface (at location 2, shown in fig. 14)of a sample from the high-Cl coal test.

Additional searching revealed no significant evidence of chloride deposition at the scale-metal interface. Analysis of the coherent scale itself revealed a sulfur content (0.34 wt%) for the high-Cl coal test (table 10) that was significantly lower than that for the sample from the low-Cl coal test (11.2 wt%) (table 7). Again, in no case was chloride deposition found either in the scale or in the combustion deposits on this sample.

Table 10 EDS analysis of the chemical composition ofthe coherent scale deposits (at location 3, shown in fig.14) of a sample from the high-Cl coal test.
