ROOF STRATA OF THE HERRIN (NO. 6) COAL MEMBER IN MINES OF ILLINOIS: THEIR GEOLOGY AND STABILITY

Summary report

H.-F. Krausse, H. H. Damberger,
W. J. Nelson, S. R. Hunt,
C. T. Ledvina, C. G. Treworgy, and W. A. White

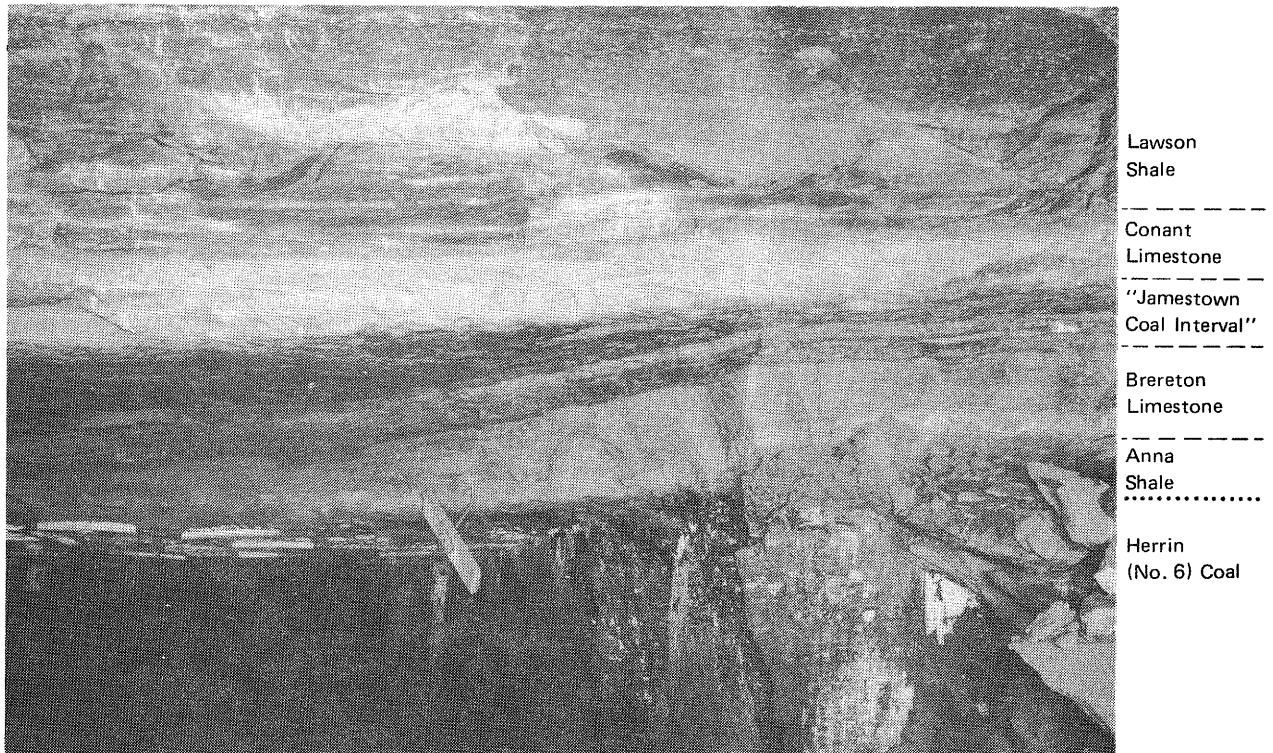
Figure 27. Wedging relationship of roof rock layers; both the Anna Shale and the Brereton Limestone pinch out (toward left side of photo). The "Jamestown Coal interval" has thin coal streaks and contributes to bedding separation. The overlying Conant Limestone is too thin to bridge stresses from one pillar to the next. The Lawson Shale is soft and mottled and contains numerous low-angle shear planes and syneresis cracks. Location: mine A, west-central Illinois.

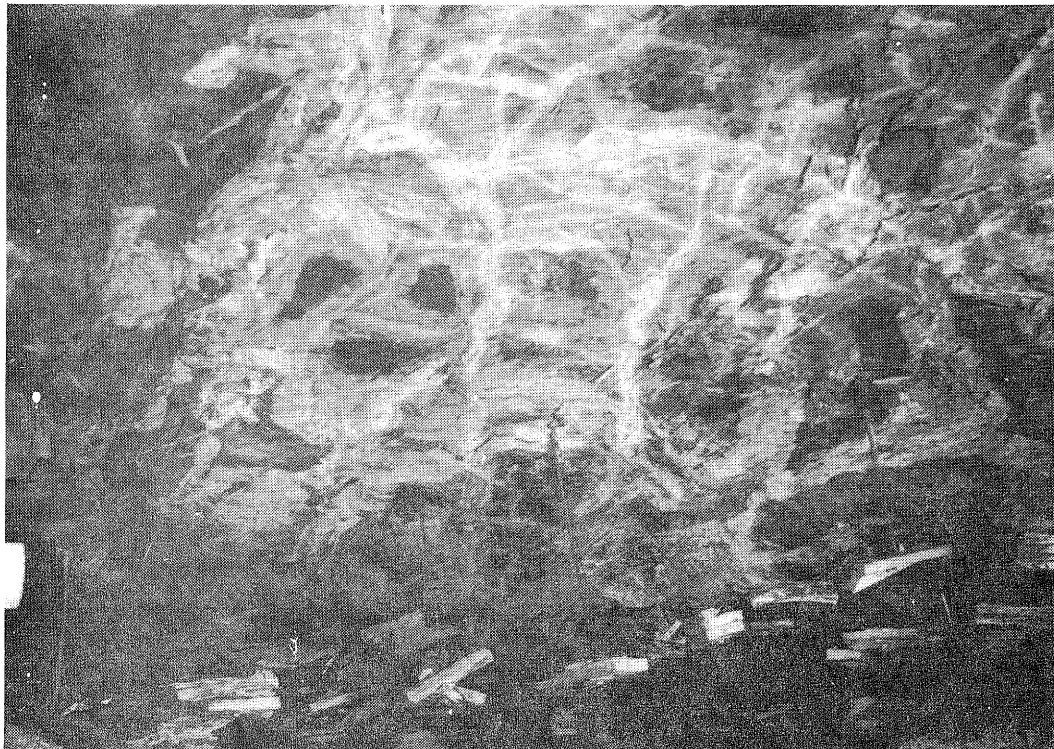
Figure 29. Mottled shale with syneresis cracks in greenish medium-gray shale, above very dark gray shale, probably Lawson Shale (with syneresis cracks) above Anna Shale. Note roof bolts hang out bare; the soft shales have fallen because of moisture slaking; in the center of roof fall, even bolt anchors have fallen out. Location: a mine in east-central Illinois.

occur (figs. 28, 29). In very few falls the Bankston Fork Limestone also has failed, exposing even higher strata.
